## SERVICE BULLETIN

**APPLICABILITY:** 23MY Outback/Legacy Models  
(including Wilderness models)  
23MY Ascent Models

**NUMBER:** 15-305-22R

**SUBJECT:** Reprogramming File Availability for Optimization of Gen 4.5 Denso CP1.5 Infotainment Systems

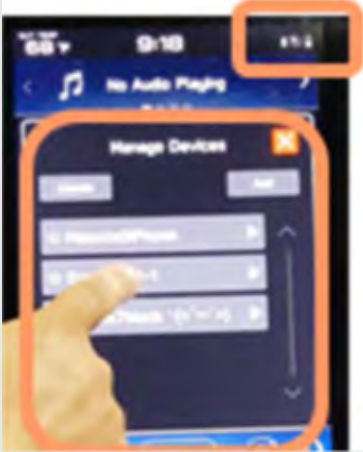
Number	Symptoms to be Improved:
<b>1</b>	CID goes black and does not accept any control.
<b>2</b>	CID reboots.
<b>3</b>	“Manage Devices” is grayed out and cannot establish Bluetooth connection.
<b>4</b>	When the Bluetooth connection is cancelled manually on the mobile phone side during hands-free calling, the Bluetooth connection is disabled for that particular mobile phone. Even when it occurs, the connection can be reestablished by deleting the device in “Manage Devices” and register the device again by adding operation.
<b>5</b>	Bluetooth connection fails against the device that was paired before and “Manage Devices” is grayed out.
<b>6</b>	Bluetooth connection is disabled with a discrepancy in the display of status bar (showing Bluetooth devices being connected) and the “Manage Devices” screen (showing no Bluetooth devices being connected.)  <div style="text-align: center;">

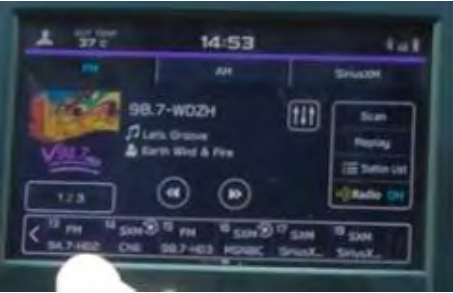
Number	Symptoms to be Improved:
11	<p>Sound is lost when changed to Subchannel 2 right after a preset HD radio channel has been selected.</p>

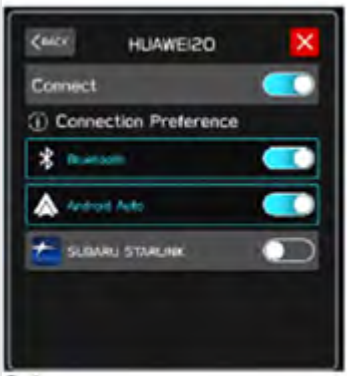
2	<p>On the "Manage Devices" screen Bluetooth cannot be selected as connection preference.</p>

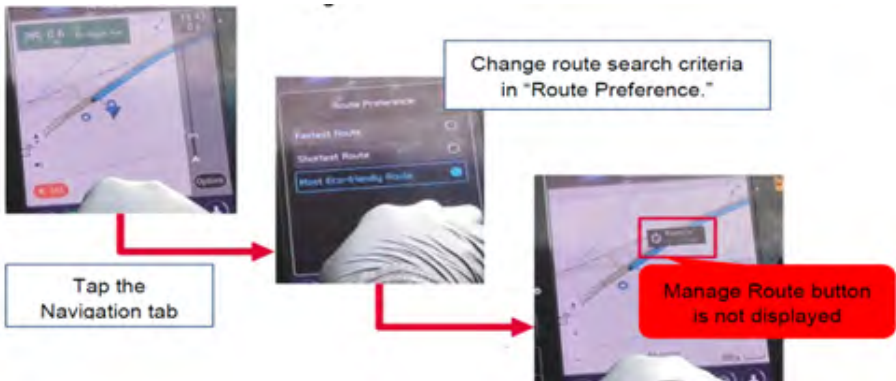
10	<p>Navigation restarts itself, when the letters are rashly entered or deleted using keyboard function to search destination.</p>
11	<p>“Manage Route” button is not displayed when touching the route line on Navigation system, when the route search criteria got changed in the Route Preference Screen after a route had been searched.</p>
