Cayenne E-Hybrid – Thermal Management Fault P26B100 Causes Check Engine Light

Vehicles Affected

Models	Model Year	Model Type	VIN Range	Vehicle-Specific Equipment
Cayenne	As of 2019 up to 2023	9YAAE1 9YACH1 9YADE1 9YBAE1 9YBCH1 9YBDE1	N/A	+OK3

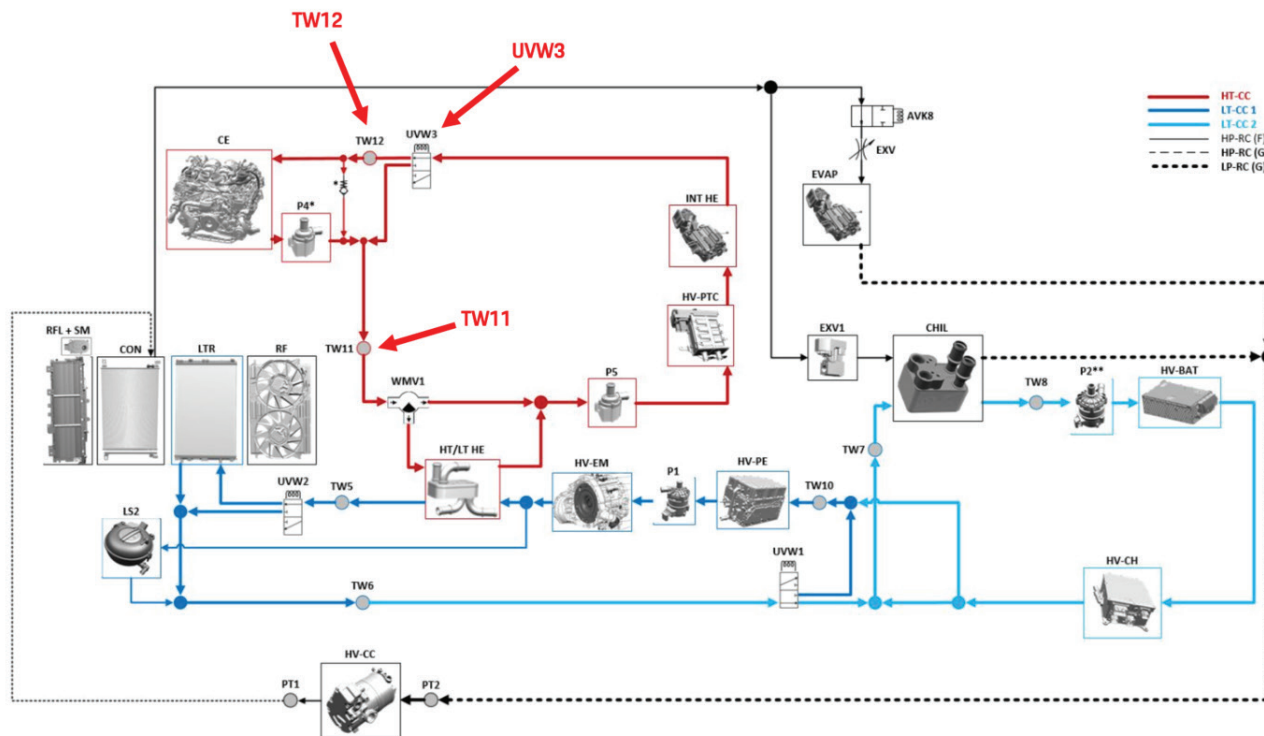
Figure 1 - Cayenne E-Hybrid Cooling Circuits

Valve UWV3 controls the direction of coolant flow based on engine temperature. The valve defaults to closed, such that the high-temp circuit excludes the engine coolant circuit. During this “small-circuit” operation, the HV PTC controls the temperature of the high-temp circuit to meet the heating and air conditioning demands of the customer. Once the engine reaches 40° C, the valve opens (“large-circuit” operation) and the high-temp circuit uses the engine heat instead of the HV PTC.

The status of UWV3 is diagnosed by the absolute value of the temperature difference between TW11 and TW12. The TME expects this difference to be **larger than 7° C while the valve is closed, but smaller than 7° C while the valve is open**. Certain operating conditions may cause the temperature difference to fall below 7° C while the valve is closed. If this condition exists while the TME is performing diagnostics, the valve will be diagnosed as open, although it is closed due to the engine temperature being less than 40° C.
