### 95B.III – Macan In-Line 4 Cylinder Engine–DME Fault P25AC00/00426A

#### Vehicles Affected

#### Condition

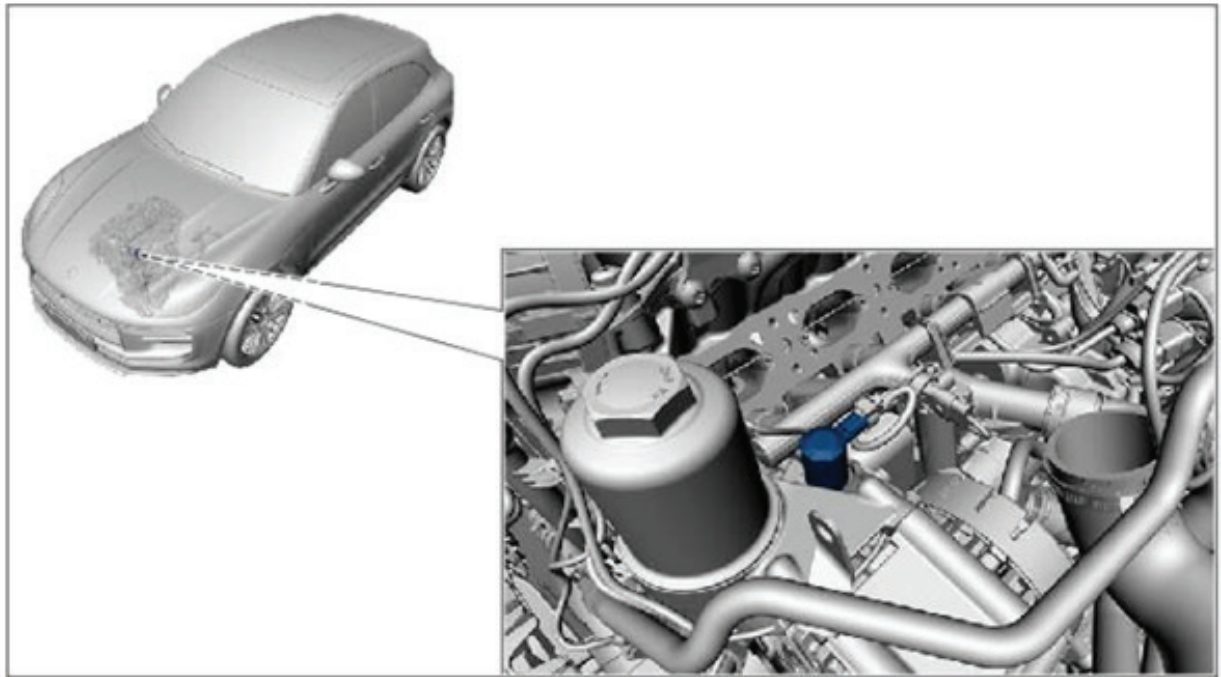
**Figure 1:**  
Installation position of control valve 9A7.115.243.A on R4 Evo with  
intake manifold removed from WM 172519.

1. Remove and replace the Oil Pressure Control Valve for Piston Cooling (9A7115243A) according to WM 172519 (highlighted blue in Figure 1 below for 2022+ R4 Evo engines, shown as location 6 in Figure 2 for pre 2022 R4 engines). Please also clean any excess debris around the valve's mating surfaces and galleys.
2. Perform an oil and filter change

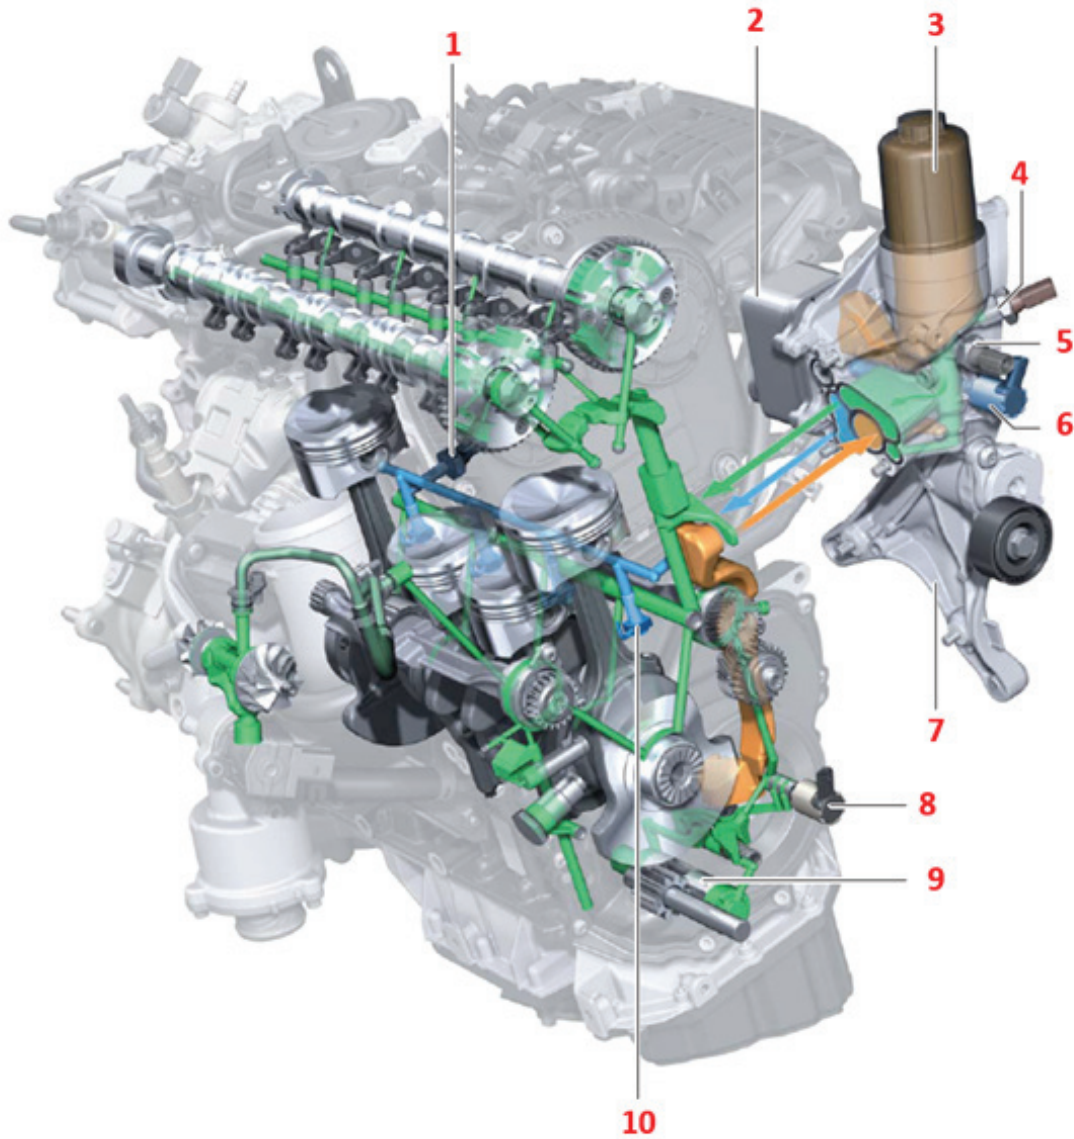
**Figure 2:**  
GFF diagram with locations of relevant oil circuit components for pre-2022 R4 engine.

3. If there are no permanent damages to the internal oil channels of the oil filter housing, clear fault and road test with new valve.
4. If the issue persists, replace the two oil pressure switches (PAC919081 and 958919081120) in positions 4 and 5 of Figure 2, or alternatively positions 17 and 18 from Figure 3.

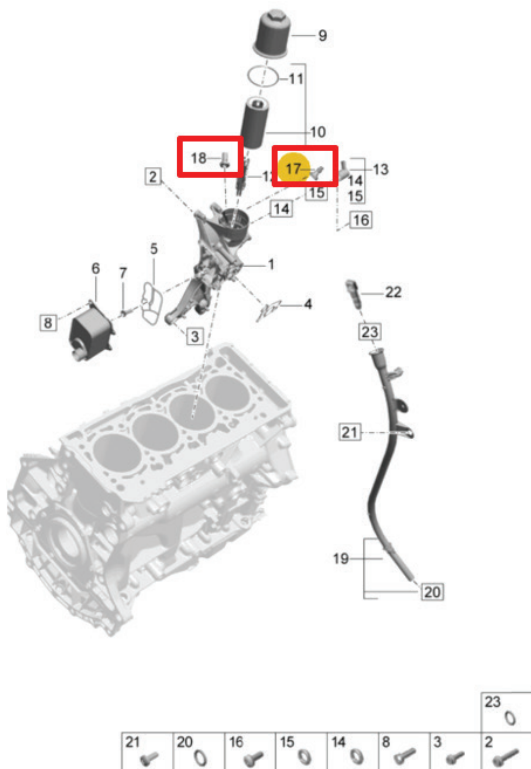
**Figure 3:**

View of oil pressure switches PAC919081 and 958919081120 at locations 17 and 18 in PET illustration.
