| Re: Recall Campaign Launch Notification Model - Sprinter Model Years 2022 Swivel Seat Wire Harness Routing | DATE: March, 2023 |

Campaign No. 2023030003, March, 2023

SUBJECT: **Model 907 Sprinter, Model Year 2022
Swivel Seat Wire Harness Routing**

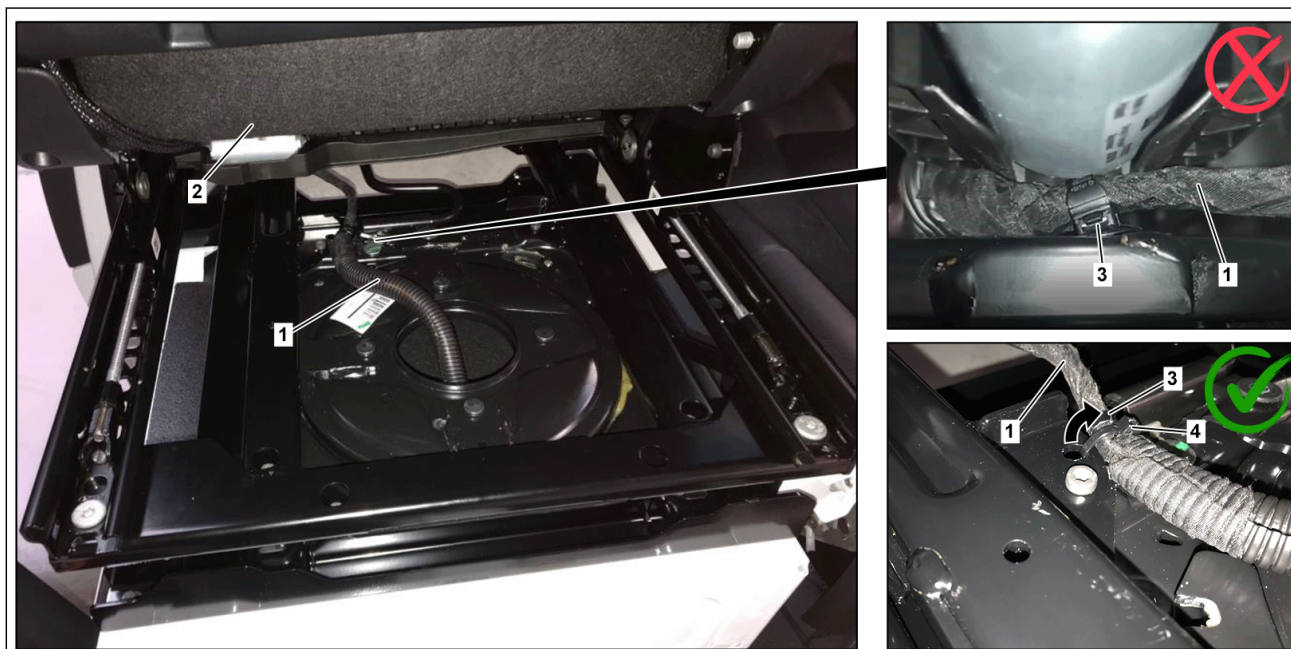
D91.29-A012-79

Mercedes-Benz AG (“MBAG”), the manufacturer of Mercedes-Benz Sprinter vehicles, has determined that on certain Sprinter (907 platform) vehicles equipped with electrically adjustable front swivel-seats, the electrical wiring harness might become damaged over time when a front swivel seat is adjusted. In the event of a damaged wiring harness, it cannot be ruled out that the function of the side airbag installed in the seat back might be impaired. This could increase the risk of injury.

Shown on driver's seat with code SF1 (Electrically adjustable driver's seat) and code SR8 (Driver's seat rotating frame)

| 2 | Check wiring harness (1) on rotating seat (2). | <p>i</p> <p>To do so, move rotating seat (2) down completely using electrical seat adjustment, and check whether there is sufficient space between wiring harness (1) and rotating seat console, or whether actuator motor of electrical seat adjustment CANNOT touch wiring harness (1).</p> <p>Check wiring harness (1) for damage.</p> <p>i</p> <p>If rotating seats (2) are installed on the driver's side and front passenger side, then the wiring harnesses (1) of both rotating seats (2) must be checked and adapted if necessary.</p> <p>If actuator motor of electrical seat adjustment touches wiring harness (1) (see picture) or wiring harness (1) is damaged:</p> <p style="text-align: center;">↓</p> <p>Repair wiring harness and continue with next operation step.</p> <p>If wiring harness (1) does not touch actuator motor of electrical seat adjustment and wiring harness (1) is not damaged:</p> <p style="text-align: center;">↓</p> <p>end the measure.</p> | |
| 4 | Subsequently modify mount of wiring harness (1) at rotating seat (2). | <p>i</p> <p>To do so, remove cable tie with fir tree clip (2) from rotating seat console and fasten wiring harness (1) next to original position on rotating seat console with a new cable tie (4). See figure.</p> <p>The old cable tie with the fir tree clip (2) can remain on the wiring harness (1).</p> | |
