GLOBAL SAFETY FIELD INVESTIGATIONS  
DCS6530  
URGENT - DISTRIBUTE IMMEDIATELY

Subject: N222375791-02 - Customer Satisfaction Program  
Park Assist Retrofit  
Population Update

# Customer Satisfaction Program

## N222375791 Park Assist Retrofit

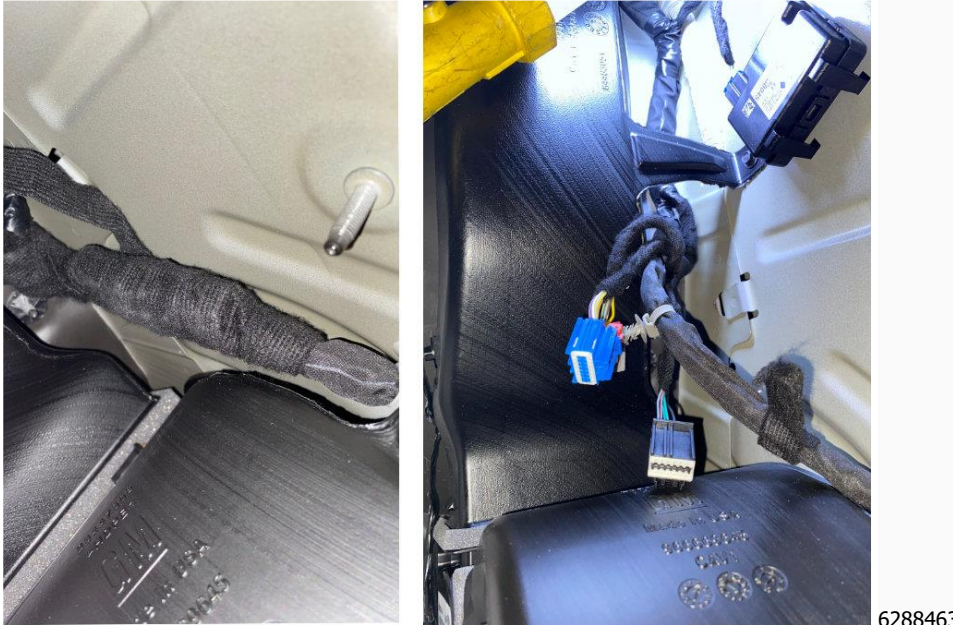
### XT6

**Note:** The wiring harness for the Parking Assist Control Module may be wrapped around an adjacent wiring harness as shown above. Remove the attaching tape by unwrapping. Do NOT cut the tape as it could damage the wiring harness.

1. Install the new Parking Assist Control Module. Refer to *Parking Assist Control Module Replacement* in SI.

2. Reprogram the Parking Assist Control Module. Refer to *K182 Parking Assist Control Module: Programming and Setup* in SI.
3. Perform setup and configuration on the Parking Assist Control Module. Refer to *K182 Parking Assist Control Module: Programming and Setup* in SI.
4. Perform setup and configuration on the Instrument Cluster. Refer to *P16 Instrument Cluster: Programming and Setup* in SI.

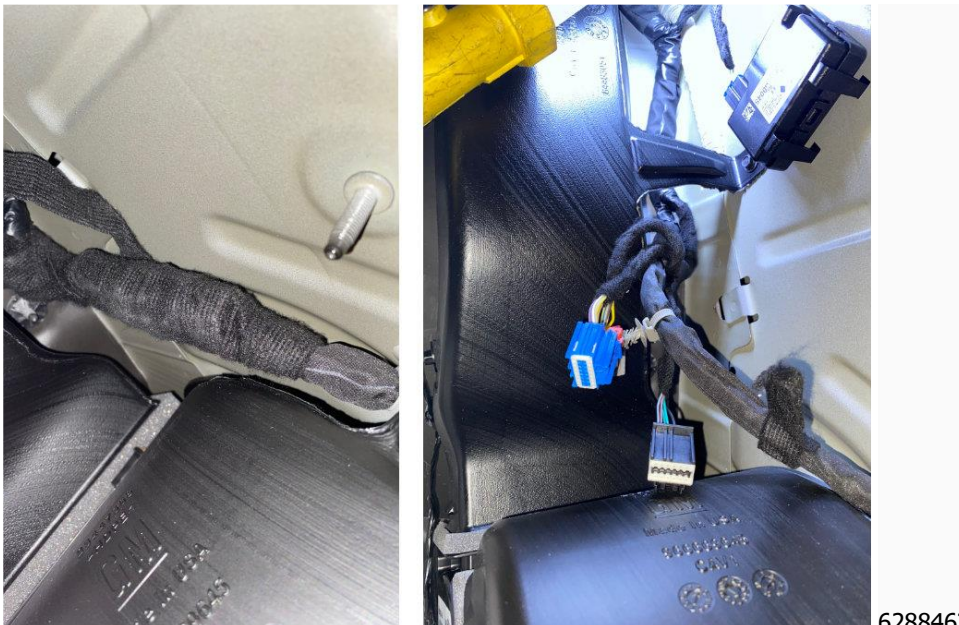
## XT5

**Note:** The wiring harness for the Parking Assist Control Module may be wrapped around an adjacent wiring harness as shown above. Remove the attaching tape by unwrapping. Do NOT cut the tape as it could damage the wiring harness.

1. Install the new Parking Assist Control Module. Refer to *Parking Assist Control Module Replacement* in SI.

2. Reprogram the Parking Assist Control Module. Refer to *K182 Parking Assist Control Module: Programming and Setup* in SI.
3. Perform setup and configuration on the Parking Assist Control Module. Refer to *K182 Parking Assist Control Module: Programming and Setup* in SI.
4. Perform setup and configuration on the Instrument Cluster. Refer to *P16 Instrument Cluster: Programming and Setup*.

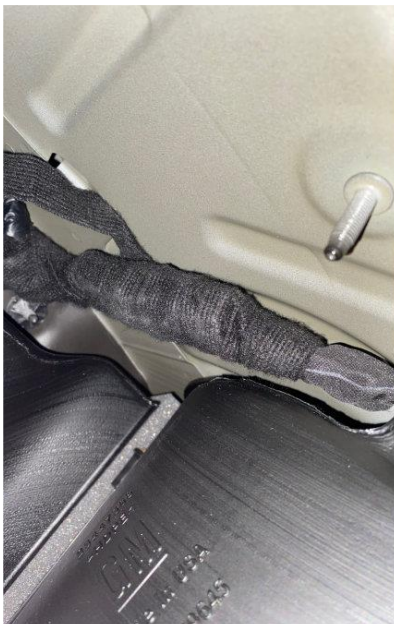
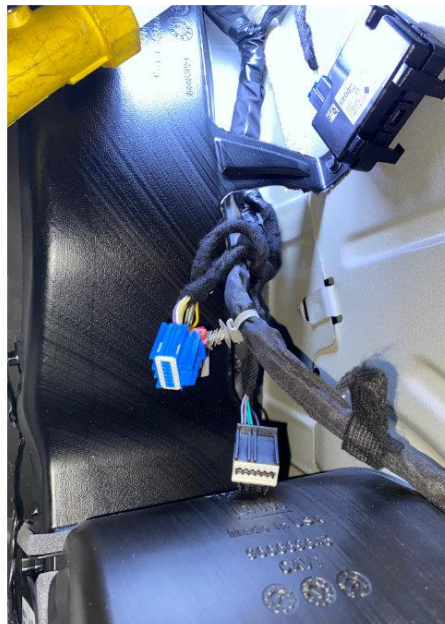
### XT4 with UD7

**Note:** The wiring harness for the Parking Assist Control Module may be wrapped around an adjacent wiring harness as shown above. Remove the attaching tape by unwrapping. Do NOT cut the tape as it could damage the wiring harness.

1. Install the new Parking Assist Control Module. Refer to *Parking Assist Control Module Replacement* in SI.

2. Reprogram the Parking Assist Control Module. Refer to *K182 Parking Assist Control Module: Programming and Setup* in SI.
3. Perform setup and configuration on the Parking Assist Control Module. Refer to *K182 Parking Assist Control Module: Programming and Setup* in SI.
4. Perform setup and configuration on the Instrument Cluster. Refer to *P16 Instrument Cluster: Programming and Setup*.

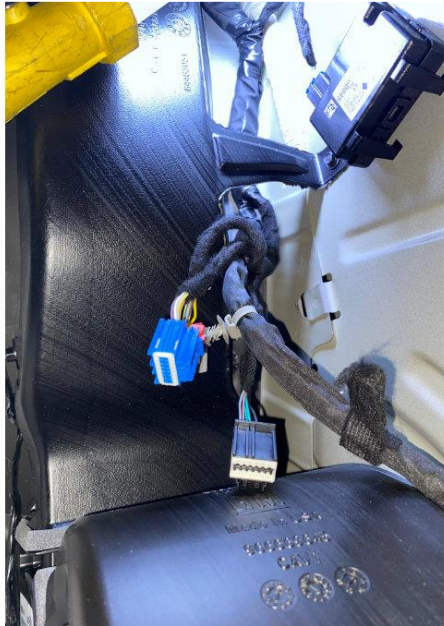
XT4 with UD5 without UGN, UVZ, or UKL

**Note:** The wiring harness for the Parking Assist Control Module may be wrapped around an adjacent wiring harness as shown above. Remove the attaching tape by unwrapping. Do NOT cut the tape as it could damage the wiring harness.

1. Install the new Parking Assist Control Module. Refer to *Parking Assist Control Module Replacement* in SI.

2. Reprogram the Parking Assist Control Module. Refer to *K182 Parking Assist Control Module: Programming and Setup* in SI.
3. Perform setup and configuration on the Parking Assist Control Module. Refer to *K182 Parking Assist Control Module: Programming and Setup* in SI.
4. Perform setup and configuration on the Instrument Cluster. Refer to *P16 Instrument Cluster: Programming and Setup*.

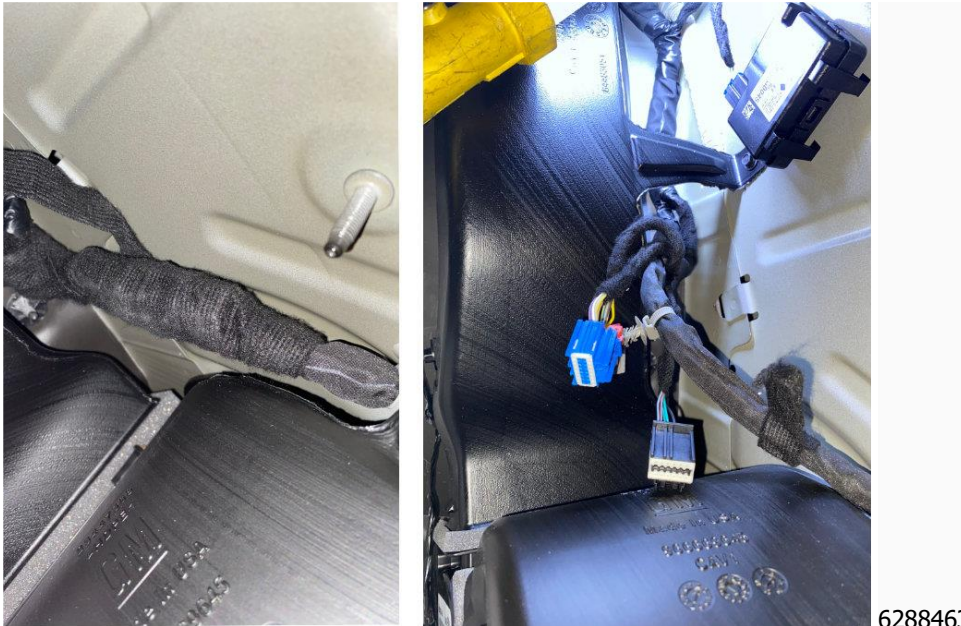
**XT4 with UD5 with UGN, UVZ, or UKL**

**Note:** The wiring harness for the Parking Assist Control Module may be wrapped around an adjacent wiring harness as shown above. Remove the attaching tape by unwrapping. Do NOT cut the tape as it could damage the wiring harness.

1. Install the new Parking Assist Control Module. Refer to *Parking Assist Control Module Replacement* in SI.

4. Perform setup and configuration on the Instrument Cluster. Refer to *P16 Instrument Cluster: Programming and Setup*.

5. Reprogram the Active Safety Control Module. Refer to *K124 Active Safety Control Module: Programming and Setup*.

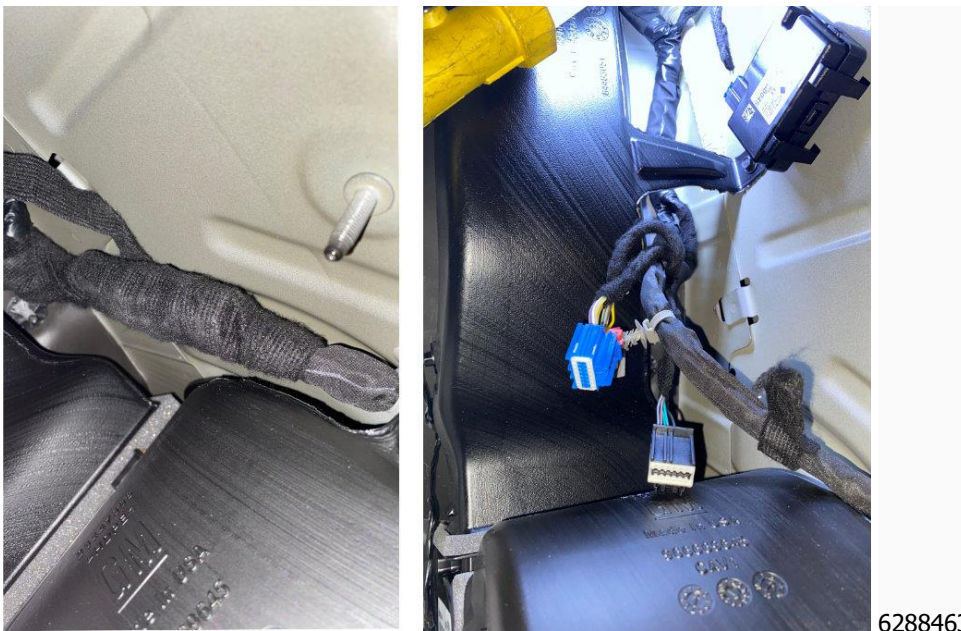
### Silverado/Sierra (Includes both 2022 and 2023 LDs and HDs)

**Note:** The wiring harness for the Parking Assist Control Module may be wrapped around an adjacent wiring harness as shown above. Remove the attaching tape by unwrapping. Do NOT cut the tape as it could damage the wiring harness.

1. Install the new Parking Assist Control Module. Refer to *Parking Assist Control Module Replacement* in SI.

2. Reprogram the Parking Assist Control Module. Refer to *K182 Parking Assist Control Module: Programming and Setup* in SI.
3. Perform configuration on the Parking Assist Control Module. Refer to *K182 Parking Assist Control Module: Programming and Setup* in SI.
4. Reprogram the Body Control Module. Refer to *K9 Body Control Module: Programming and Setup* in SI.
5. Perform program and configuration on the Instrument Cluster. Refer to *P16 Instrument Cluster: Programming and Setup* in SI.

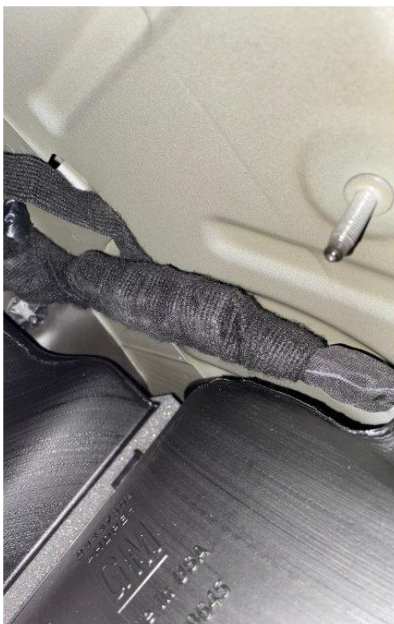
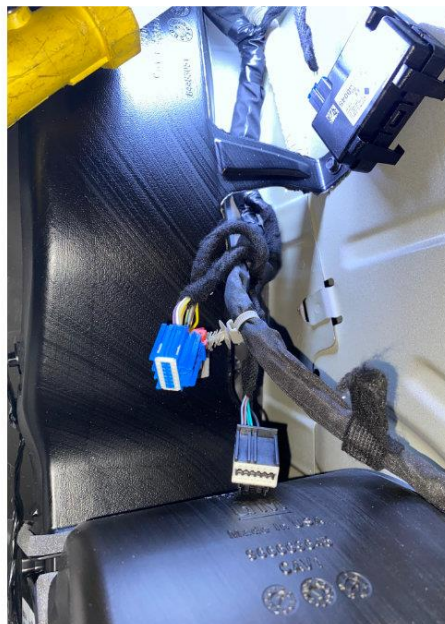
**Enclave without UGN, UVZ, or UKL.**

**Note:** The wiring harness for the Parking Assist Control Module may be wrapped around an adjacent wiring harness as shown above. Remove the attaching tape by unwrapping. Do NOT cut the tape as it could damage the wiring harness.

1. Install the new Parking Assist Control Module. Refer to *Parking Assist Control Module Replacement* in SI.

2. Reprogram the Parking Assist Control Module. Refer to *K182 Parking Assist Control Module: Programming and Setup* in SI.
3. Perform configuration on the Parking Assist Control Module. Refer to *K182 Parking Assist Control Module: Programming and Setup* in SI.
4. Perform setup and configuration on the Instrument Cluster. Refer to *P16 Instrument Cluster: Programming and Setup*.

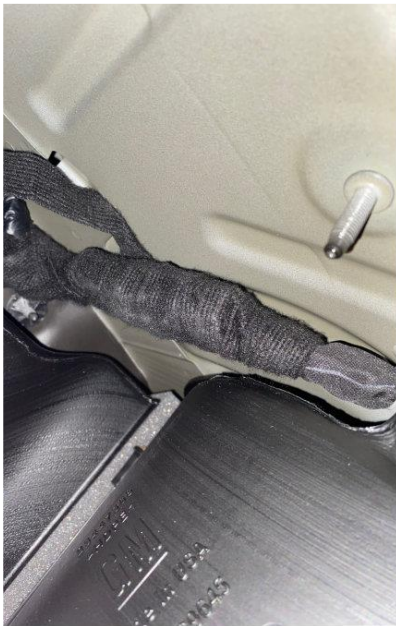
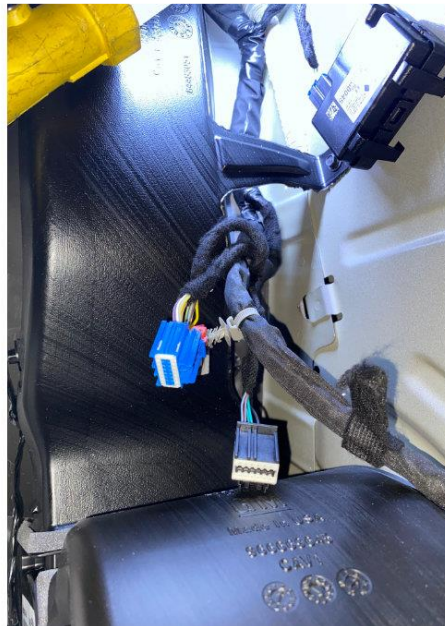
## Acadia with UGN, UVZ, or UKL

**Note:** The wiring harness for the Parking Assist Control Module may be wrapped around an adjacent wiring harness as shown above. Remove the attaching tape by unwrapping. Do NOT cut the tape as it could damage the wiring harness.

1. Install the new Parking Assist Control Module. Refer to *Parking Assist Control Module Replacement* in SI.

2. Reprogram the Parking Assist Control Module. Refer to *K182 Parking Assist Control Module: Programming and Setup* in SI.
3. Perform configuration on the Parking Assist Control Module. Refer to *K182 Parking Assist Control Module: Programming and Setup* in SI.
4. Perform setup and configuration on the Instrument Cluster. Refer to *P16 Instrument Cluster: Programming and Setup*.
5. Reprogram the Active Safety Control Module. Refer to *K124 Active Safety Control Module: Programming and Setup*.

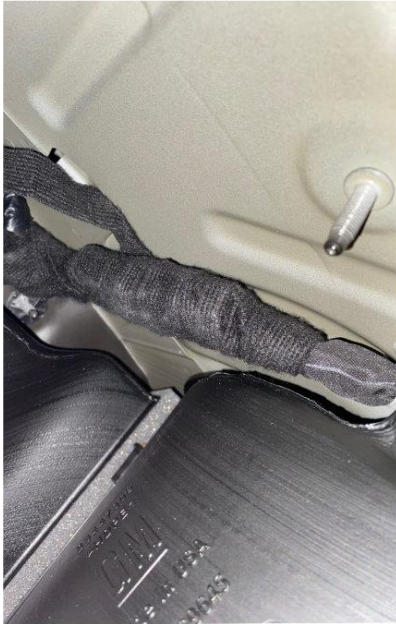
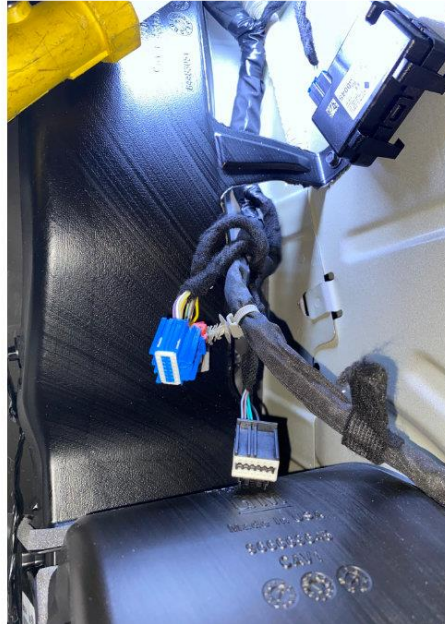
### Acadia without UGN, UVZ, or UKL

**Note:** The wiring harness for the Parking Assist Control Module may be wrapped around an adjacent wiring harness as shown above. Remove the attaching tape by unwrapping. Do **NOT** cut the tape as it could damage the wiring harness.

- Install the new Parking Assist Control Module. Refer to *Parking Assist Control Module Replacement* in SI.

- Reprogram the Parking Assist Control Module. Refer to *K182 Parking Assist Control Module: Programming and Setup* in SI.
- Perform configuration on the Parking Assist Control Module. Refer to *K182 Parking Assist Control Module: Programming and Setup* in SI.
- Perform setup and configuration on the Instrument Cluster. Refer to *P16 Instrument Cluster: Programming and Setup*.
