Service Bulletin

Bulletin No.: 23-NA-059

Subject: Gap at Door Armrest Decorative Trim to the Armrest/Door Switch

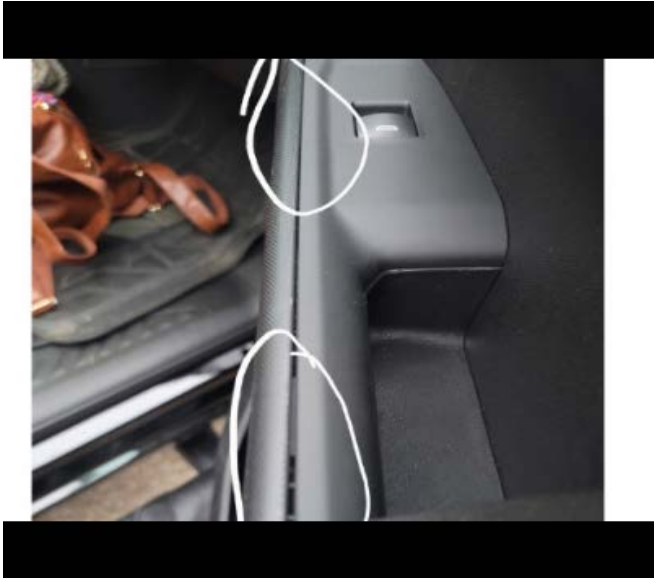
<p data-bbox="1419 779 1482 800">6307050</p> <p data-bbox="540 810 1398 858">Some customers may comment on a gap at the door armrest decorative trim to the armrest/door switch.</p>
Cause	The cause of the condition may be due to poor positioning.
Correction	<p data-bbox="540 911 1455 961">Remove trim and loosen door switch from the door panel and re-tighten the switch while holding the switch in the proper position.</p> <p data-bbox="540 968 1162 993">When the trim is reinstalled the gap should be 1 mm or less.</p>
