# Service Bulletin

Bulletin No.: 23-NA-060

**Subject: Creak/Tick Noise from the Left (Driver) Side Rear of the Vehicle When Traveling Over Bumps/Uneven Surfaces**

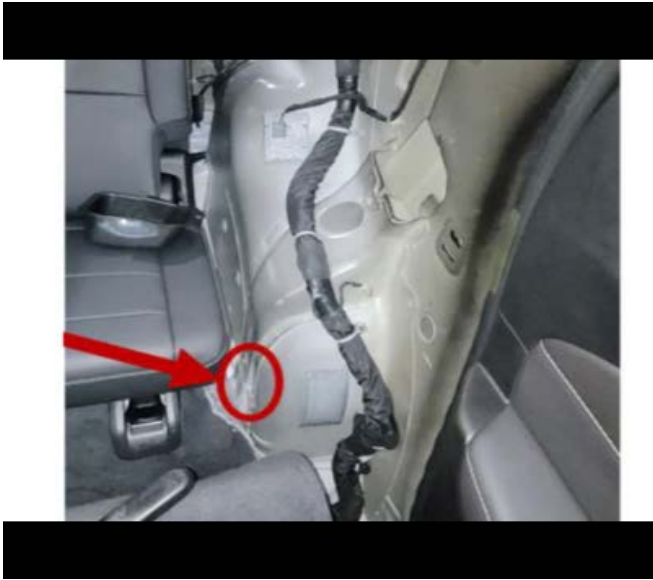
6305283

- 2. Inspect the area circled for possible movement or itching of the body panels.

- 3. Insert a crow bar or similar pry tool into the gap between panels and bend the panel out.

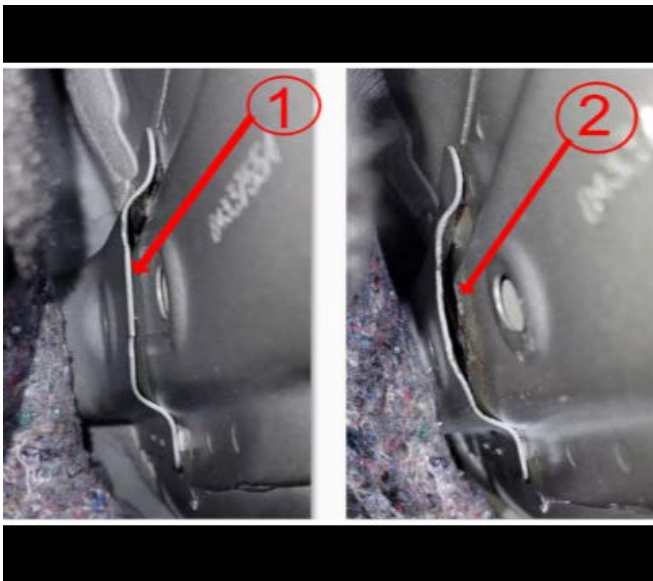
6305285

(1) shows the area before adjusting the outer panel. (2) shows the area after adjusting the outer panel.

**Note:** Only a minor adjustment is necessary.

- 4. Apply a liberal amount of structural adhesive into the gap between the panels and allow to cure overnight.

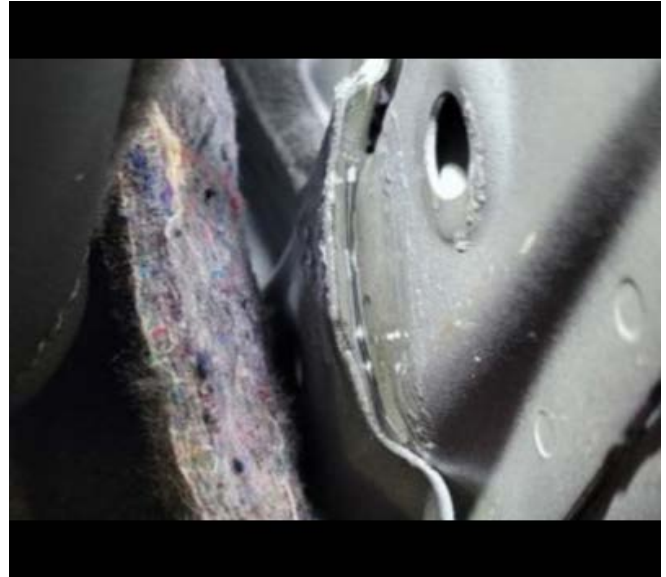
6305287

Photo shows the area after repair is complete.
