Bulletin No.: PIT5832G

PIT5832G Diagnostic Tip: Unable to complete the Serial Data Authentication Configuration/ No Start Or Unable To Perform Theft Relearn After Replacing Or Programming A Module / DTC U1962

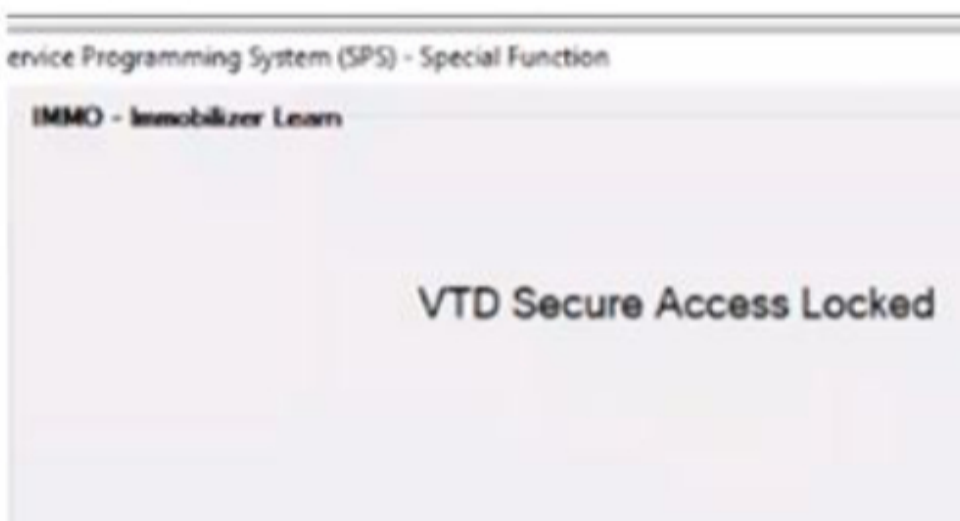
1. If a module was replaced, make sure the new module was SPS programmed correctly or the SDAC will fail and not complete correctly.
2. If a module such as the BCM is replaced, and the immobilizer learn needs to be completed after replacement, the tech needs to make sure that the SDAC completes correctly, or a pop-up message like the one below will be displayed:

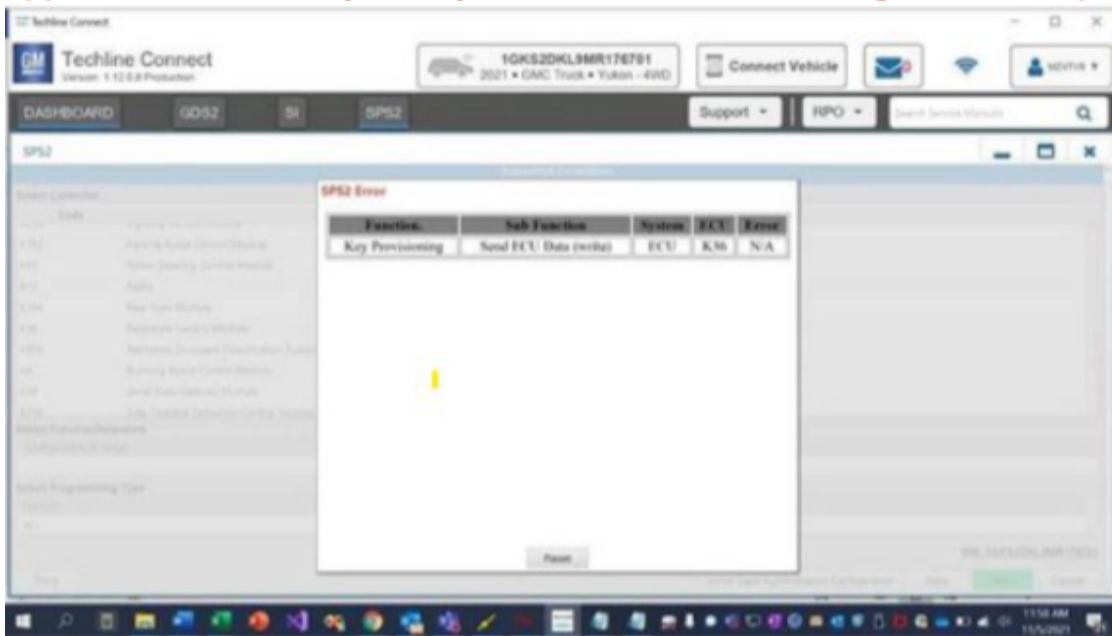
- The SDAC will run up to 3 times before it fails. When it fails, there should be a pop box that shows up on the screen like the one below. Check and record the items listed under System and ECU. If the system box reads "Server" then the issue is related to the SPS system server or internet connection and not related to the vehicle. Attempt the SDAC again at a later time or the next day early in the morning. (If the box doesn't read "Server" continue to step 5)

NOTE: Be patient because it can take a few moments for it to actually pop-up box to appear or sometimes you may have to rerun the SDAC again for it to pop-up

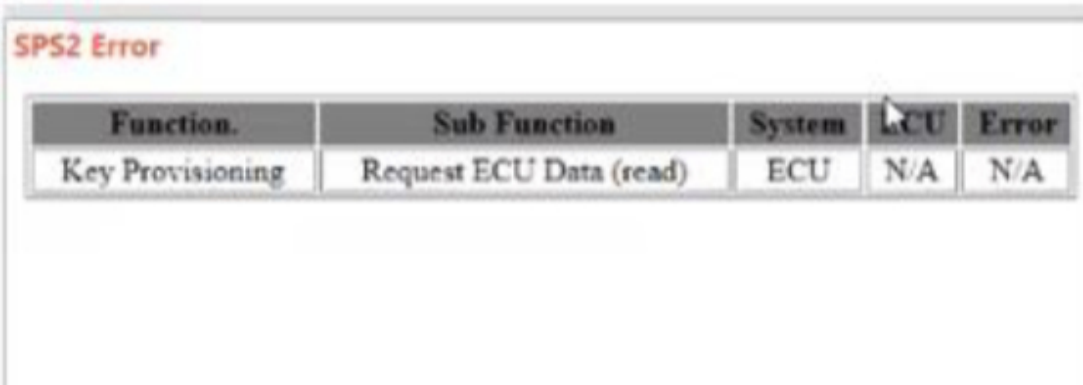
- If the system box reads "ECU", then the Global ID of the module that is causing the concern should be able to be obtained. In the example below, the Global ID is listed as K36, which is for the SDM. The module's name can be found by looking at the global codes listed under "Control Module References" document in SI for the vehicle that is being working on.

- Sometimes the pop-up box will read "ECU" but it will not give you a Module ID in the ECU box. In this case, the servicing dealer will have to contact Techline support and they will have to assist by getting a SPS log file from the dealership's system. If this is the case, they must be contacted right after the SDAC failure. If any other programming is attempted before contacting Techline, then the SPS log will be erased.

- Once the module that caused the concern has been identified, attempt to SPS program the module if a update is available and then attempt to run the SDAC again.
- If the vehicle is repaired, you may release to the customer. If the SDAC still fails, Continue to step 9

9. Pull the fuse that supplies battery power to that module. Sometimes the fuse is a three-prong fuse that feeds other modules. In this case, the servicing technician will need to find a two-prong fuse to power the other module that was not involved in the SDAC failure.
10. If the SDAC completes after removing battery power from the module in question, that module will need to be replaced.
11. Replace the effected module before releasing the vehicle to the customer and verify that the SDAC completes after SPS programming of the new module.
