## SERVICE BULLETIN

**APPLICABILITY:** Legacy and Outback 2000-2009MY w/ 5MT  
 Forester 1999MY and Later w/ 5MT  
 Impreza (Including WRX) 1999MY and Later w/ 5MT

**NUMBER:** 03-70-12  
**DATE:** 12/13/12

**SUBJECT:** Repair Procedure for High-Pitched Sound from Extension Housing Area Using Latest Generation Production Parts

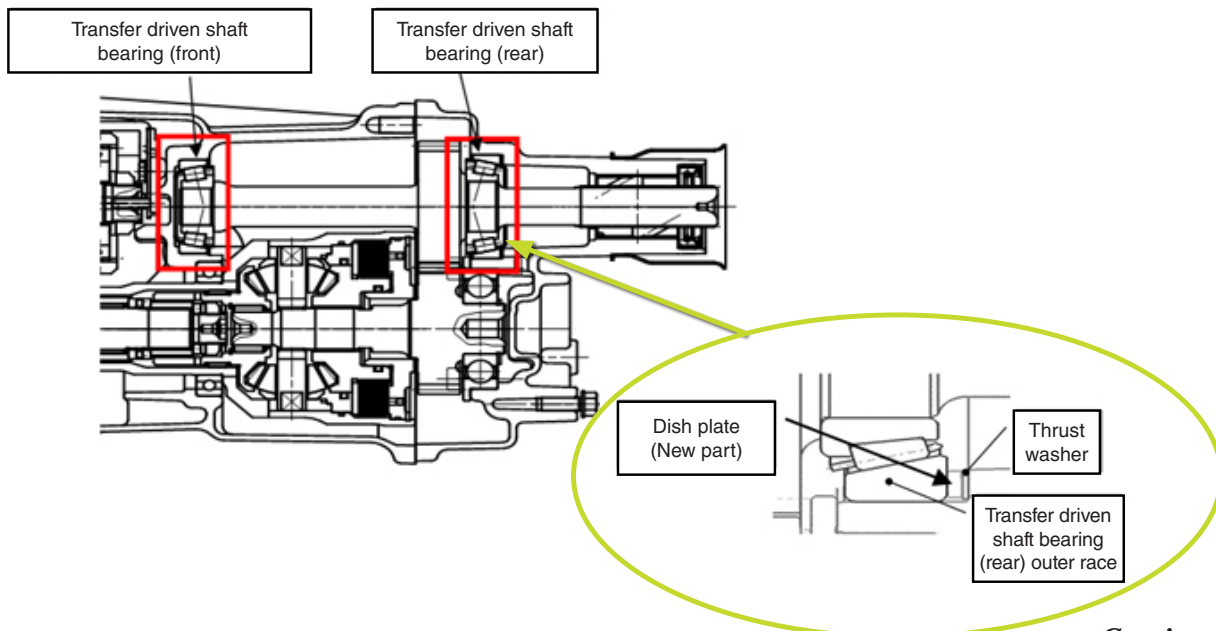
In cold temperatures, thermal contraction causes shrinking of the transmission case. In high temperatures, expansion of the case occurs. These temperature changes affect the amount of pre-load on the transfer driven shaft bearings. In some rare cases, when preload is very near the limit of specification combined with unusual driving conditions, this thermally-induced pre-load change may cause damage to the bearings and result in the sound heard by the customer.

A change has been made to the extension case and a new “Dish Plate” added. The machining depth of the extension housing has been increased to accommodate the new dish plate. When used along with a selective thrust washer, the spring tension of the dish plate helps to maintain a consistent amount of pre-load on these bearings throughout varying temperature conditions.
