SERVICE BULLETIN

APPLICABILITY: 2010-2012MY Legacy and Outback Models with CVT

NUMBER: 16-85-12

SUBJECT: CVT Secondary Pressure Sensor Diagnostics

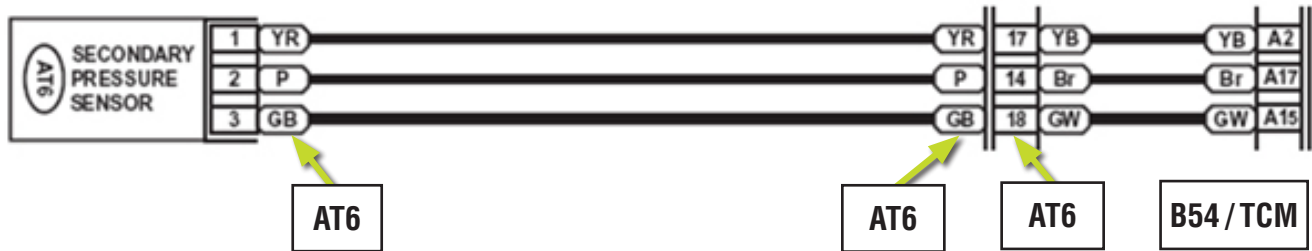
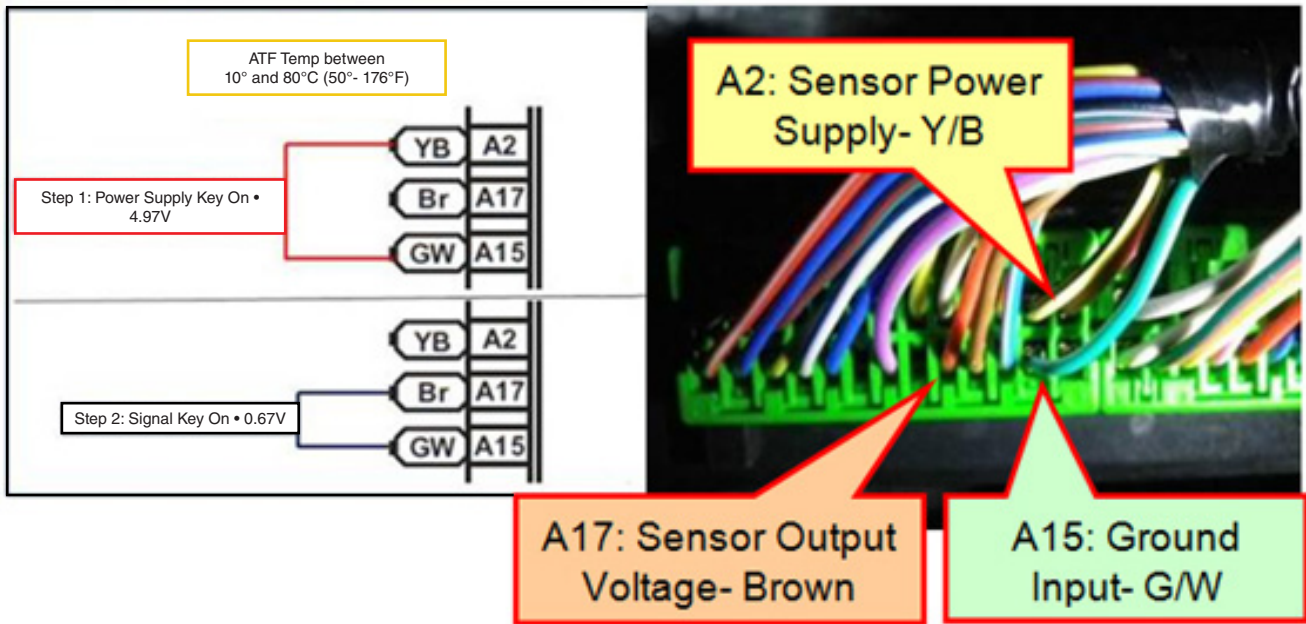
- Perform the following voltage checks on the TCM connector, B54:
 1. With the ignition switch on and engine off, check the voltage between pin #2 (power supply) and #15 (ground). Specified value is 4.8v to 5.2v. If the voltages are outside of the specified range, the TCM is damaged along with the pulley surfaces of the CVT due to chain slippage. Replace both the TCM and the CVT assembly.

2. With the ignition switch on and engine off, check the voltage between pin #17 (pressure sensor output voltage) and #15 (ground). Specified value is 0.45v to 0.55v. If the voltages are outside of the specified range, the secondary pressure sensor is damaged along with the pulley surfaces of the CVT due to chain slippage. Replace the CVT assembly.
3. **IMPORTANT:** Before ordering a new TCM and / or CVT, perform these same voltage checks at the secondary pressure sensor connector (AT6) and (if necessary), the main transmission harness connectors (T4 and B11). Ruling out wiring issues will prevent repeat or unnecessary component replacements.

REMINDER: Whenever replacing the CVT assembly, TCM, control valve body or servicing the CVT fluid, the Learning Control procedure must be completed.
