Rattle Noise When the Sliding Roof Is Tilted Open

Service Category Vehicle Exterior

Section Sliding Roof/Convertible

YEAR(S)	MODEL(S)	ADDITIONAL INFORMATION
2021	RAV4 Prime	
2019 - 2021	RAV4, RAV4 HV

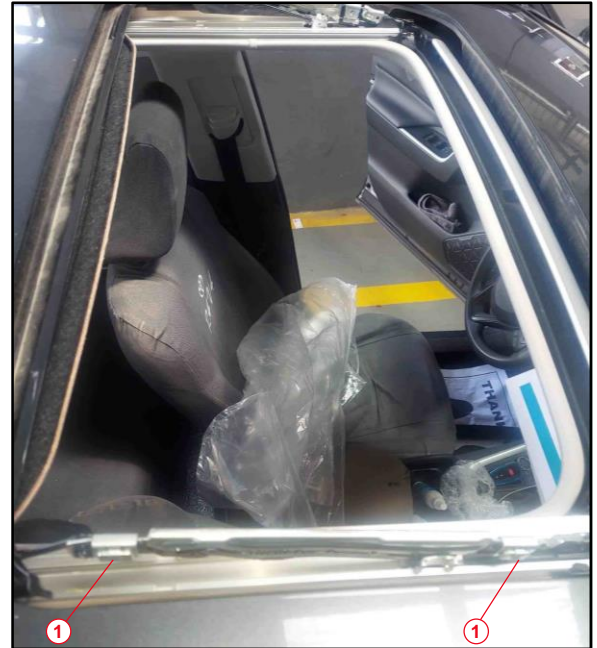
Figure 1. Sliding Roof Assembly

The moon roof adjustment nuts shown in Figure 1 are in the same location on the other side of the sliding roof assembly.

1	Moon Roof Adjustment Nuts
----------	----------------------------------

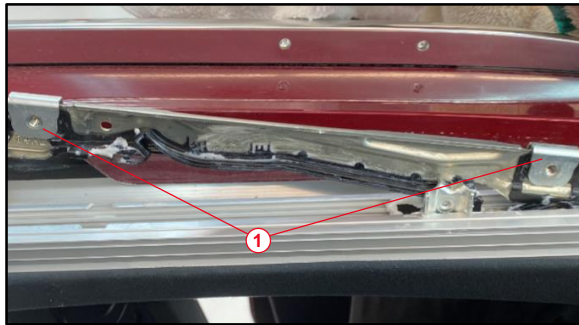
Figure 2.

1	Nut Cover
----------	------------------

3. Remove the adjustment nuts.
 - A. Remove the nut covers by gently inserting the removal tool (e.g., plastic pliers) and twisting, as shown in Figure 3.

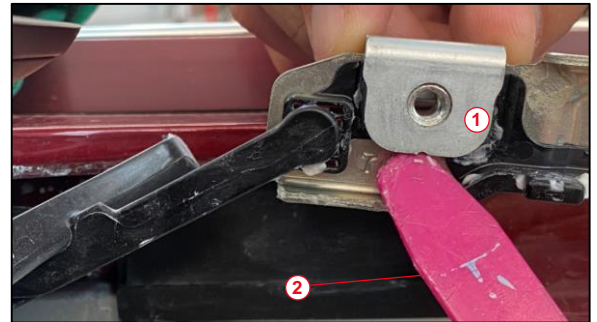
Figure 3.

1	Nut Cover
2	Removal Tool

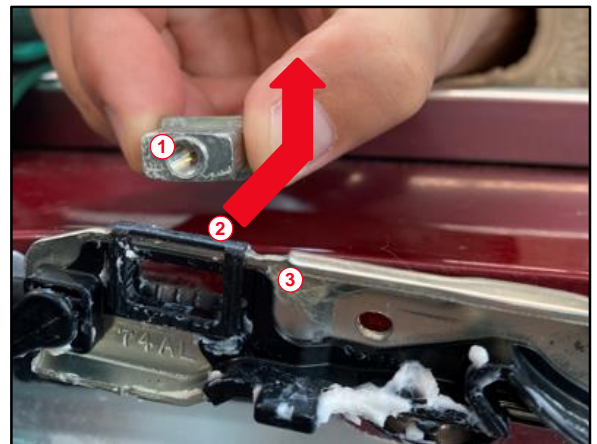
Figure 4.

1	Adjustment Nut
2	Pull Out in This Direction
3	Mechanical Bracket

- B. Remove the adjustment nuts by pulling them out of the mechanical bracket.

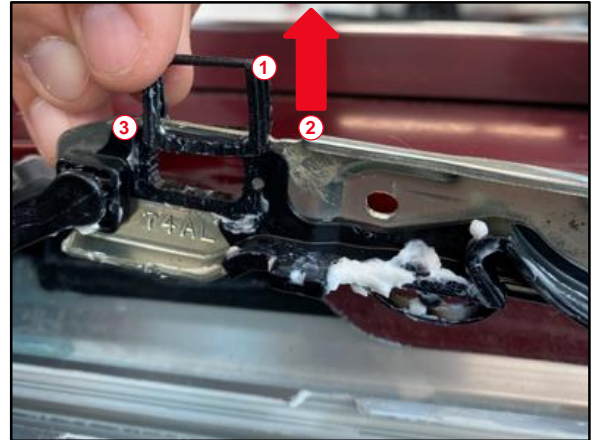
Figure 5.

1	Rubber Pad
2	Remove in This Direction
3	Mechanical Bracket

- Remove the rubber pads by pulling them up from the mechanical bracket.

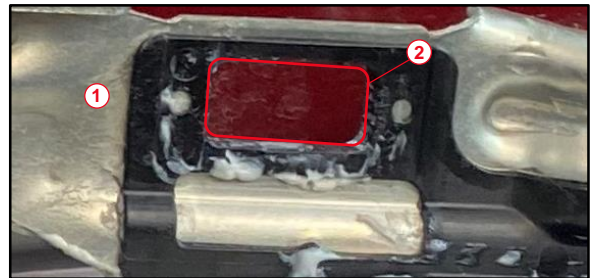
Figure 6.

1	Mechanical Bracket
2	Apply Grease

- Clean and apply NEW grease to the contact areas of the mechanical bracket.

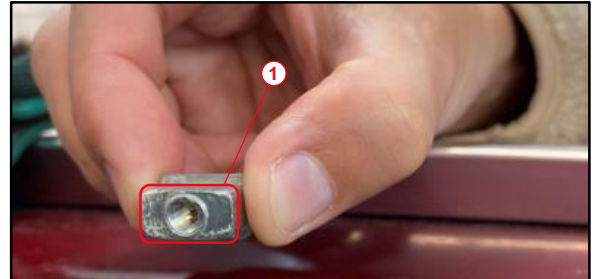
Figure 7.

1	Apply Grease
----------	---------------------

6. Apply grease to the outer circumference area of the NEW adjustment nut.

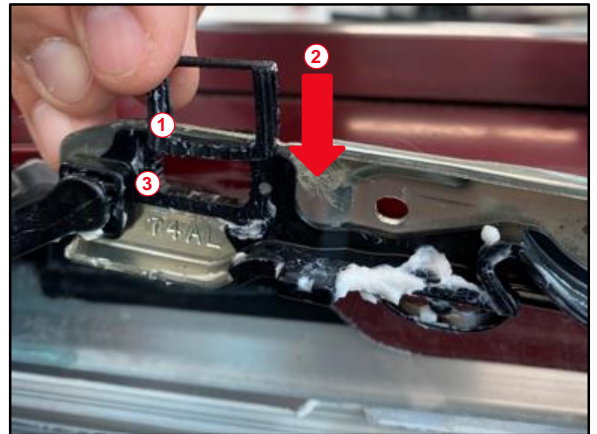
Figure 8.

1	Rubber Pad
2	Install in This Direction
3	Mechanical Bracket

7. Reinstall the rubber pad to the mechanical bracket.

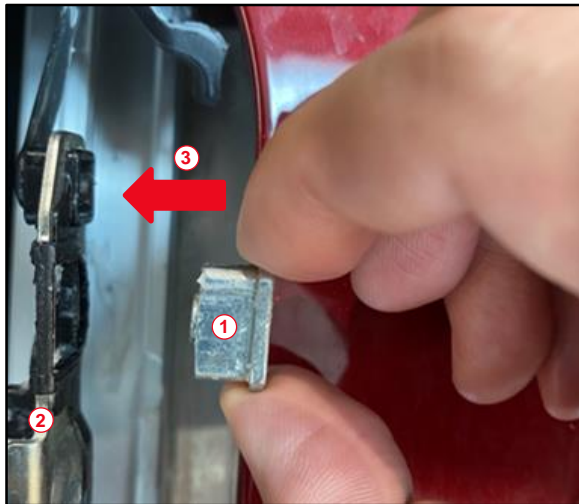
Figure 9.

1	Adjustment Nut
2	Mechanical Bracket
3	Install in This Direction

- Reinstall the adjustment nut to the mechanical bracket.

Insert the adjustment nut from outside the vehicle toward the interior.

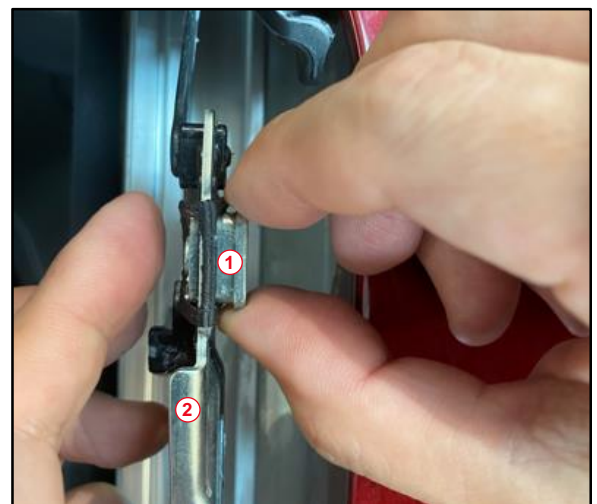
Figure 10.

1	Adjustment Nut
2	Mechanical Bracket

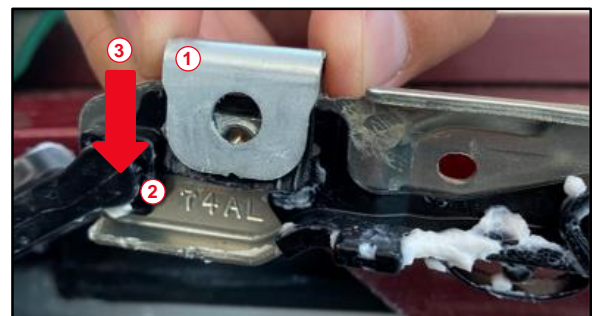
Figure 11.

1	Nut Cover
2	Mechanical Bracket
3	Install in This Direction

- Push down the nut cover from the top of the mechanical bracket and insert it firmly.

When installing the nut cover, do NOT interfere with the rubber pad.
