STAR ONLINE PUBLICATION

Case Number: S1408000384 Rev. C

Release Date: February 2023

Symptom/Vehicle Issue: Start Stop Charging Warning Lamp Illuminated On, Intelligent Battery Sensor (IBS) State of Charge (SOC) Inaccurate, Battery Charging Message, Presence of IBS related Diagnostic Trouble Codes (DTCs), or Battery Warning Lamp On

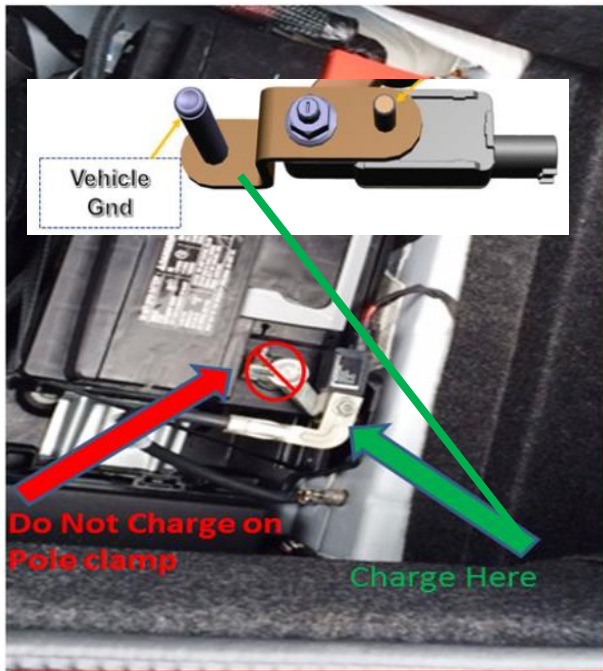
Improper IBS Charging

In-Vehicle systems is not an issue. Please note to charge through the IBS or tie negative clamp to Body/engine ground. Customers, Dealers, Mechanics, and Engineers usually want to place the negative clamp on the pole of the battery. This creates Blind charging. **“DO NOT BLIND CHARGE”**
See below proper connections for charging.

Do not put Negative clamp on IBS Pole clamp

Do not remove IBS for charging

- IBS SOC adaptation is needed after charging the batteries.
- Note IBS will self-adapt in the next available quiescent state.
- A common misdiagnosis is Battery light illuminated. The IBS has NOTHING to do with this light. The battery Light is indicative of a “CHARGING SYSTEM and condition of the battery”
