**Technical Service Bulletin (TSB)**  
**Hands Free Access (Entry) Inoperative**

<b>REFERENCE:</b>	<b>TSB:</b> 08-039-23 <b>GROUP</b> 08 - Electrical	<b>Date:</b>	February 1, 2023	<b>REVISION:</b>	-
<b>VEHICLES AFFECTED:</b>	2022 - 2023 (H1) Jeep Commander This bulletin applies to vehicles built on or after March 23, 2022 (MDH 0323XX) and on or before November 02, 2022 (MDH 1102XX).			<b>MARKET APPLICABILITY:</b>	
				<input type="checkbox"/> NA	<input type="checkbox"/> MEA
				<input checked="" type="checkbox"/> SA	<input type="checkbox"/> IAP
				<input type="checkbox"/> EE	<input type="checkbox"/> CH
<b>CUSTOMER SYMPTOM:</b>	Customer will not be able to open the back cover using the hands-free optional.				
<b>CAUSE:</b>	Hands Free Module.

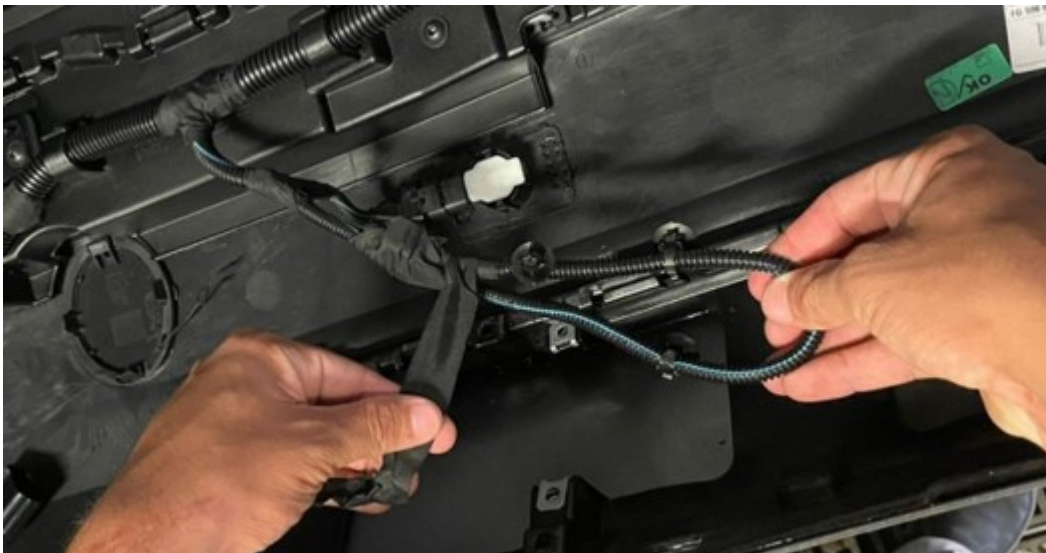
**Fig. 1**  
**Tape From Wiring**

- Is the vehicle on the RSU VIN list?
  - YES >>> Proceed to [Step 2](#).
  - NO >>> This Bulletin does not apply. Normal diagnosis should be performed.
- Does the liftgate function properly with the use of the hands free option?
  - YES >>> This bulletin has been completed, use inspect LOP (08-14-49-04) to close the active RSU.
  - NO >>> Proceed to [Step 3](#).
- Remove the rear fascia. Refer to the detailed service procedures available in DealerCONNECT> Service Library under: Service Info> 13 - Frame and Bumpers / Bumpers / Fascia, Rear / Removal.
- Remove the tape from the wiring ([Fig. 1](#)) .

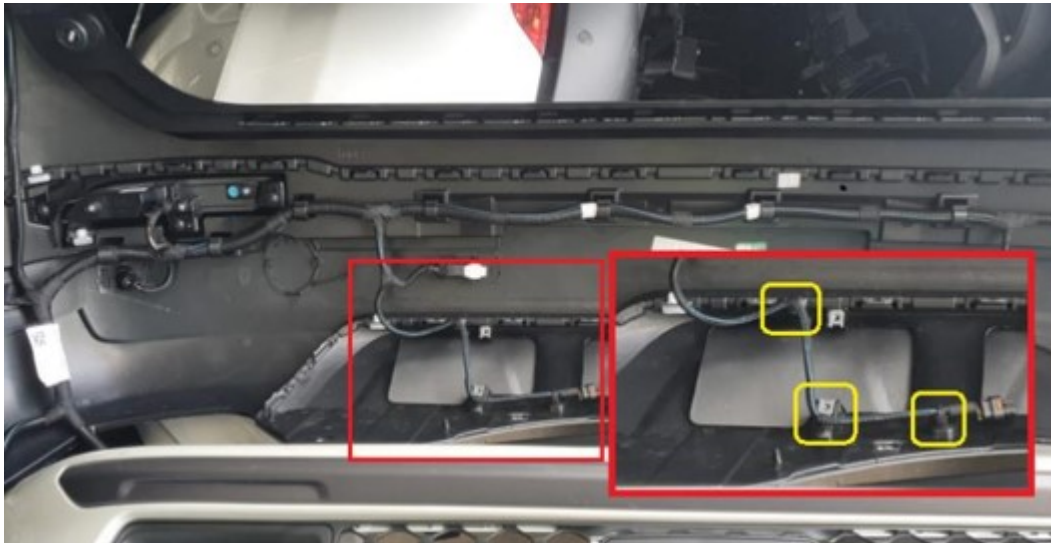
**Fig. 2**  
**Proper Layout of Wiring**

- Put the wiring into the proper layout ([Fig. 2](#)) .

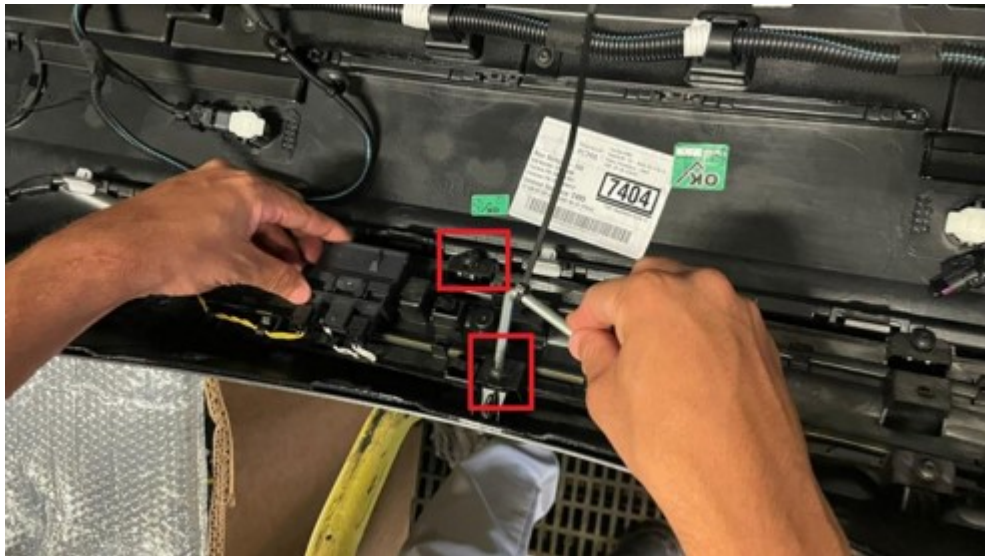
**Fig. 3**  
**Module Install**

6. Install the new hands free module (Fig. 3) .

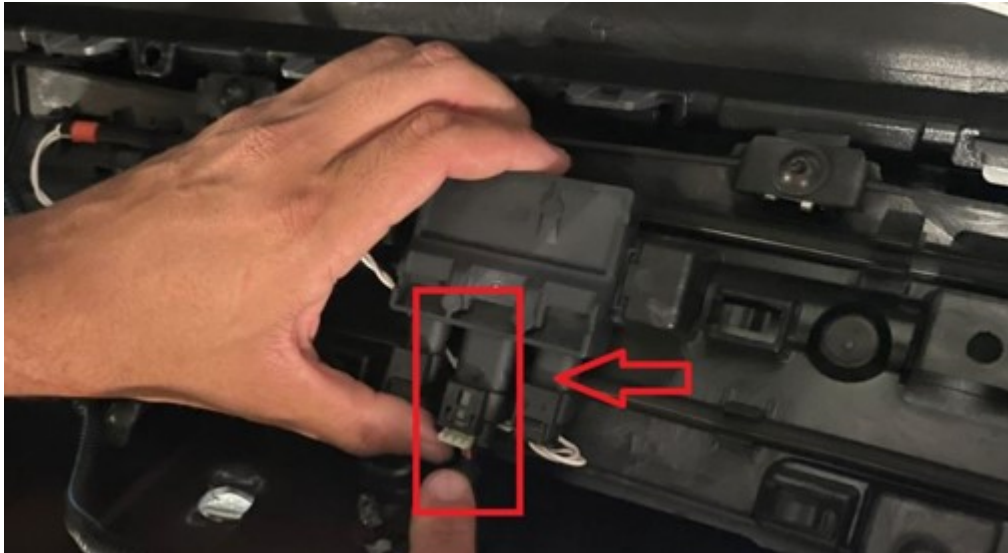
**Fig. 4**  
**Connector**

7. Connect the wiring connector (Fig. 4) .
