<b>REFERENCE:</b>	<b>TSB:</b> 09-006-23 <b>GROUP</b> 09 - Engine	<b>Date:</b>	February 17, 2023	<b>REVISION:</b>	09-008-22 REV. A
<b>VEHICLES AFFECTED:</b>	<p><b>2022 - 2023 (B1) Jeep Renegade</b>  <b>2022 - 2023 (H1) Jeep Commander</b>  <b>2022 - 2023 (M1) Jeep Compass</b>  <b>This bulletin applies to vehicles equipped with a 1.3L I4 Turbo Mair DI Eng w/ESS E100 (Sales Code EYJ):</b></p> <ul style="list-style-type: none"> <li>• M1 built on or after April 28, 2021 (MDH 0428XX) and built on or before <b>**January 28, 2023 (MDH 0128XX)**</b>.</li> <li>• H1 built on or after <b>**October 02, 2021 (MDH 1002XX)</b> and built on or before January 30, 2023 (MDH 0130XX)**.</li> <li>• B1 built on or after January 14, 2022 (MDH 0114XX) and built on or before <b>**January 27, 2023 (MDH 0127XX)**</b>.</li> </ul> <p><b>This bulletin applies to vehicles equipped with a 1.3L I4 Turbo Mair DI Engine w/ESS (Sales Code EYF):</b></p> <ul style="list-style-type: none"> <li>• M1 built on or after <b>**November 12, 2021 (MDH 1112XX)</b> and built on or before December 19, 2022 (MDH 1219XX)**.</li> <li>• H1 built on or after March 25, 2022 (MDH 0325XX) and built on or before August 24, 2022 (MDH 0824XX).

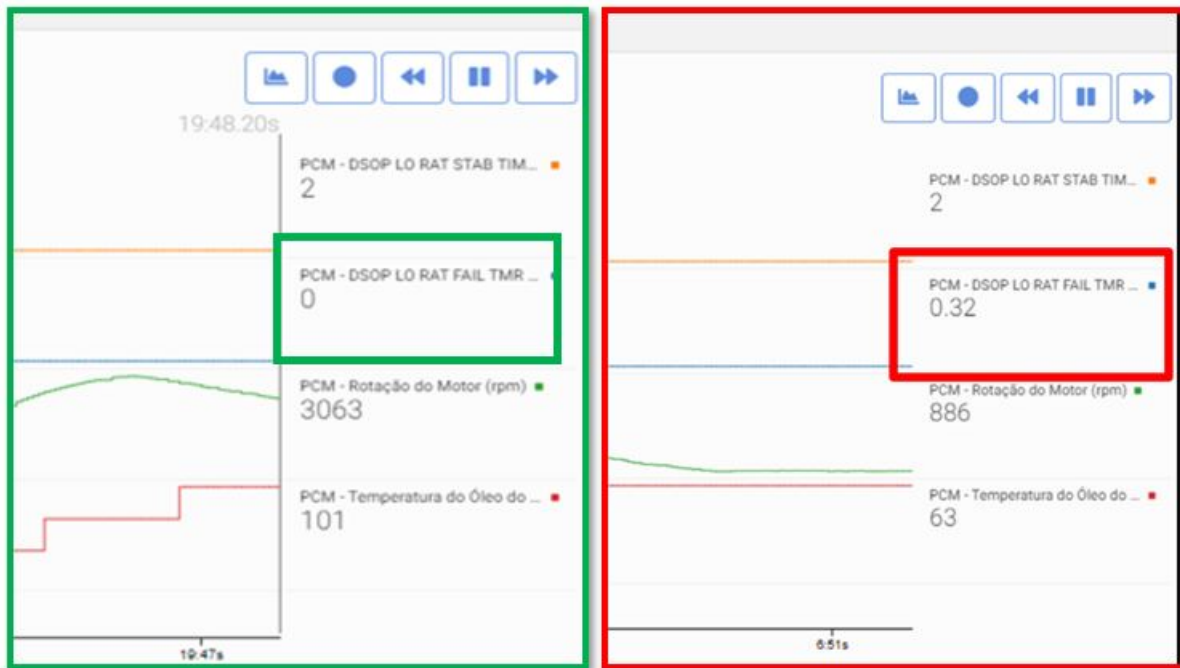
**Fig. 1  
Graph Showing Correct And Not Correct Values**

1. Using wiTECH check if DTC P06DD is set in the Powertrain Control Module (PCM).
2. Was DTC P06DD found in the PCM?
  - YES>>> Replace the timing chain cover. Proceed to [Step 6](#).
  - NO>>> Proceed to [Step 3](#).
3. Start the engine at let it run at idle until the engine oil temperature reaches more than 85° C (185° F).
4. Create a graph of “DSOP LO RAT FAIL TMR” and review the value. **If it shows anything but “0”, the timing cover needs to be replaced (Fig. 1) .**

**NOTE: The “DSOP LO RAT FAIL TMR” value can change quickly, less than 20 seconds, then the oil pump (timing chain) is faulty and will need to be replaced.**

5. Did the “DSOP LO RAT FAIL TMR” value read anything but “0”?
  - YES>>> Create a screen shot of the graph showing values other than “0” and attach it to the work order. Proceed to [Step 6](#).
  - NO>>> If the value always shows “0” and DTC P06DD was not found, this bulletin has been completed. Use inspection LOP (09-65-01-A2) to close the active RSU.
6. Replace the timing chain cover. Refer to the detailed service procedures available in DealerCONNECT/ Service Library under: 09 - Engine, 1.3L I4 16V Multi Air Turbo / Valve Timing / Cover (s), Engine Timing / Removal and Installation.
7. Using wiTECH clean any DTCs that may have been set.
