# Technical Service Bulletin

## 96 High beam assist or traffic sign detection limited, DTC C12B3FD may be stored in the DAS control module

96 23 85 2059201/6 April 13, 2023. Supersedes Technical Service Bulletin Group 96 number 22-77 dated April 14, 2022, for reasons listed below.

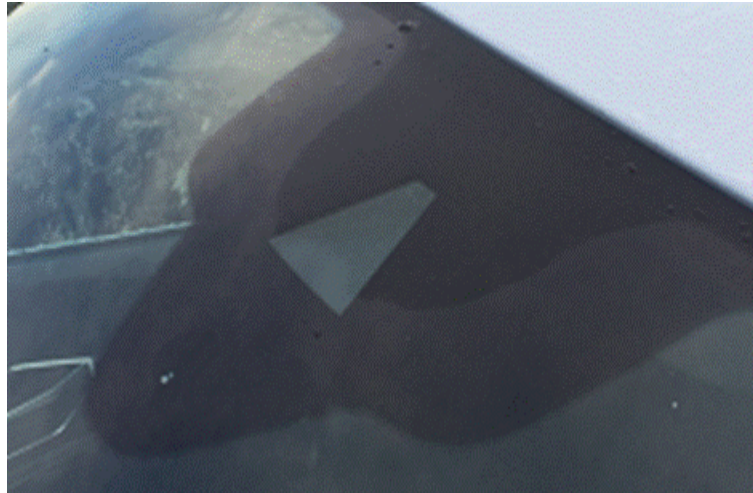
The viewing area of the front camera can be fogged up both on the inside and/or on the outside (Figures 1 - 2).

**Figure 1.** Viewing area fogged up from outside.

3. The customer cannot see this from the interior of the vehicle. Often it is enough to switch on the wiper system to fix the concern.
4. If the front camera is fogged up from the inside fairly often, it can help to remove its lens hood in order to clean and dry the viewing area of the camera.

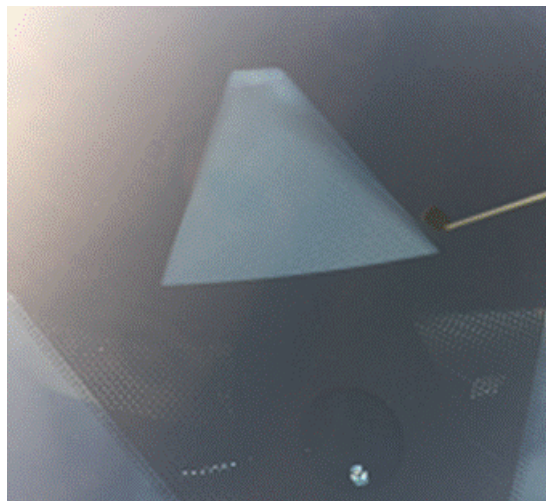
**Figure 2.** Viewing area fogged up from inside.

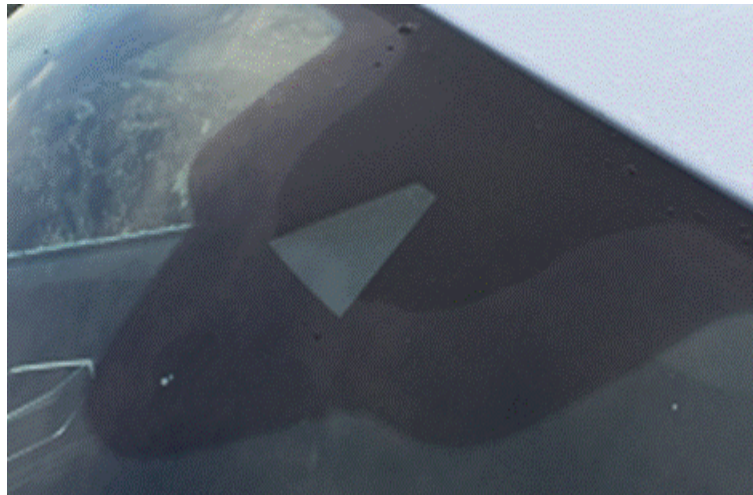
The viewing area of the front camera can be fogged up both on the inside and/or on the outside (Figures 1 - 2).

**Figure 1.** Viewing area fogged up from outside.

3. The customer cannot see this from the interior of the vehicle. Often it is enough to switch on the wiper system to fix the concern.
4. If the front camera is fogged up from the inside fairly often, it can help to remove its lens hood in order to clean and dry the viewing area of the camera.

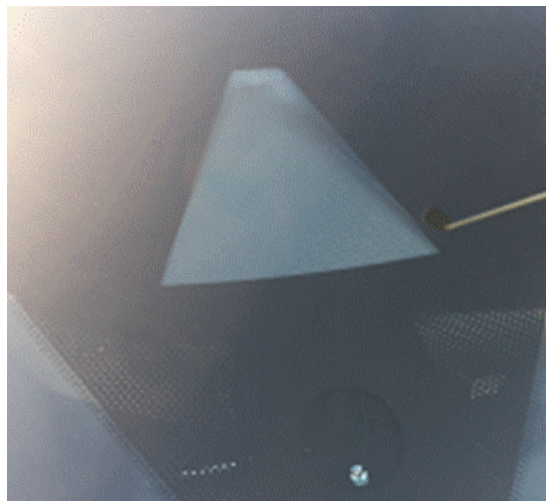
**Figure 2.** Viewing area fogged up from inside.
