# Technical Service Bulletin

## 60 Sunroof frame modification

60 23 65 2065731/3 April 7, 2023. Supersedes Technical Service Bulletin Group 60 number 22-59 dated May 6, 2022, for reasons listed below.

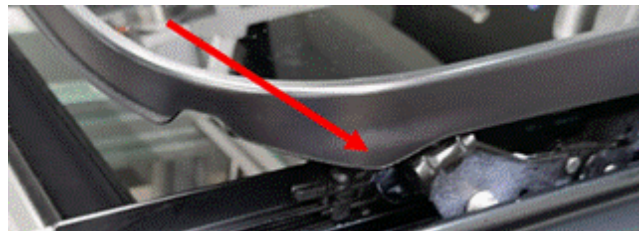
1. If the sunroof frame and/or front sunroof glass panel require replacement the water guidance washer on the sunroof mechanism pivot protrudes to the extent that the rubber “skirt” on the front glass panel also protrudes creating interference between the glass panel and the sunroof opening. This interference can prevent the front glass panel closing sequence from completing.
2. Figure 2 shows the location of the “skirt” protrusion from the water guidance washer.

**Figure 1.** The front sunroof glass panel side skirt is deformed due to a protruding water guidance washer.

4. Remove the front sunroof glass panel. Using a small pair of diagonal cutters (side cutters) trim away the water guidance washer. The washer must be cut back such that it protrudes no greater than the pivot pin. Perform this operation to both sides.

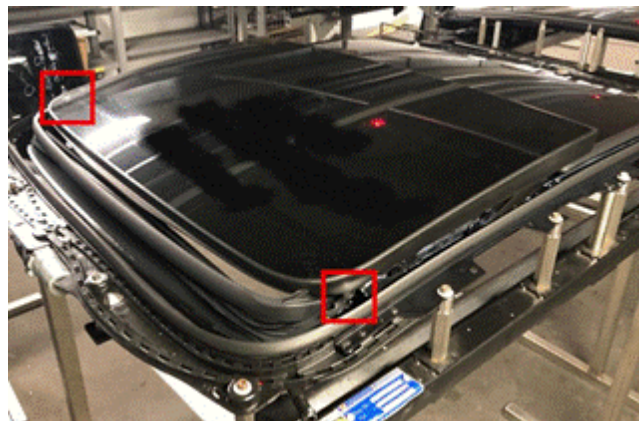
**Figure 2.** Front sunroof glass panel side skirt protrusion from an unmodified water guidance washer.

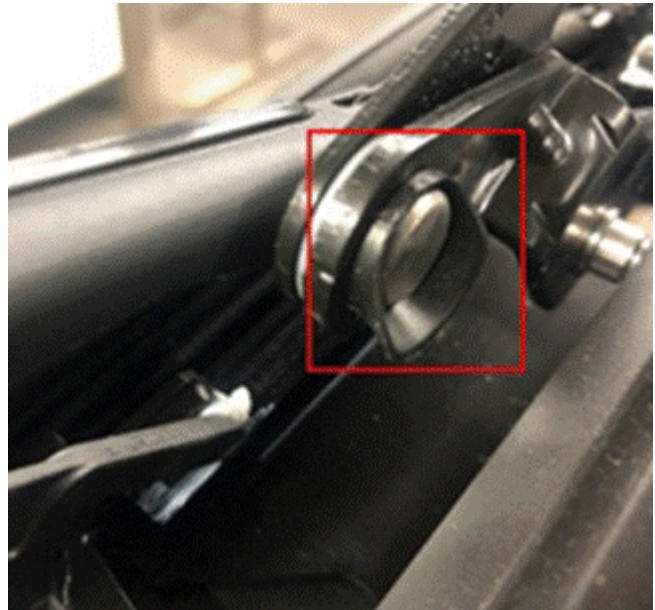
3. Figure 3 shows the water guidance washer with the front sunroof glass panel removed.

**Figure 3.** Water guidance washer on the front frame mechanism pivot.

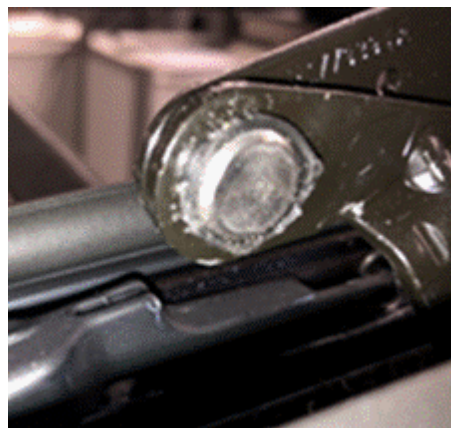
5. Figure 5 shows the removed water guidance washer trimmed below the pivot pin. Since this pivot pin is concealed by the front sunroof glass panel “skirt” it is not necessary to smooth the edges of the cut surfaces.

**Figure 5.** Water guidance washer on the front frame mechanism pivot.

**Note:**  
 Ensure that all plastic fragments from the water guidance washer created during the modification are removed completely. Use a vacuum cleaner if necessary. Stray plastic fragments from this modification that remain will cause permanent damage to the sunroof frame mechanism.
