Service Update

N232397530 SBZA Modules Installed on Wrong Side of Rear Bumper

Release Date: April 2023

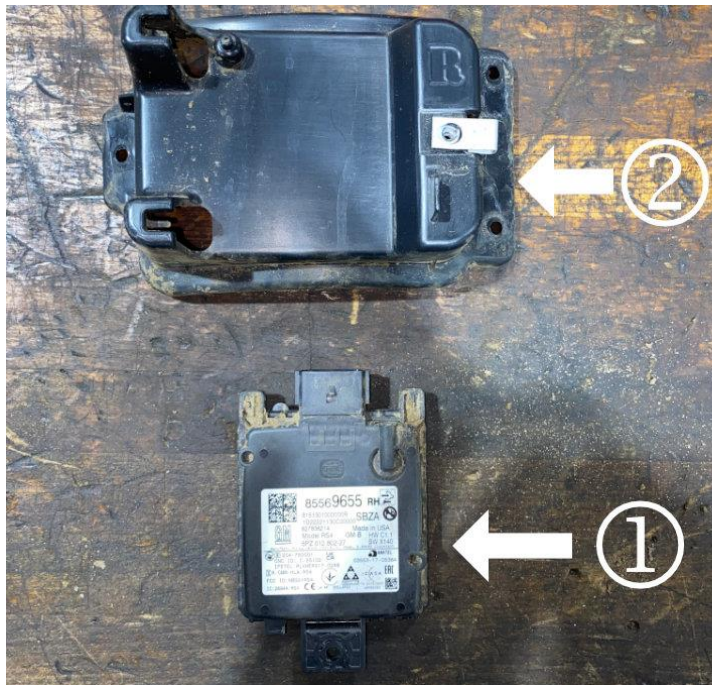
6328031

Note: The label on the module has “RH” listed after the part number to indicate it is the RH Side Obstacle Detection Control Module. The bracket has an “R” molded into the part to indicate it is the R bracket.

- Verify the RH Side Obstacle Detection Control Module (1) is installed in the R bracket (2).
- Install the RH Side Obstacle Detection Control Module (1) and R bracket (2) onto the passenger’s side of the vehicle. Refer to *Side Obstacle Detection Control Module Replacement (ULV)* in SI.

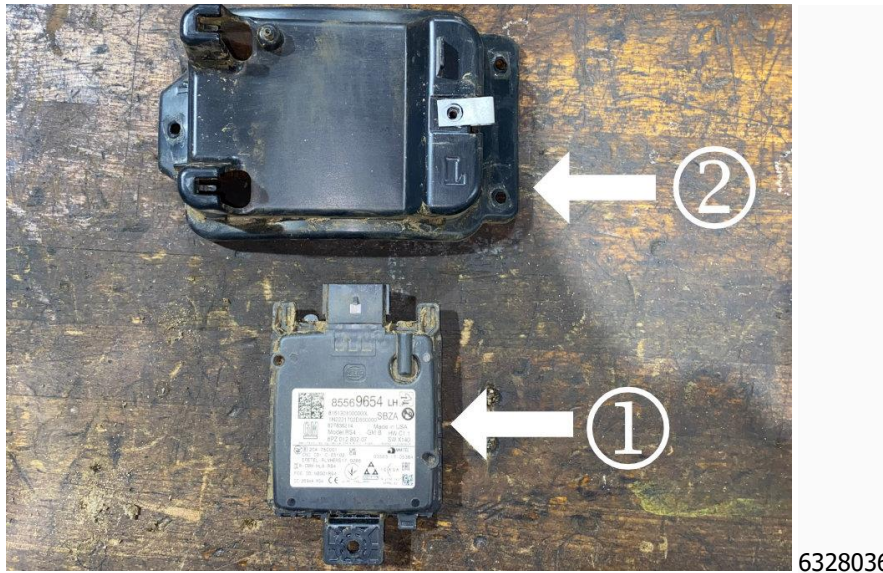
Note: The label on the module has “LH” listed after the part number to indicate it is the LH Side Obstacle Detection Control Module. The bracket has an “L” molded into the part to indicate it is the L bracket.

4. Verify the LH Side Obstacle Detection Control Module (1) is installed in the L bracket (2).
5. Install the LH Side Obstacle Detection Control Module (1) and L bracket (2) onto the driver’s side of the vehicle. Refer to *Side Obstacle Detection Control Module Replacement (ULV)* in SI.
