# Technical Journal

**Audio switches on steering wheel, no function**

| <b>REF NO:</b><br>TJ 32033.3.1 | <b>ISSUING DEPARTMENT:</b><br>Technical Service | <b>CAR MARKET:</b><br>United States and Canada | |

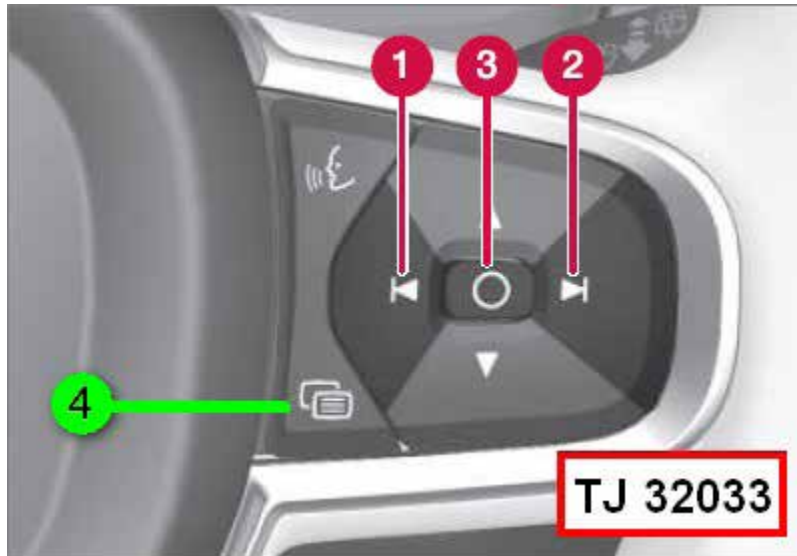
| File Name | File Size |
|---|---|
| TJ 32033.jpg | 0.0239 MB |

After using voice command to adjust the climate, the switches for “Forward”, “Back” and “Confirm” on steering wheel audio switch may stop functioning (marked as “1”, “2” and “3” in picture TJ 32033.jpg). The switches for “Speech”, “Open/Close menu” and “volume adjustment” are still operational.

All switches will be operational again if pushing twice on the “Open/Close menu” switch (marked as “4” in picture TJ 32033.jpg).

This is a software issue that was corrected in the Drivers Information Module (DIM) SW released week 19, 2017.

If the customer complaint matches exactly symptom 1 and the car has not been updated since the improved Software was released week 19, 2017 then perform a Total Upgrade in accordance with TJ 31543.

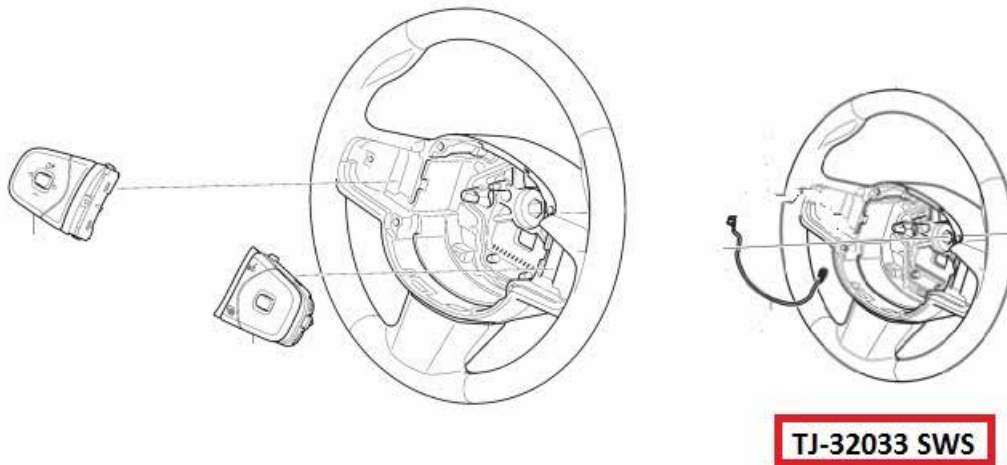
| File Name | File Size |
|---|---|
| TJ 32033 SWS.jpg | 0.0455 MB |

A connection issue in the steering wheel switches may give intermittent or permanent function loss on any of the audio switches.

If the customer complaint does not match symptom 1 or the car has been updated after week 19, 2017 then replace both steering wheel switches and the wires harness in between the switches, see attached picture TJ 32033 SWS.jpg
