Technical Journal

Rattling noise when closing front door

REF NO: TJ 32381.3.0	ISSUING DEPARTMENT: Technical Service	CAR MARKET: United States and Canada	
PARTNER: 3 US 7510 Volvo Car USA		ISSUE DATE: 2018-03-22	STATUS DATE: 2018-04-04
FUNC GROUP: 8311	FUNC DESC: Side door, complete	Page 1 of 3

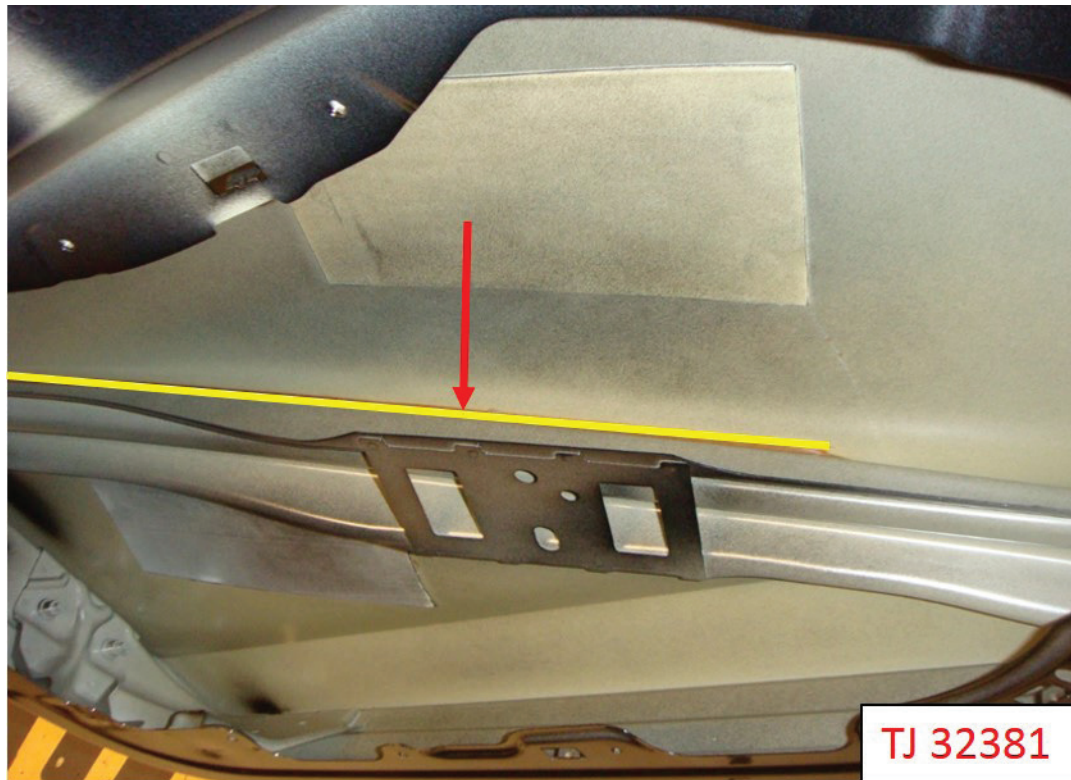
File Name	File Size
TJ32381.jpg	0.1055 MB

When closing the front or rear door a rattle noise may occur from the middle of the outer door panel.

Remove door panel and window lift according to VIDA.

Apply new sealing compound ~20-30 cm (8 to 11 inches) on top of the original glue on the upper part of the beam, so that you get contact between the beam and the outer door panel.

Do not push the outer door panel when applying the glue, see attached picture TJ32381.jpg. Diameter of the glue: Ø8 mm.

Install window lift and door panel according to VIDA.
