Technical Journal

TITLE:
SPA Brake noise

REF NO: TJ 34246.5.0	ISSUING DEPARTMENT: Technical Service	CAR MARKET: United States and Canada	
PARTNER: 3 US 7510 Volvo Car USA		ISSUE DATE: 2019-03-27	STATUS DATE: 2019-04-02
FUNC GROUP: 5100	FUNC DESC: Wheel brake	Page 1 of 17

Brake NVH issues in SPA platform

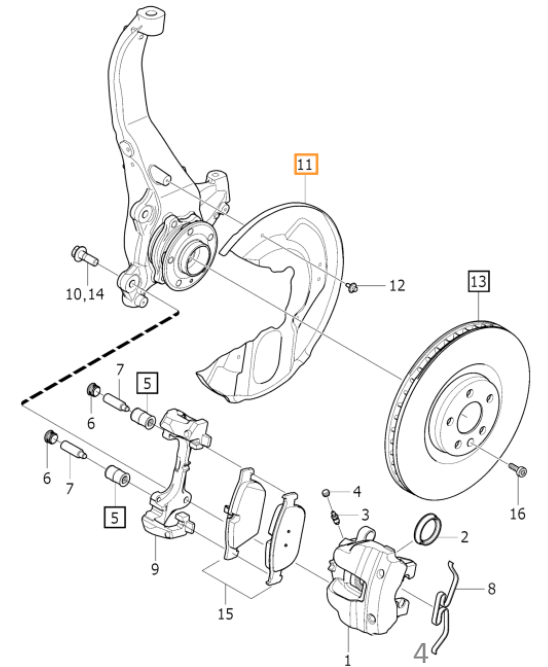
Rattle / Clapper noise

Low frequency vibration noise over bumpy road (ex: gravel road)

- Change to damped dust shield (Protecting plate) according to VIDA (all service part dust shields (Protecting plates) are damped)

Note : 16" rear brake -> service part dust shield is not damped

99921-2 Change to damped dust shield

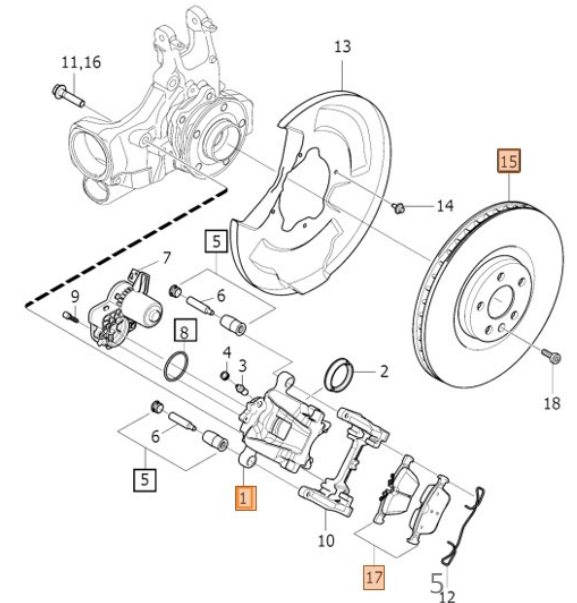
Chirp noise

Unbraked noise while driving (off-braking, intermittent noise)

- Change rear calipers to latest part number + change rear discs + change rear pads according to VIDA

(latest part number of rear calipers has increased rollback)

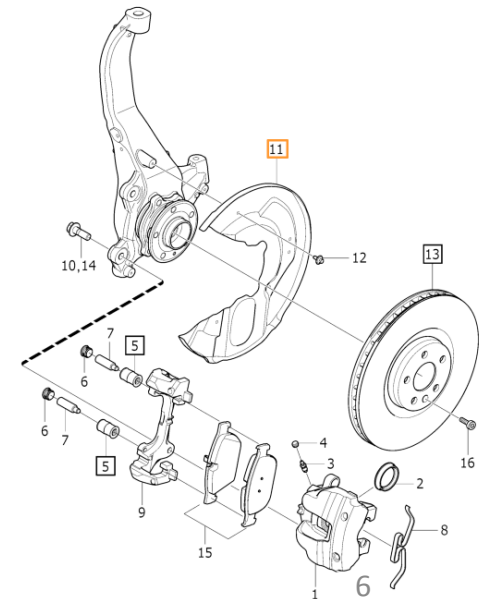
End-of-stop metallic noise

Metallic noise at end-of-stop

- Change to damped dust shield (Protecting plate) in the front and rear according to VIDA (all service part dust shields (Protecting plates) are damped)

Note : 16" rear brake -> service part dust shield is not damped

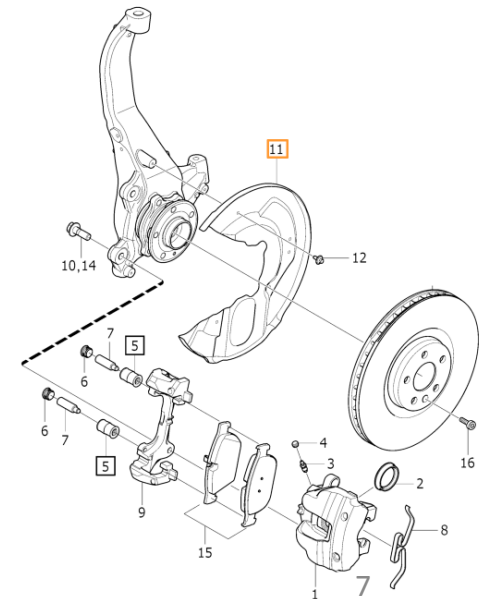
Trumpet noise

Noise that occurs when rolling slowly in Drive or Reverse (automatic gearbox) while braking

- Change to damped dust shield (Protecting plate) in the front brakes according to VIDA (all service part dust shields (Protecting plates) are damped)

Note : 16" rear brake -> service part dust shield is not damped

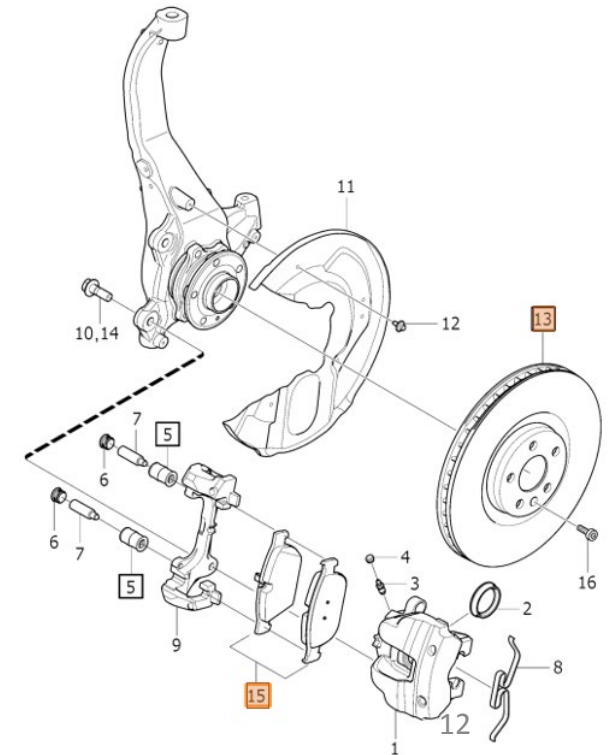
Brake squeal: 16" front

- Main squeal issue: 4.1 kHz cold noise

- Change front discs + front pads according to VIDA

- 4.1 kHz cold noise squeal Issue solved
