# Technical Journal

**SiriusXM Radio inop or No Sound on SAT Source**

<b>REF NO:</b> TJ 34021.1.1	<b>ISSUING DEPARTMENT:</b> Technical Service	<b>CAR MARKET:</b> United States and Canada	
<b>PARTNER:</b> 3 US 7510 Volvo Car USA		<b>ISSUE DATE:</b> 2018-08-08	<b>STATUS DATE:</b> 2018-09-18
<b>FUNC GROUP:</b> 3900	<b>FUNC DESC:</b> Media, navigation and communication	Page 1 of 4

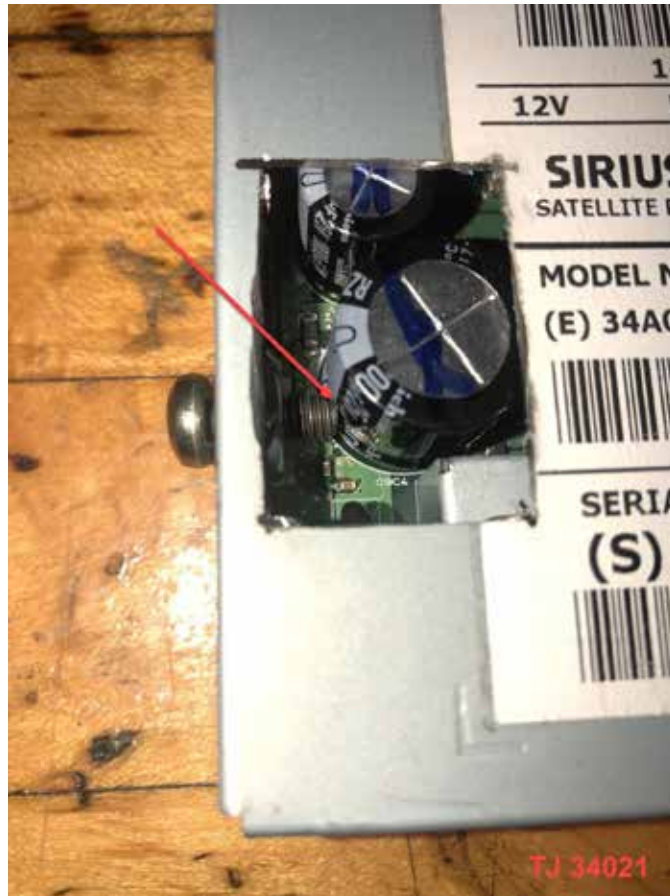
If a new or known good RDAR unit is plugged in, it will work normally. However, after mounting the unit, it may become inoperative immediately or after a period of time (several days or weeks).

Check the length of the RDAR mounting screws. If too long a screw is used in the mounting hole closest to connector "A" on the RDAR, it can make contact with and damage one of the internal capacitors (see attached photo TJ 34021\_1.jpg).
