Technical Journal

Left engine pad click sound

REF NO: TJ 33442.3.0	ISSUING DEPARTMENT: Technical Service	CAR MARKET: United States and Canada	
PARTNER: 3 US 7510 Volvo Car USA		ISSUE DATE: 2018-04-10	STATUS DATE: 2018-04-26
FUNC GROUP: 2180	FUNC DESC: Engine mounting	Page 1 of 3

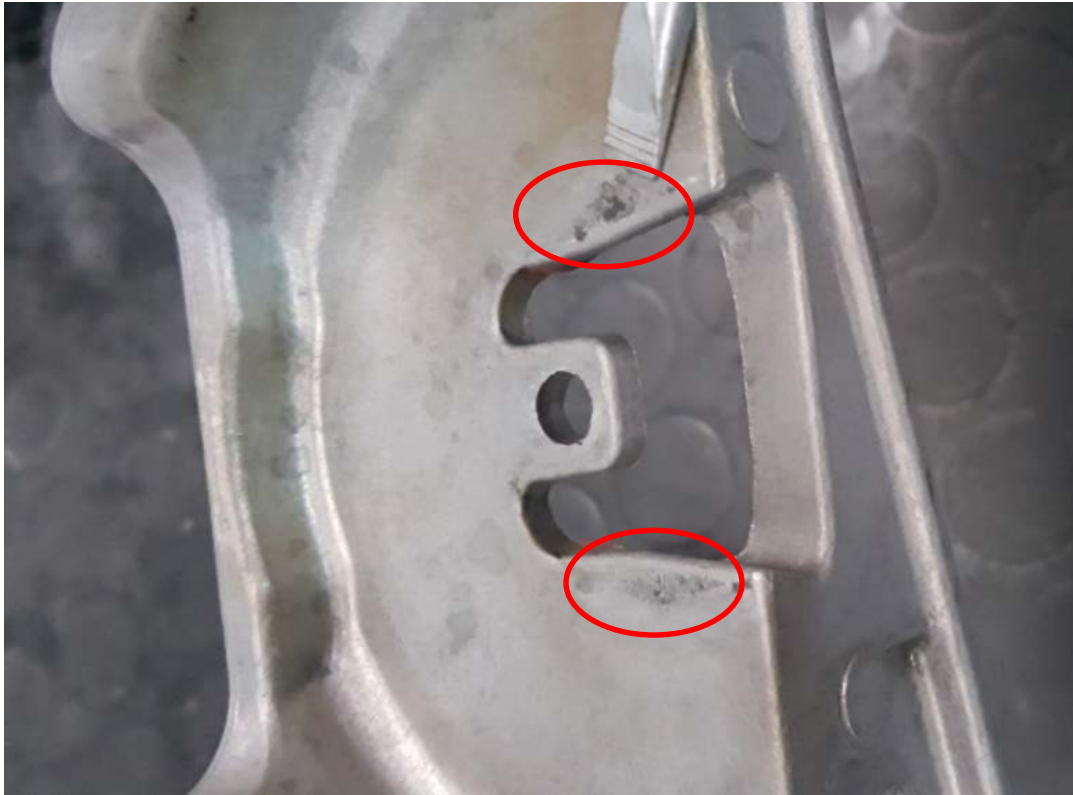
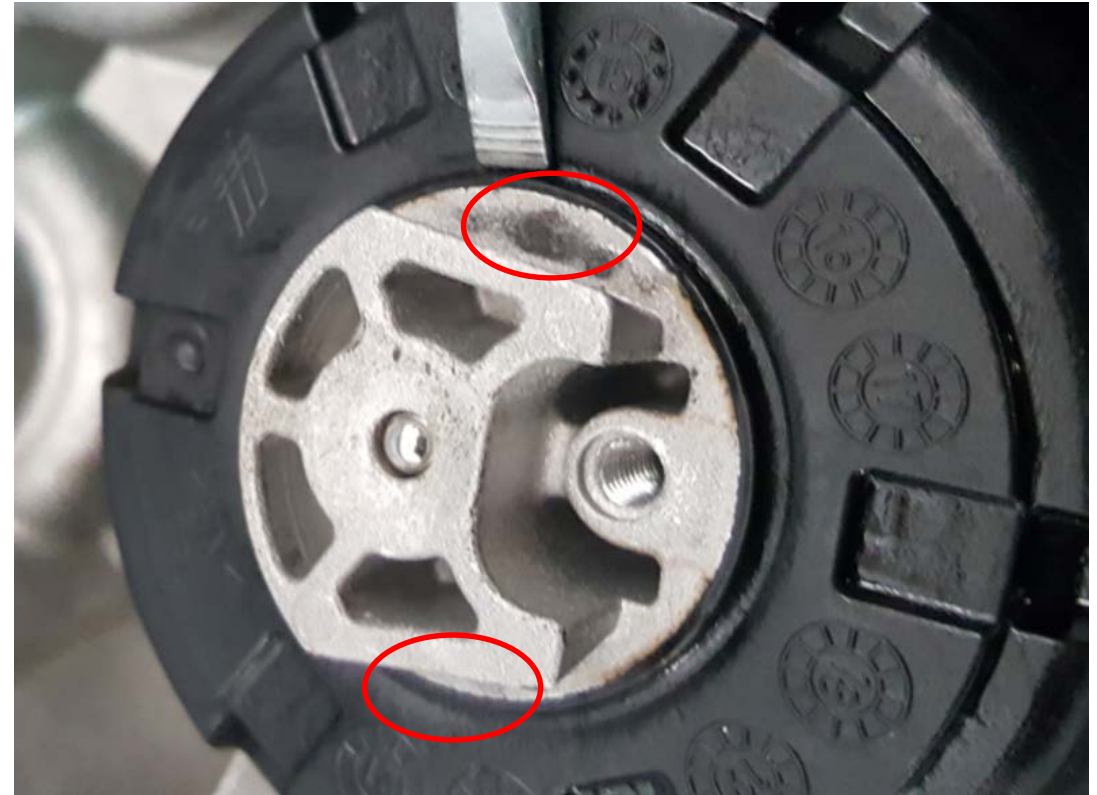
SPA – Left engine pad click sound

Make sure that the sound is coming from the engine pad, NOT from the drive shaft. This is a different sound.

If the vehicle has a click sound from the left engine pad, follow the advice under "Service".

Remove the left engine pad and split by removing the small screw. Lubricate with graphite grease (PN 1161851) or Wurth PN0890921284 (AL1100 aluminum paste) on points as in attachment.

Torque for small screw is 8 nm.

Put lubricating grease with graphite on red marked points as in pictures above.
