SERVICE BULLETIN

APPLICABILITY: 2013MY BRZ

NUMBER: 09-54-12R

SUBJECT: High-Pitched “Chirp,” “Squeak” or “Cricket”
 Sound from the Engine

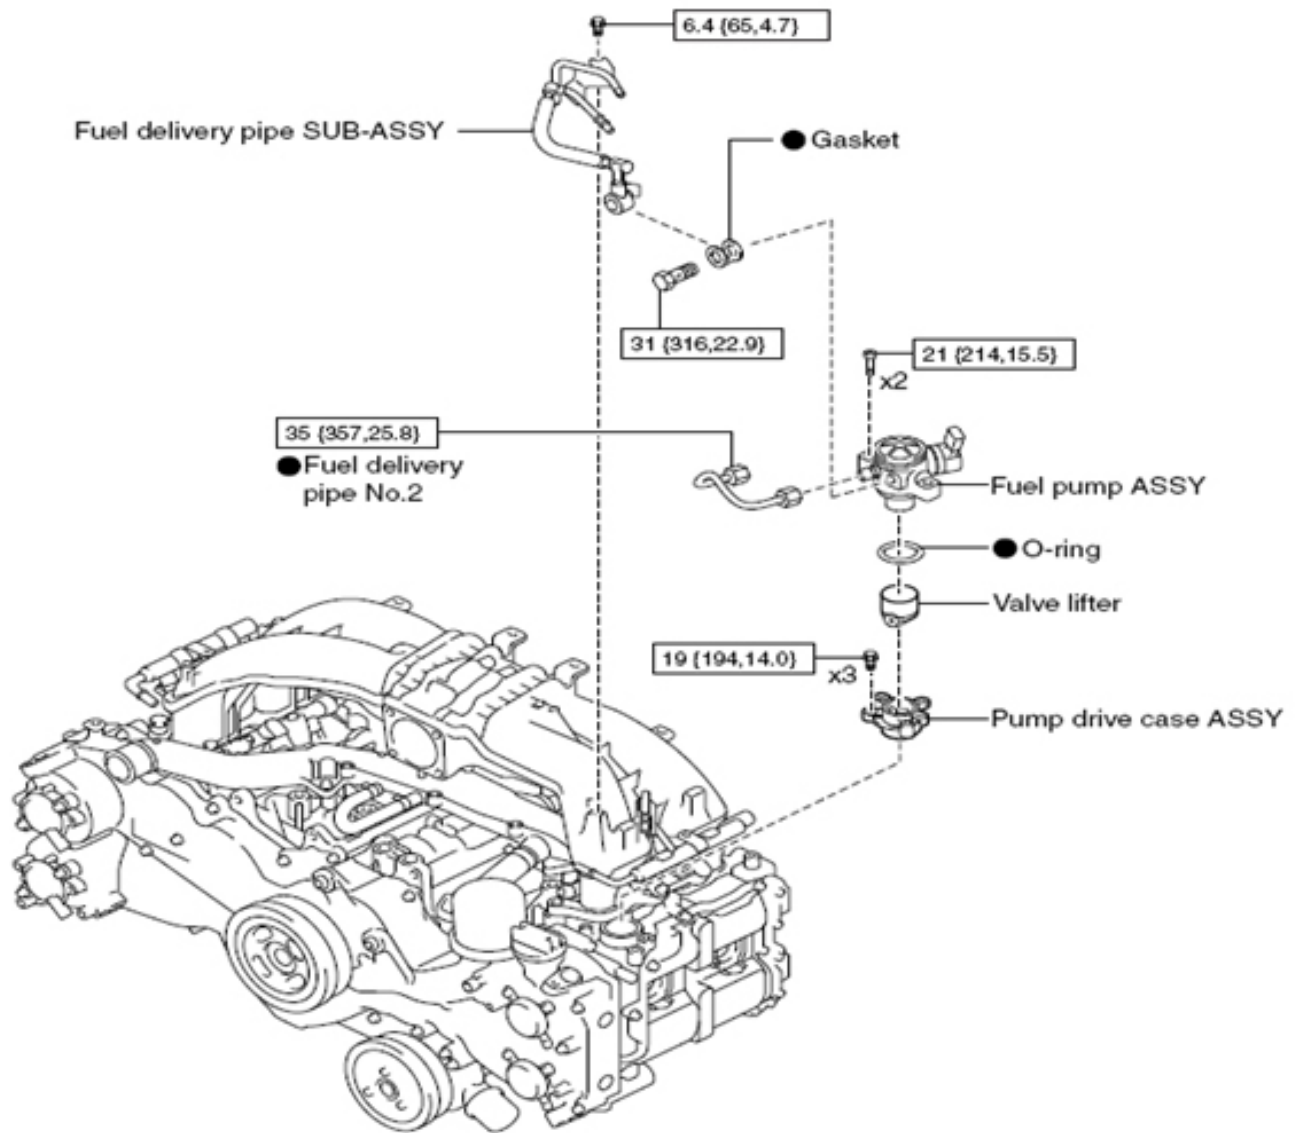
PART INFORMATION

- Items indicated in the exploded view with a ● are “non-reusable” and **MUST** be replaced.
- The o-ring is included with the fuel pump assembly.
- Part numbers and quantity required to complete the procedure are listed below.

IMPORTANT: Always follow the tightening torque specifications as indicated in the applicable Service Manual (and the exploded view diagram on pg. 2) during re-assembly.
