Customer Satisfaction Program

N222381840 Side Blind Zone Alert Retrofit

Release Date: April 2023

Subject: REVISION: N222381840-01 - Customer Satisfaction Program
Side Blind Zone Alert Retrofit with RPO 00S
Revised Parts Section

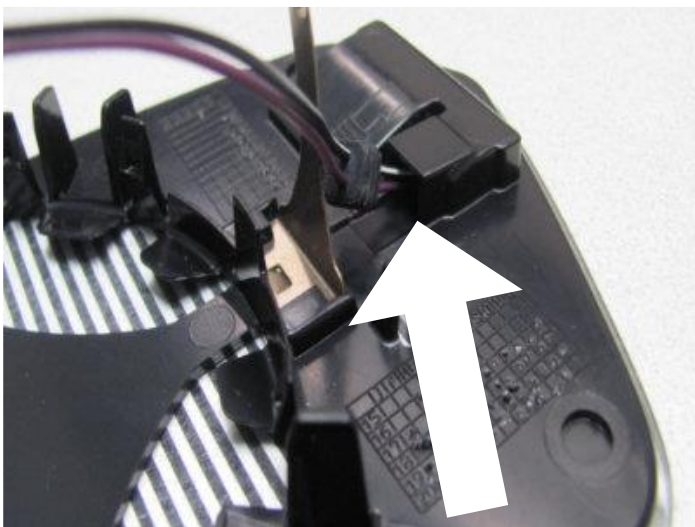
6291752

1. Install the left and right-side obstacle detection control modules. Ensure the correct part number is installed in the correct left-right position. Refer to *Side Obstacle Detection Control Module Replacement* in SI. The brackets and fasteners are already installed on the vehicle. Only remove the rear bumper fascia enough to install the modules, it is not necessary to completely remove the assembly. When programming the modules, only the left module requires programming.

Important: When removing the mirror glass, rotate the wiring harness (purple and black/white circuit) electrical connector while gently pulling on the harness. There is a step on the connector that catches on the opening and rotating the harness will release the connector. Do not apply excessive pull to the harness, the connector will be damaged.

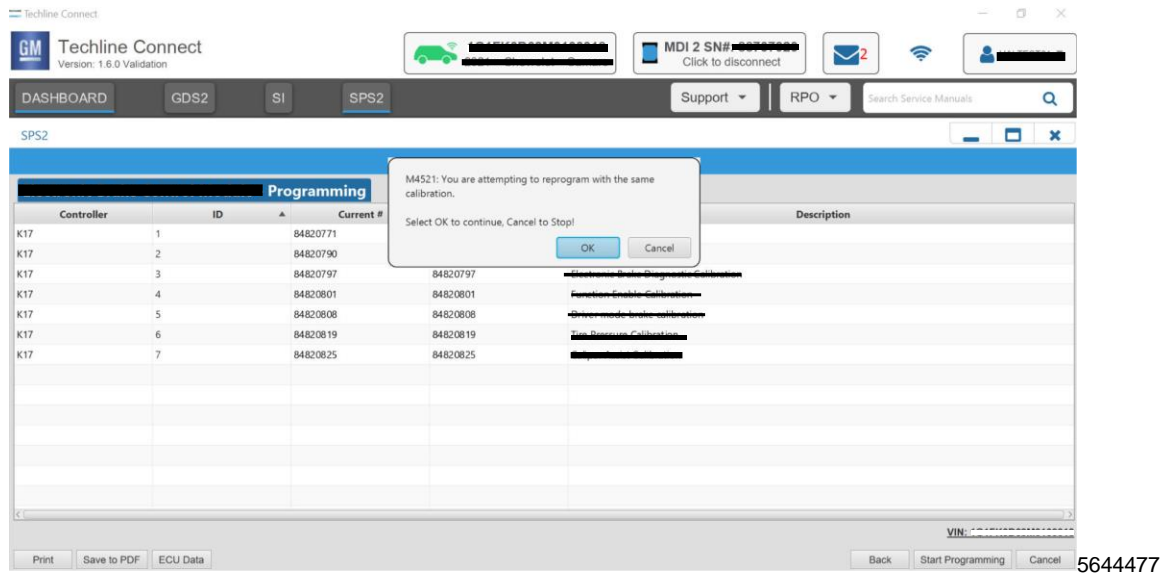
Important: Techline Connect screens shown above.

Important: If the same calibration/software warning is noted on the TLC Summary screen, select OK and follow screen instructions. After a successful programming event, the WCC is located in the Service Programming System dialogue box of the SPS Summary screen. No further action is required. Refer to the Warranty section of the bulletin.

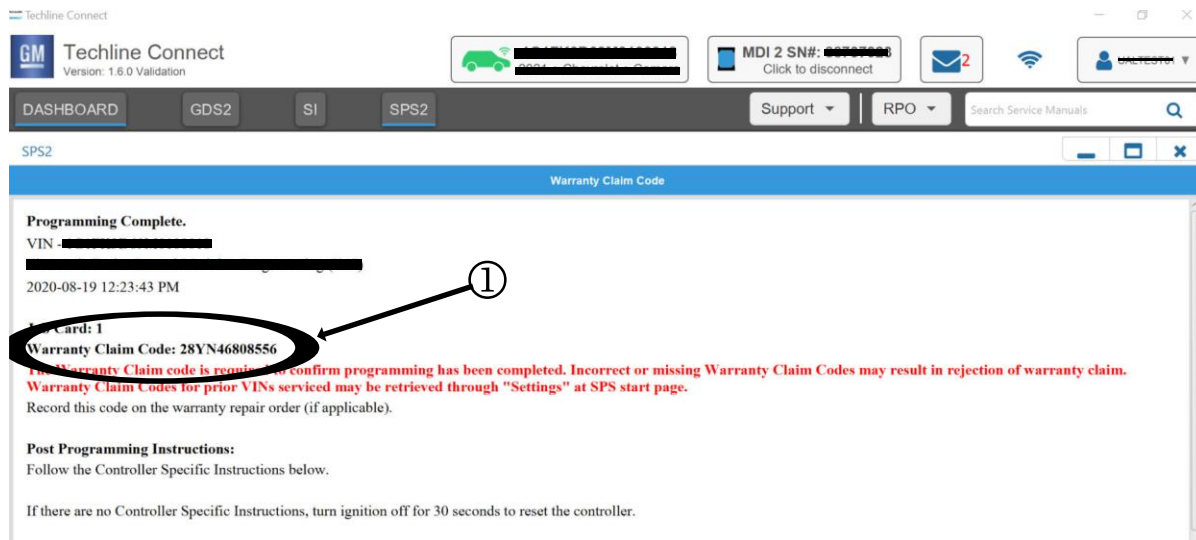
5644478

Note: The screenshot above is an example of module programming and may not be indicative of the specific module that is being programmed. Module selection and VIN information have been blacked out.

Important: To avoid warranty transaction rejections, you MUST record the warranty claim code provided on the Warranty Claim Code (WCC) screen shown above on the job card. Refer to callout 1 above for the location of the WCC on the screen.
