Volvo VHD Models - Allison Reduced Engine Load At A Stop (RELS) Diagnostic Trouble Code P071A Or P07CE - Non-Split/Drop Box PTO

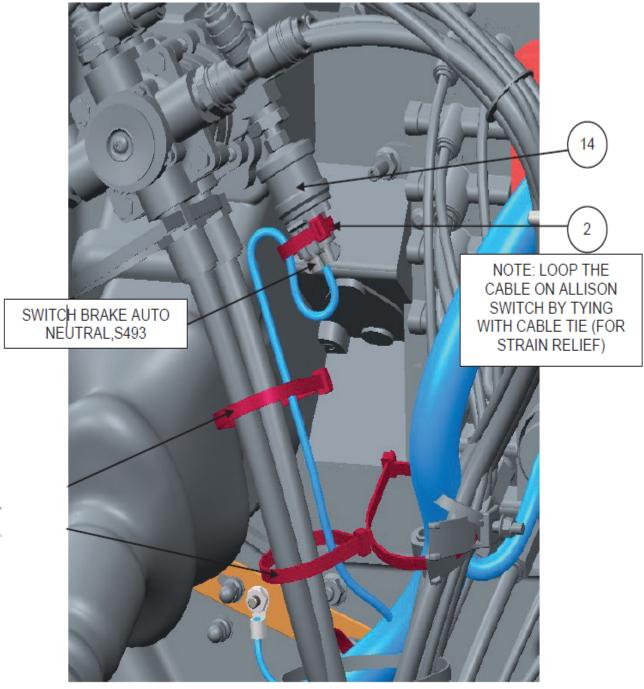
Service Brake Switch Inspection

The codes and symptom may occur if the brake pressure sensor is missing or unplugged on the left side of the treadle valve.

Visually inspect the service brake switch and verify that it is installed and the harness is connected.

If the service brake switch has not been installed refer to the p/n below:

Description	P/N
Allison Brake Switch	29511309
