Technical Service Bulletin

44 Wheel alignment

44 23 98 2056386/8 April 18, 2023. Supersedes Technical Service Bulletin Group 44 number 21-86 dated December 23, 2021, for reasons listed below.

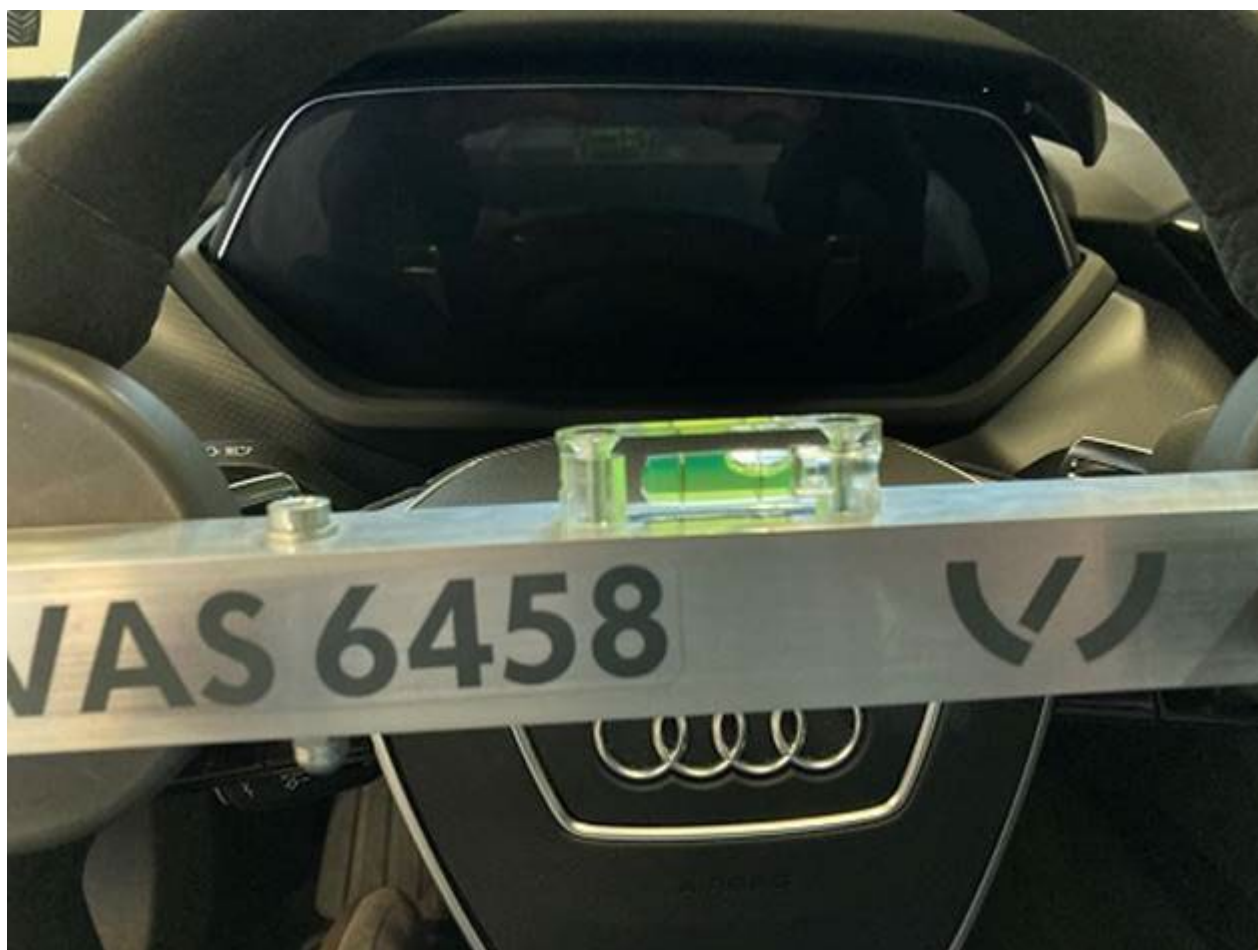
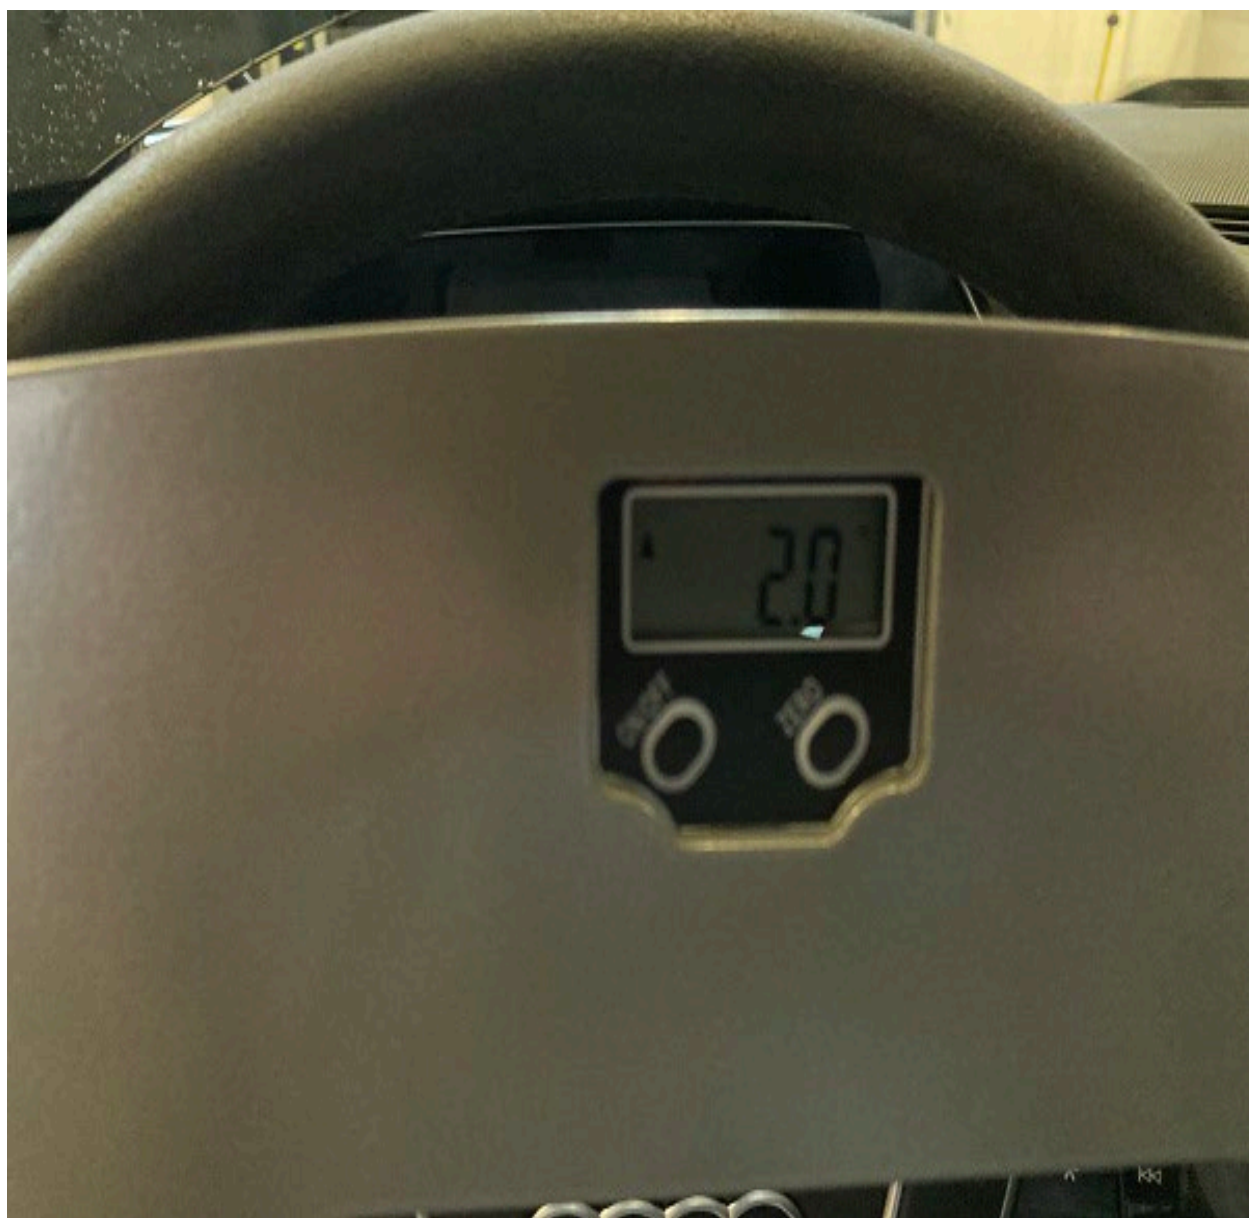
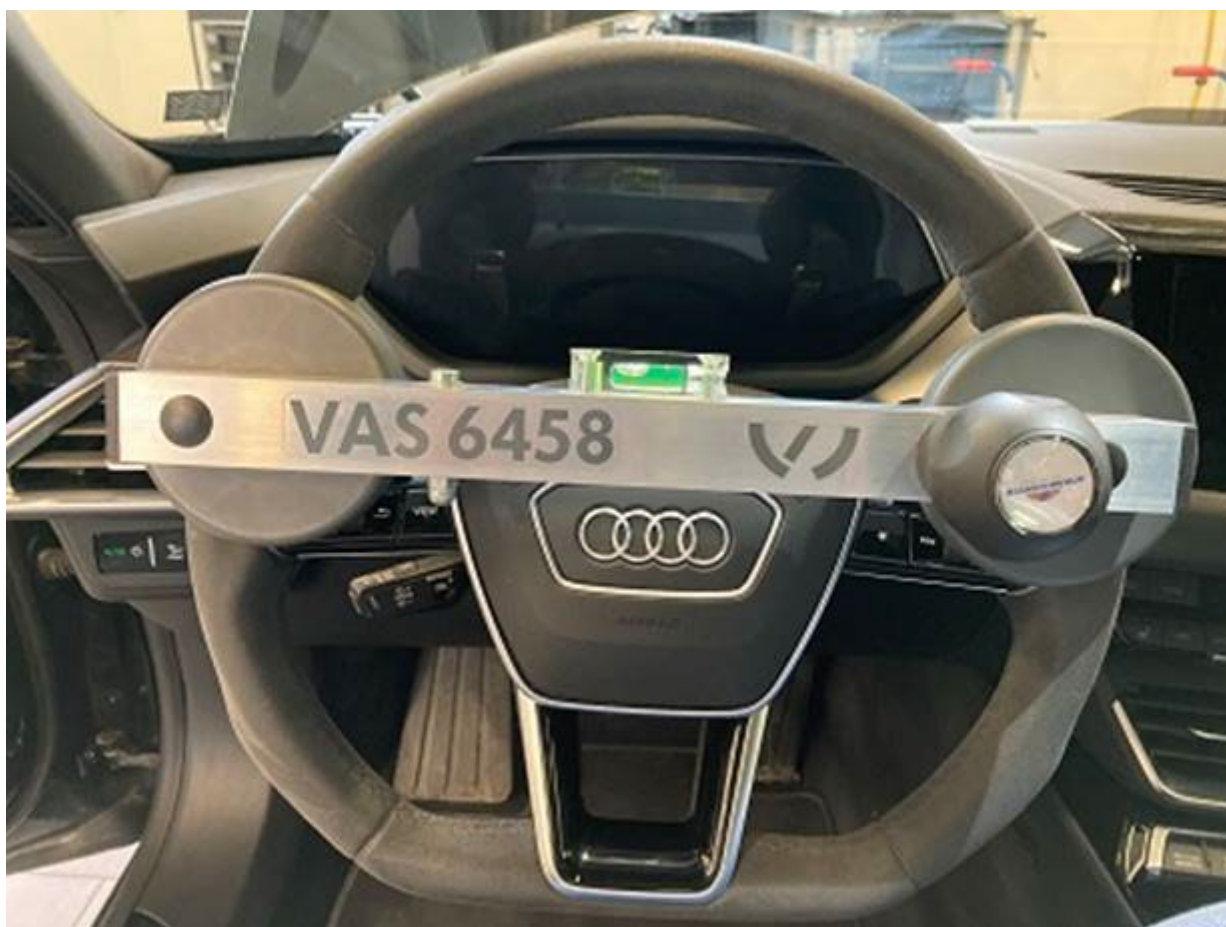
Deviations of $\pm 2^\circ$ in the steering wheel position are within the permitted tolerances for the individual toe settings and therefore do not constitute a fault.

Below are some examples of the Steering wheel off center by 2° to the left and 2° to the right. (Figures 1 to 5).

Figures 1 to 5: Examples of Steering wheel off center by 2° to the left and 2° to the right with VAS 6458 and VAS 6826 installed.
