Technical Service Bulletin

GROUP CAMPAIGN	NUMBER 23-01-021G
DATE APRIL 2023	MODEL(S) GV80 (JX1)

SUBJECT: 3.5L T-GDI ENGINE TURBOCHARGER OIL PORT RESURFACING
(SERVICE CAMPAIGN T25G)

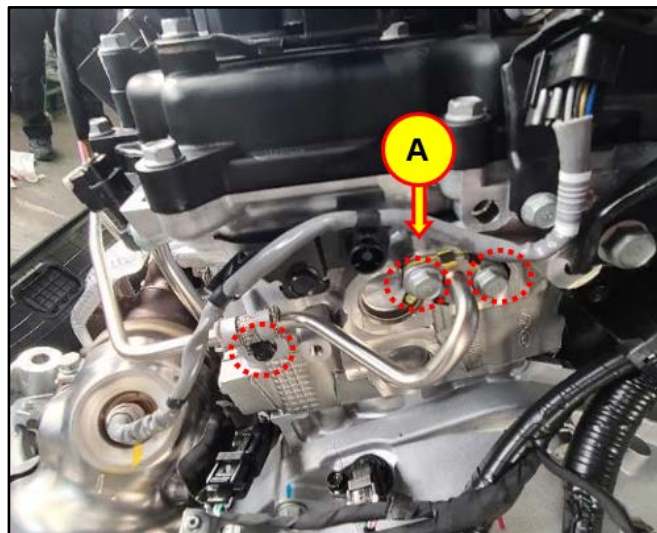
- Inspect the turbo oil feed mating surface on the LH side cylinder head for scratches.
 - If a scratch is found, continue to the next step.
 - If no scratch is found, reinstall the removed parts from Step 2 above in reverse order of removal and continue to **TURBOCHARGER OIL FEED REWORK (RH SIDE)** in the following pages.

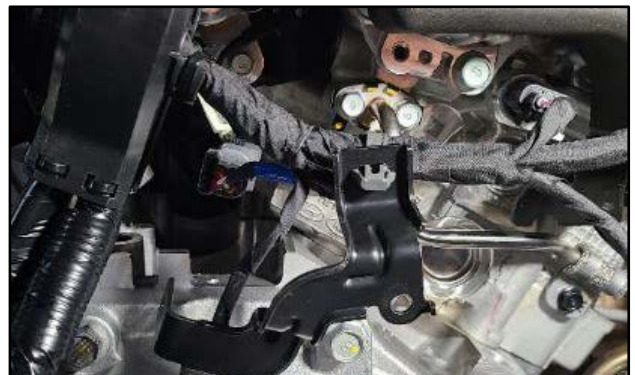
- Inspect the turbo oil feed mating surface on the RH side cylinder head for scratches. If a scratch is found, continue to the next step. If no scratch is found, skip Step 7 below and proceed directly to Step 8.
