Technical Service Bulletin

44 Wheel alignment

44 23 99 2056386/9 April 19, 2023. Supersedes Technical Service Bulletin Group 44 number 23-98 dated April 18, 2023, for reasons listed below.

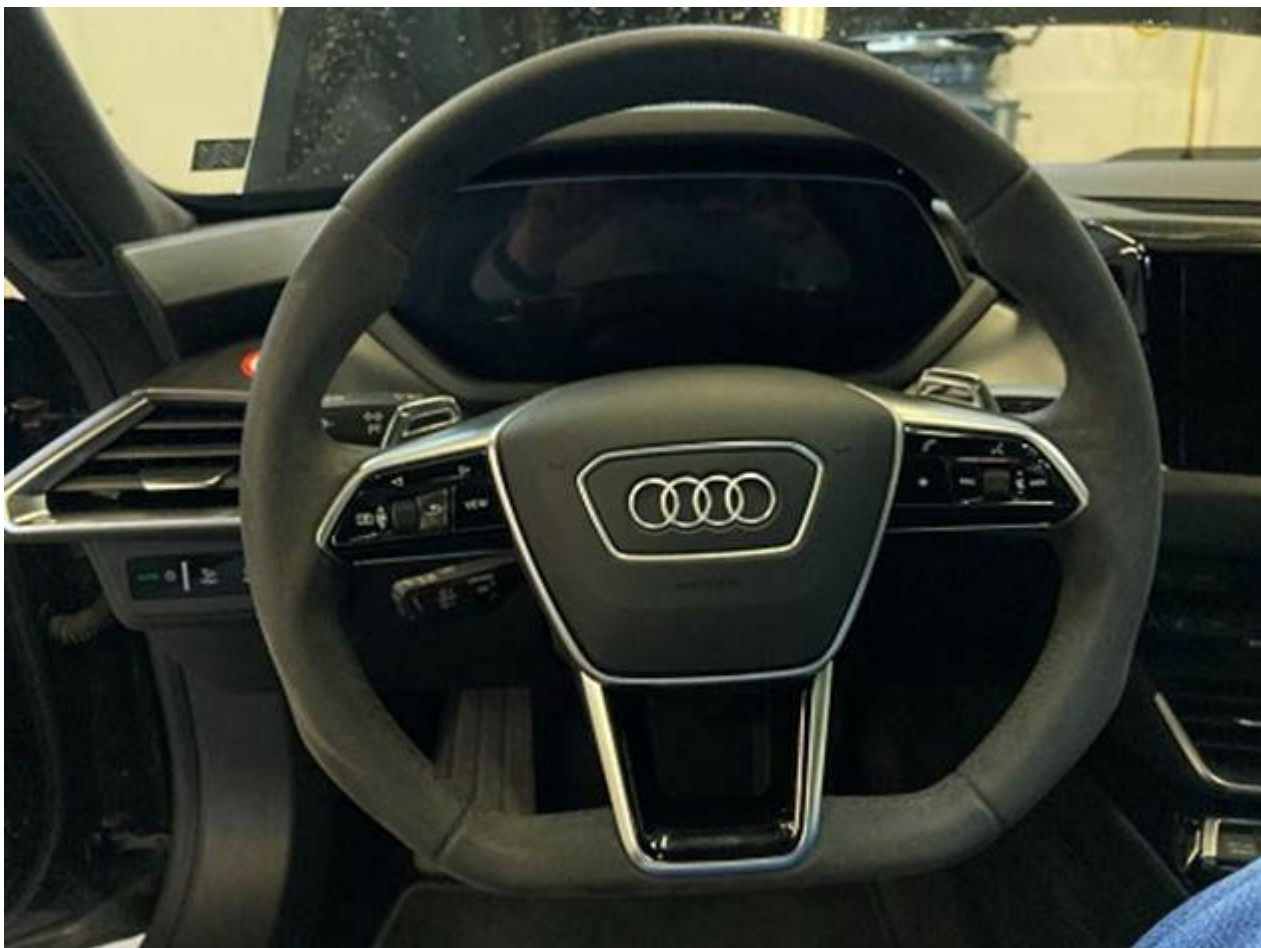
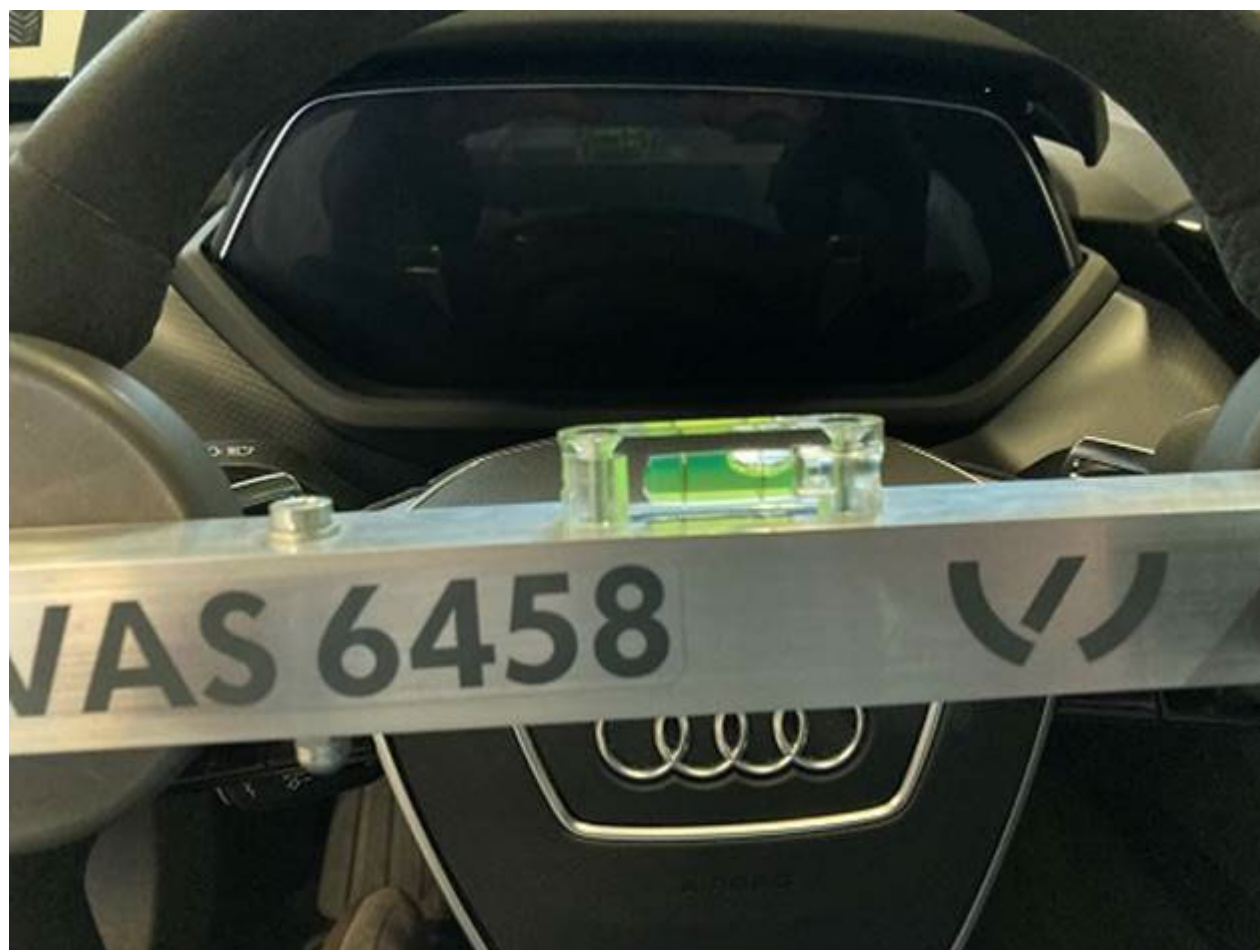
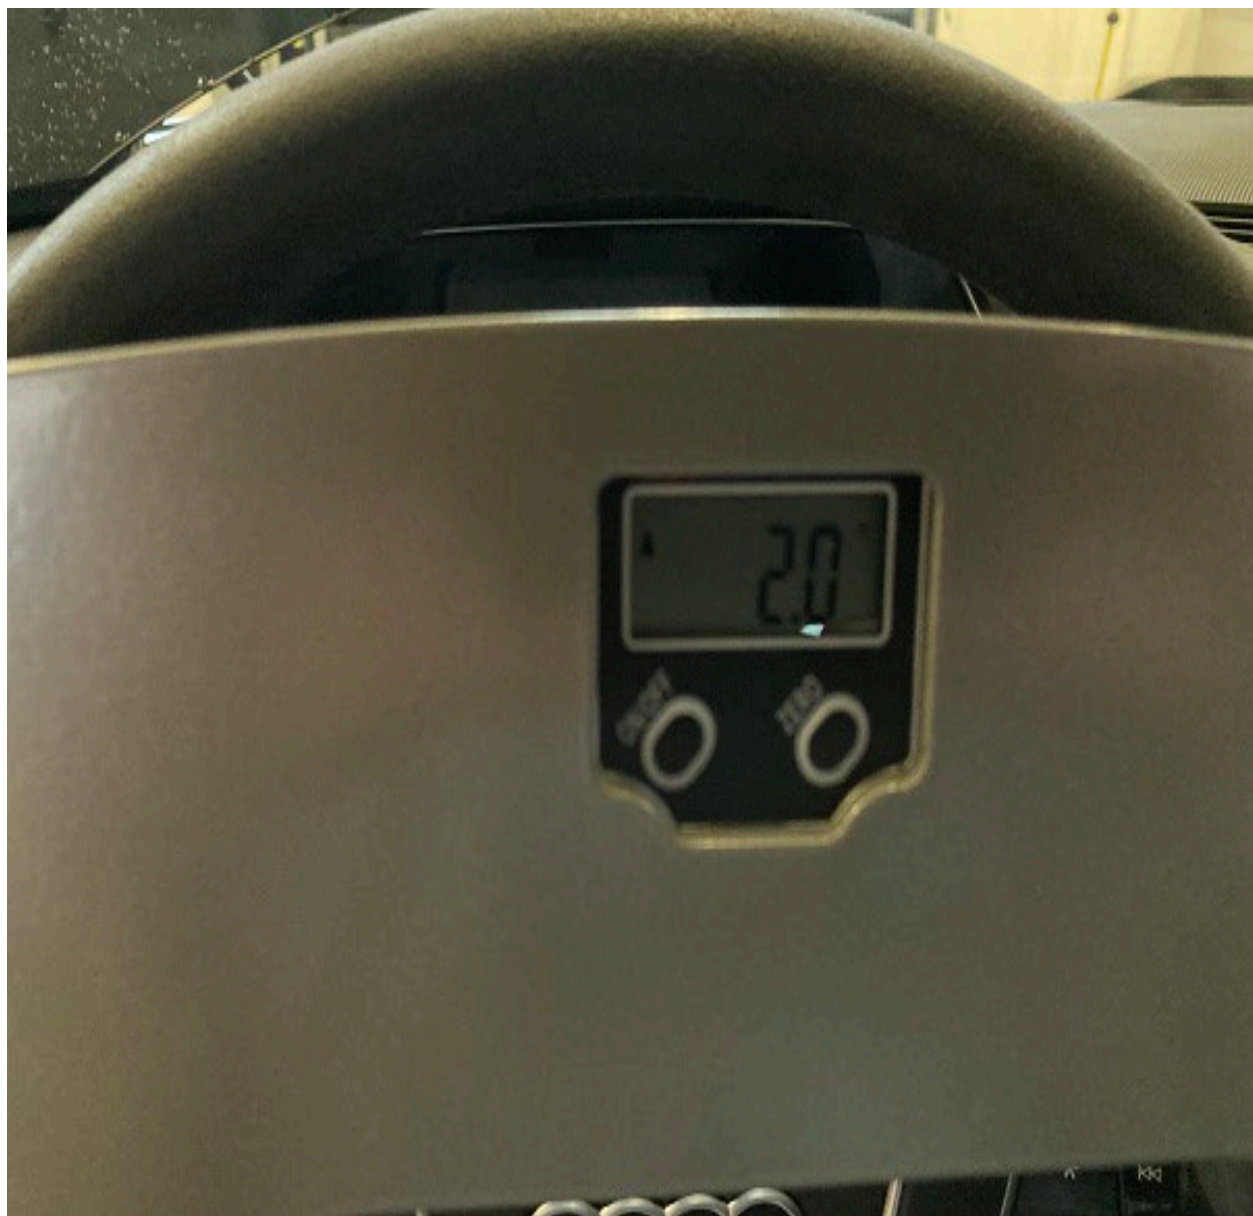
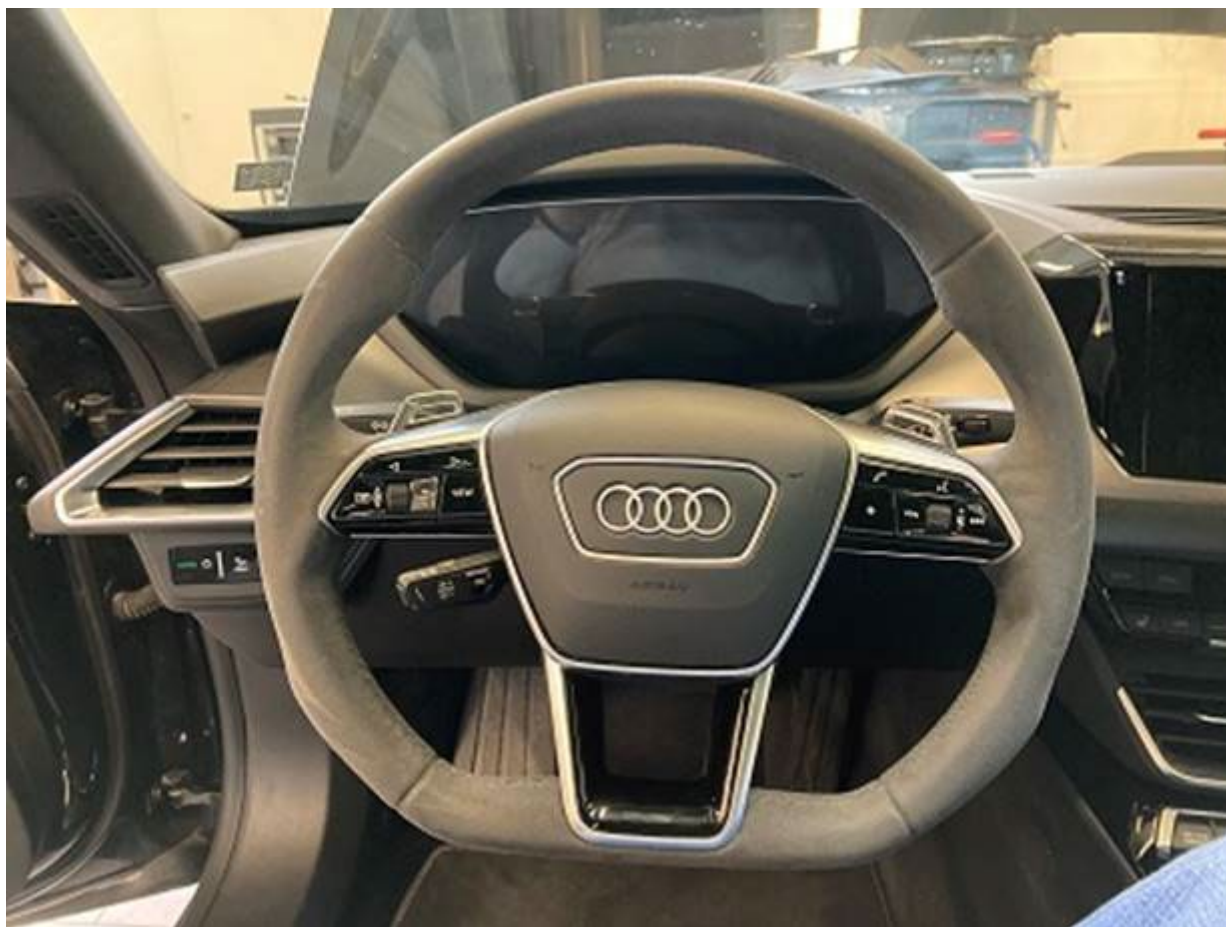
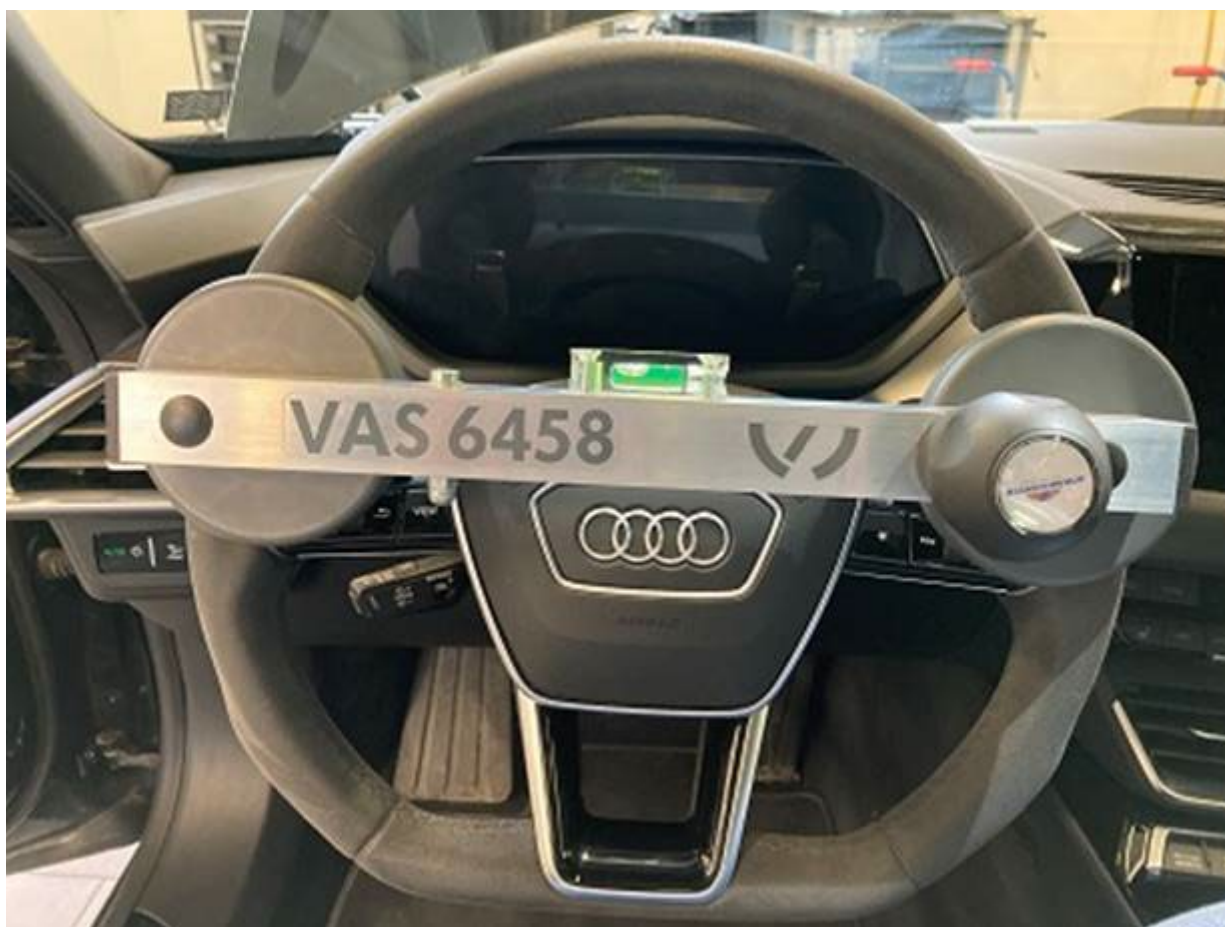
Deviations of $\pm 2^\circ$ in the steering wheel position are within the permitted tolerances for the individual toe settings and therefore do not constitute a fault.

When assessing the customer statement “the steering wheel is not straight or is crooked”, **make sure that the steering column is in the top position and is pushed as far as it will go toward the dash panel.**

If the steering wheel/steering column is in a different position, there may be a misalignment within the tolerance of $\pm 2^\circ$.

Below are some examples of the Steering wheel off center by 2° to the left and 2° to the right. (Figures 1 to 5).

Figures 1 to 5: Examples of Steering wheel off center by 2° to the left and 2° to the right with VAS 6458 and VAS 6826 installed.
