Mack Chassis - Allison Reduced Engine Load At A Stop (RELS) Diagnostic Trouble Code P071a Or P07ce - GR,TE,LR Models - Non-Split/Drop Box PTO

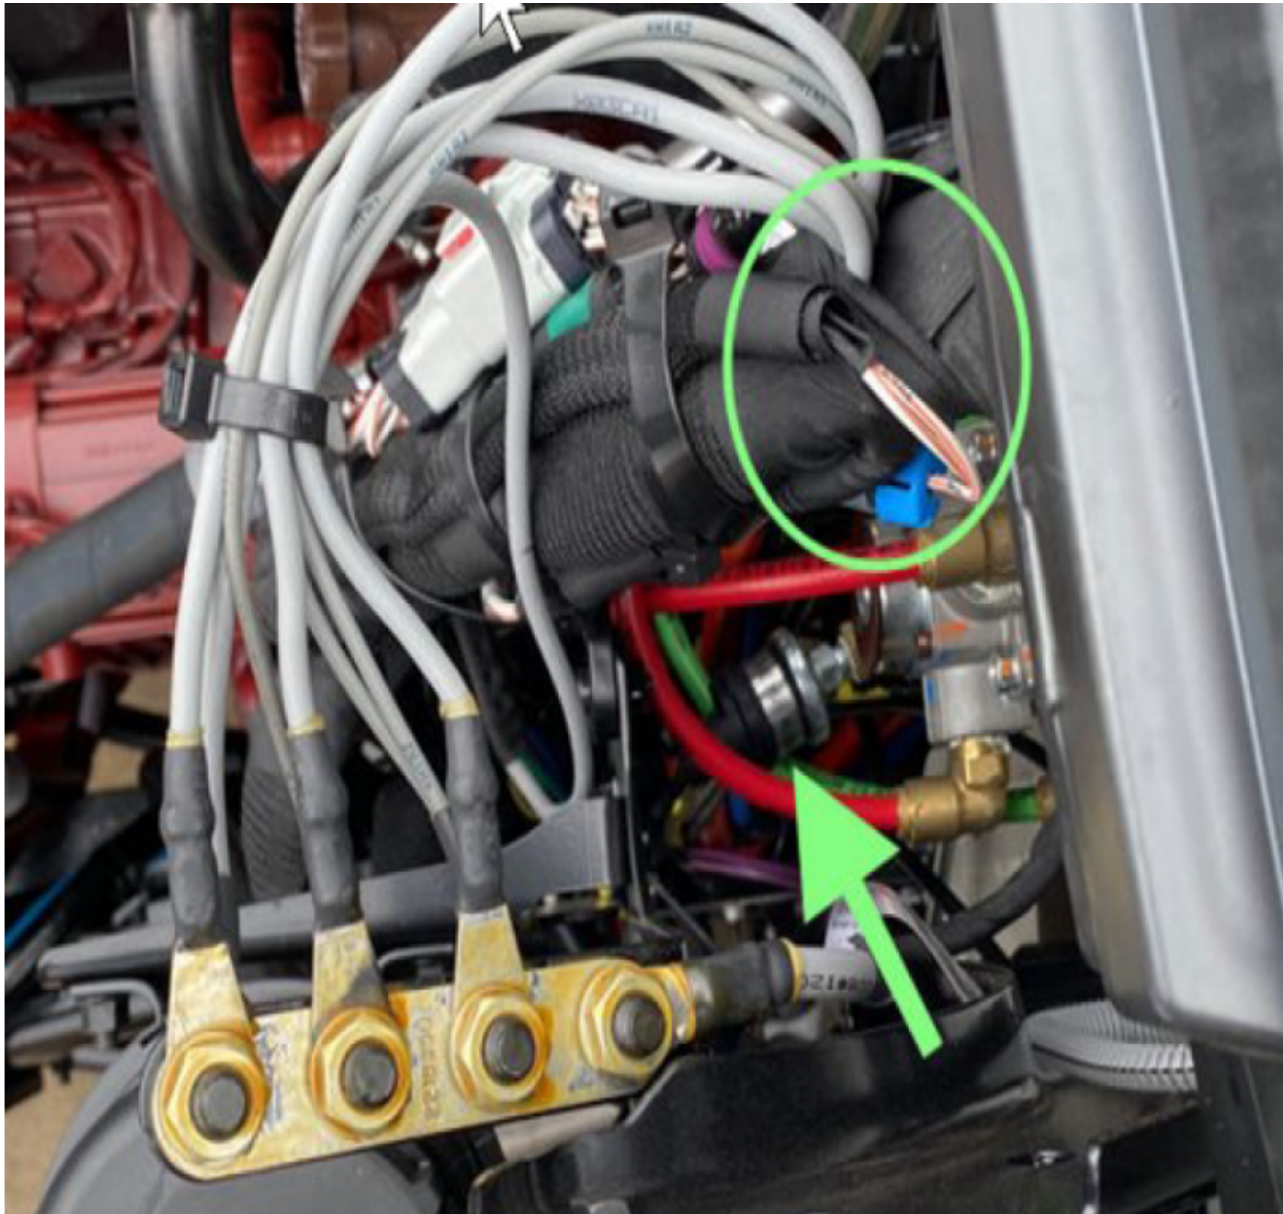
GR

Visually inspect the service brake switch and verify that it is installed and the harness is connected.

If the service brake switch has not been installed refer to the p/n below.

Description	P/N
Allison Brake Switch	29511309

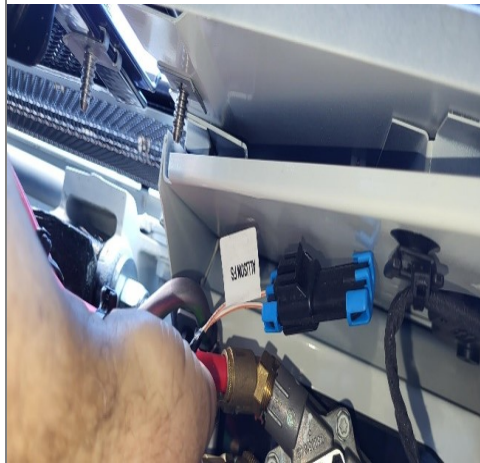
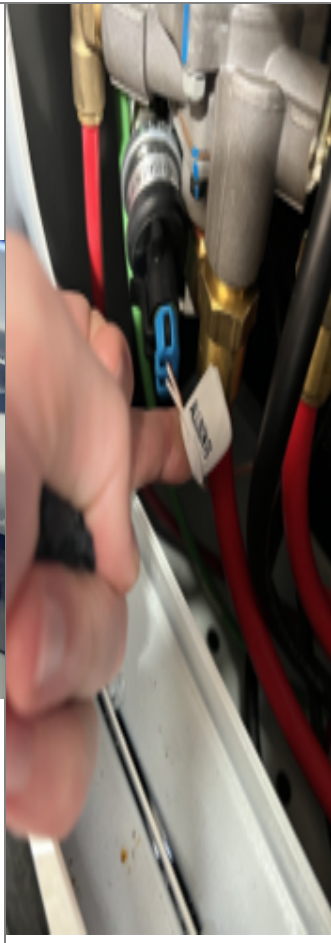
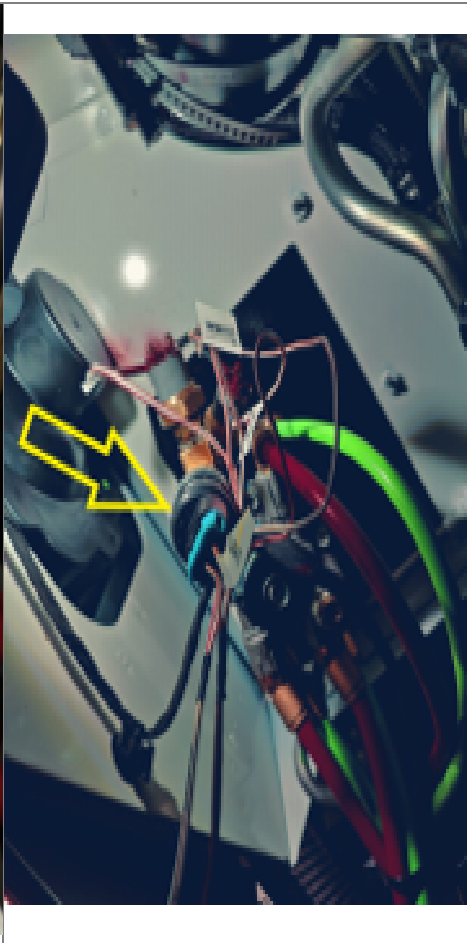
LR

<p>1. There is a pig tail under the left side drivers station "ALLISON FS" not plugged into anything.</p>	<p>2. Right side brake valve has pressure sensor connected.</p>	<p>3. Install a Tee on the brake valve and connect the Secondary sensor and brake pressure sensor.</p>
