POWERTRAIN – MISFIRE ON NEW REPLACEMENT OR REMAN UNITS – AJ126

17-19MY Discovery, Range Rover, RR Sport, RR Velar
17-19MY XE, XF, XJ, F-PACE, F-TYPE

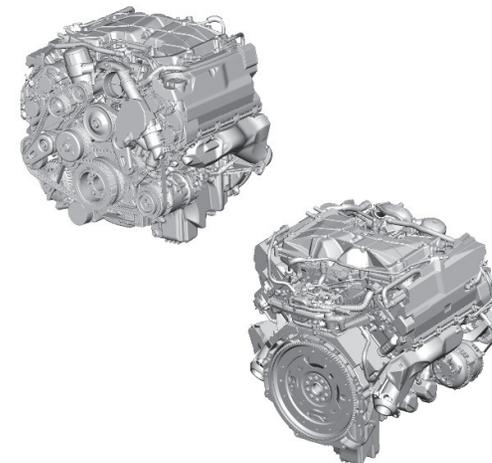
E152254

- JLR have received reports of replacement new or remanufactured 3.0L AJ126 gasoline engines experiencing misfiring and/or rough running for the first few minutes after a cold start.

- Root cause confirmed by Engineering as build issue which is now rectified, the affected engines may have improper valve clearances.

- Check the clearances of all valves and correct any discrepancies.
- Submit an EPQR if valve clearances are not to spec and include the part number and serial number of the replacement engine.
- If valve clearances have been checked and are within specifications, perform basic diagnostic procedures as outlined in the TOPIx workshop manual.
