Cayenne E-Hybrid – Thermal Management Fault P26B100 Causes Check Engine Light

Models	Model Year	Model Type	VIN Range	Vehicle-Specific Equipment
Cayenne	As of 2019 up to 2023	9YAAE1 9YACH1 9YADE1 9YBAE1 9YBCH1 9YBDE1	N/A	+OK3

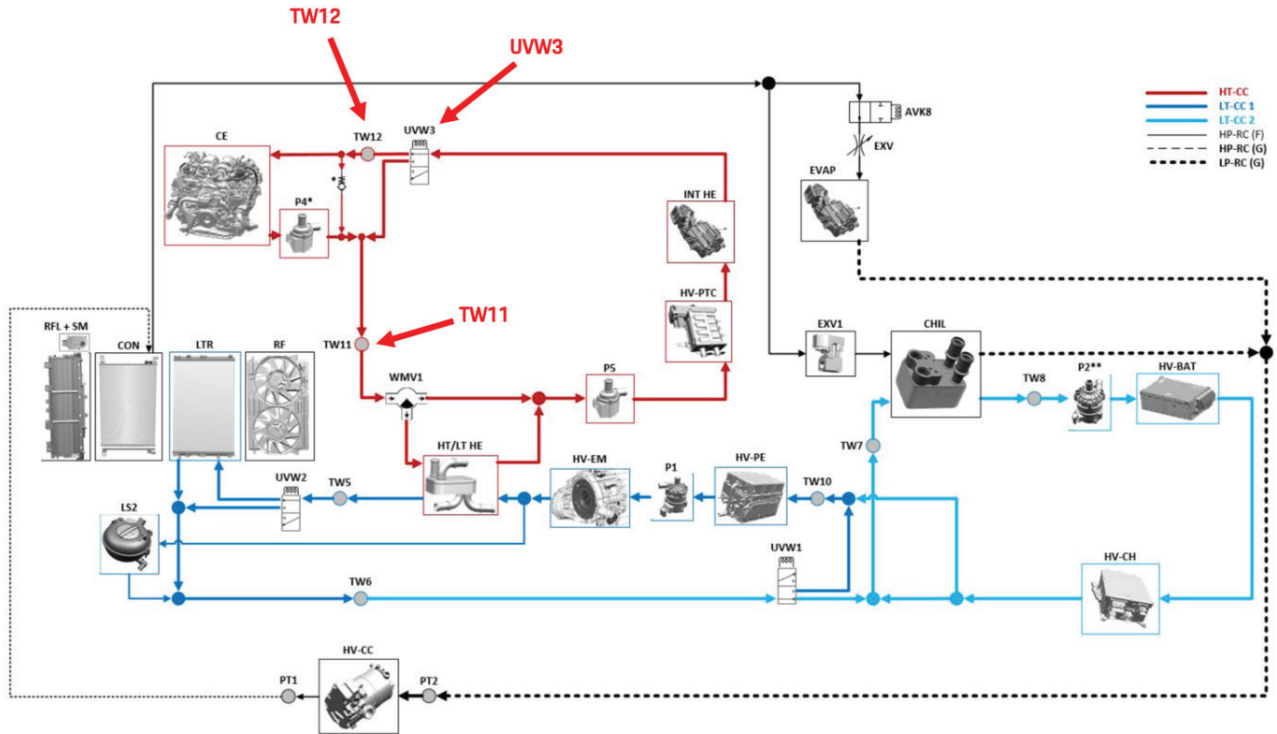
Figure 1 - Cayenne E-Hybrid Cooling Circuits

Valve UWV3 controls the direction of coolant flow based on engine temperature. The valve defaults to closed, such that the high-temp circuit excludes the engine coolant circuit. During this “small-circuit” operation, the HV PTC controls the temperature of the high-temp circuit to meet the heating and air conditioning demands of the customer. Once the engine reaches 40° C, the valve opens (“large-circuit” operation) and the high-temp circuit uses the engine heat instead of the HV PTC.

The status of UWV3 is diagnosed by the absolute value of the temperature difference between TW11 and TW12. The TME expects this difference to be **larger than 7° C while the valve is closed, but smaller than 7° C while the valve is open**. Certain operating conditions may cause the temperature difference to fall below 7° C while the valve is closed. If this condition exists while the TME is performing diagnostics, the valve will be diagnosed as open, although it is closed due to the engine temperature being less than 40° C.
