Technical Service Bulletin:
TSB220220

Front Face Cup Plug Missing from Cylinder Head

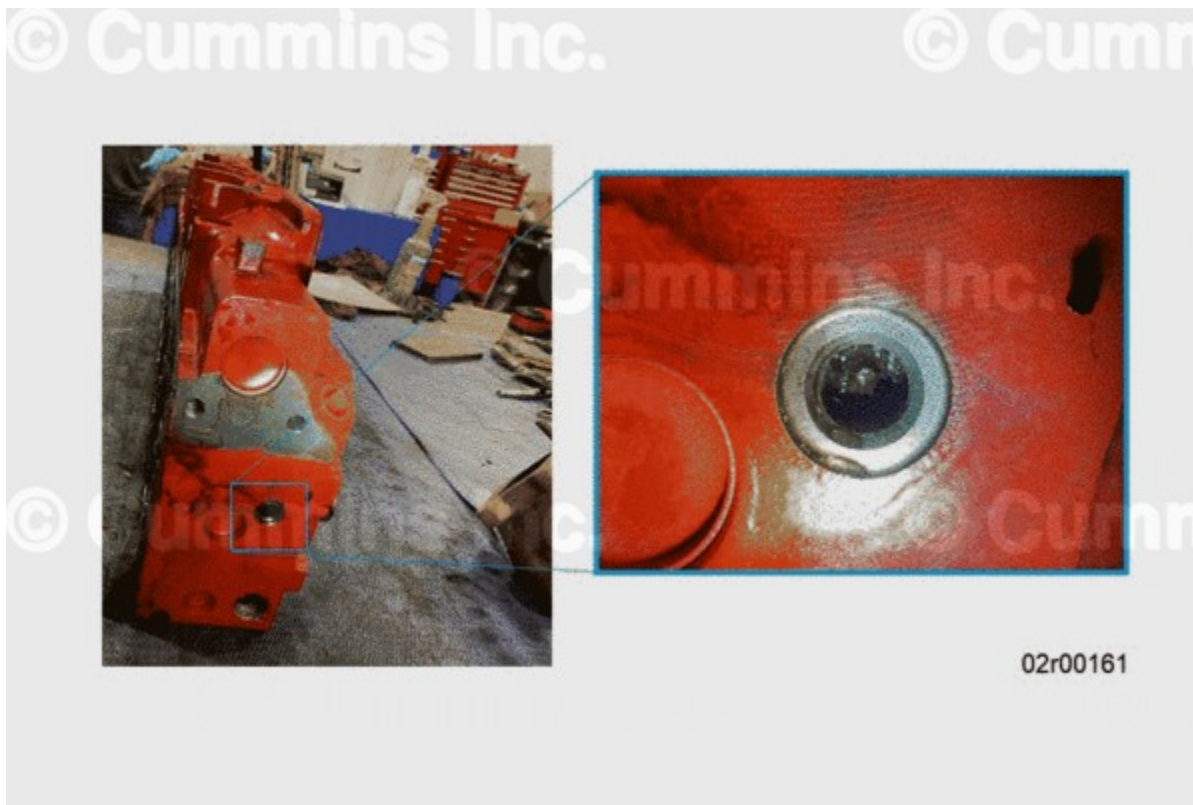
- Debris plugging the fuel drain line at the rear of the cylinder head causing excessive fuel drain line restriction and resulting in cup plug dislodging.
- Analysis has consistently shown urea in these deposits, indicating diesel exhaust fluid (DEF) in fuel tank.

- Inspect the fuel drain line on the cylinder head for debris. See Figure 1.
- Debris present in the fuel drain line contains urea/DEF.

Figure 1, Example View of Fuel Return Line Clogged with DEF Debris.

- Reference Service Bulletin, Diesel Fuel Contaminated with Water, Gasoline, or Diesel Exhaust Fluid (DEF), Bulletin 5659823.
- Remove check valve fitting from the rear of the cylinder head and look for debris in the drilling. If found, remove the number 6 injector and clean out the debris.
- Run a flexible brush through the fuel drain line, the high-pressure fuel line, and the injector bore to clean out all the debris. Use contact cleaner as needed.
