| <b>Topic</b> | HVAC refrigerant leakage - Diagnosis guidelines |
| <b>Brand</b> | Bentley |
| <b>Transaction No.</b> | 2069806/1 |

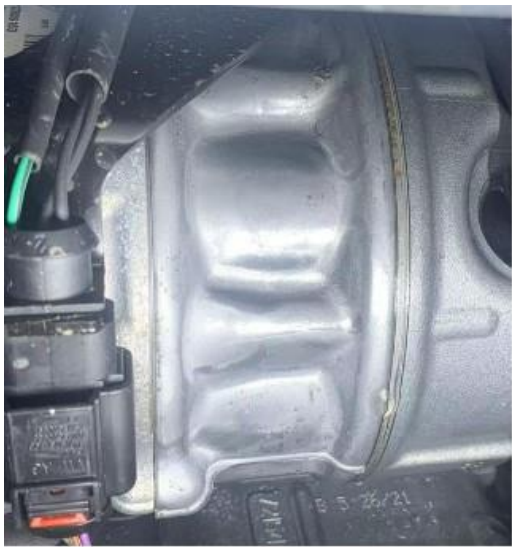
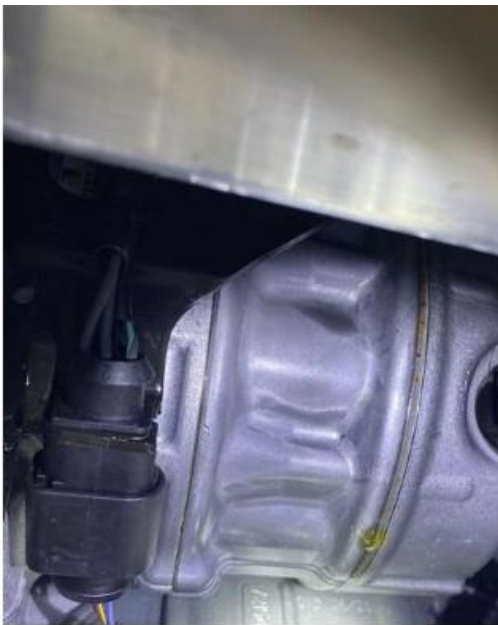
Figure 1

please refer to the examples shown below (Figures 1,2 and 3) of leaks found on a HVAC compressor

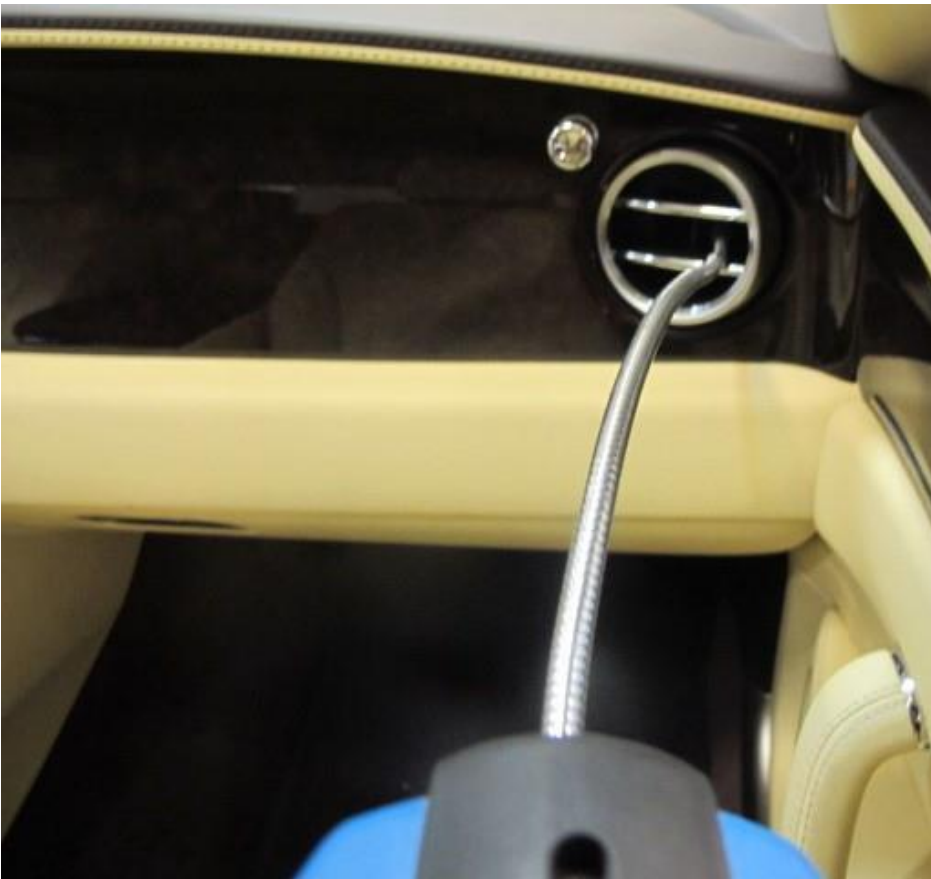
Figure 4

CAUTION: In the event the HVAC sniffer tool traces a HVAC leak from any of the outlets (Figure 4)

A complaint is received that refrigerant is evident within the cabin the operative **MUST** first ensure that a leak is not evident within the plenum chamber or around the centre console (Figures 5 and 6) as refrigerant could be leaking into the plenum chamber/cabin and recirculated back into the cabin as this could lead to misdiagnosis and/or incorrect part replacement
