Service Campaign Bulletin

Campaign No. 2023030004, April 2023

SUBJECT: **Model SL (232 platform)**
Model Year 2022-2023

Check Convertible Roof Frame, Calibrate if Necessary

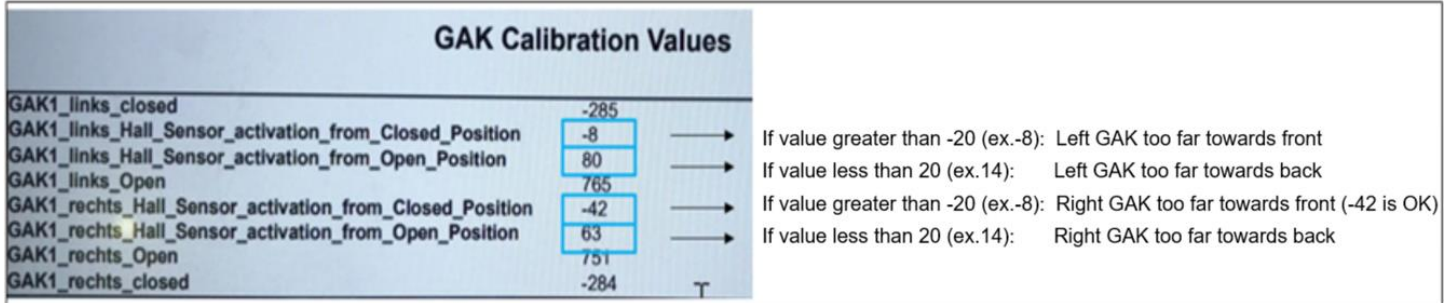
Figure 1: Interpretation of GAK calibration value from control unit log

Left GAK	Closed Position	Not OK for 0 up to -19	OK < -19
	Open Position	Not OK for 0 up to +19	OK > +19
Right GAK	Closed Position	Not OK for 0 up to -19	OK < -19
	Open Position	Not OK for 0 up to +19	OK > +19

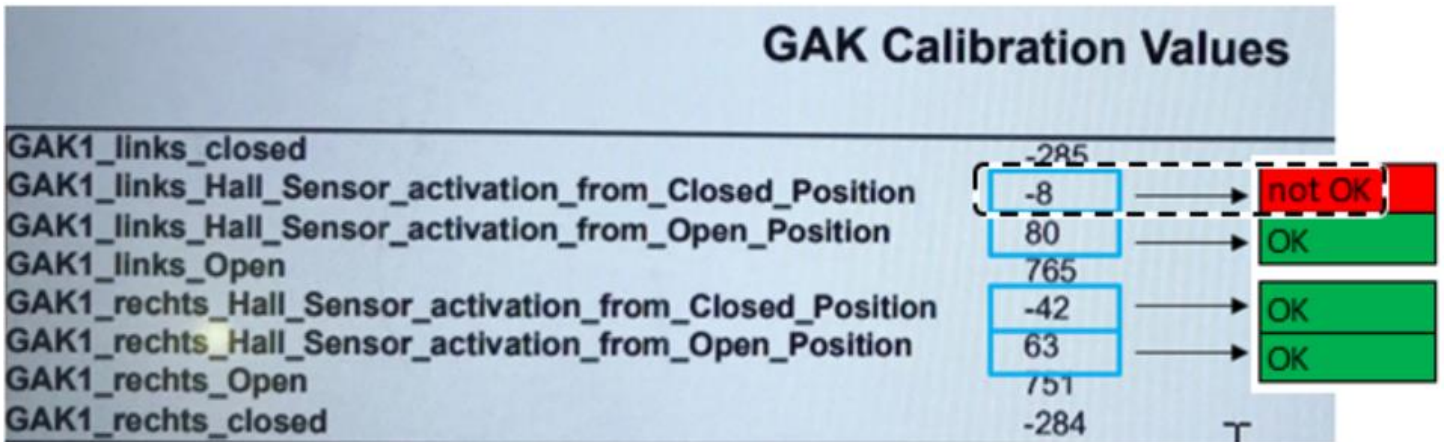
Figure 2: Determination of rework scope

- i** Example: **-8 not OK**. Here the **left GAK** must be moved to the rear.

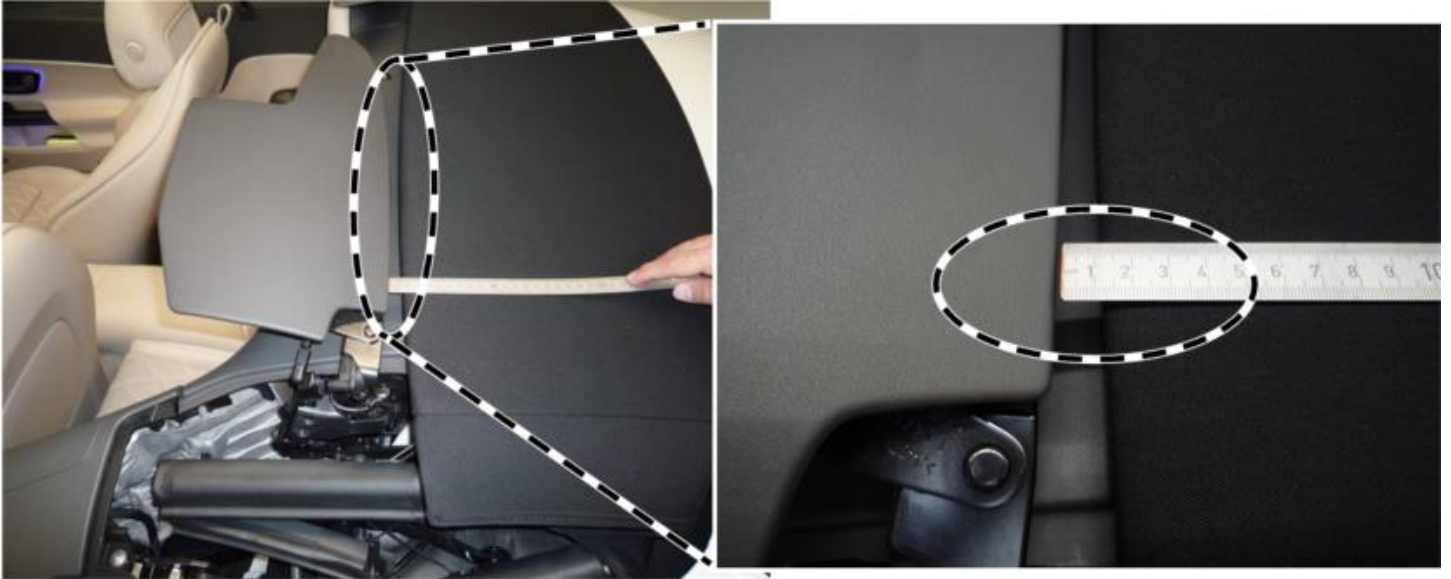
Figure 7 not OK

i Perform distance measurement at narrowest location in movement between GAK and soft top.

i A distance of **at least 15 mm must** always be ensured at both convertible roof frame outlet flaps to the soft top!

5. Readjustment of **not OK** GAK (figure 7)

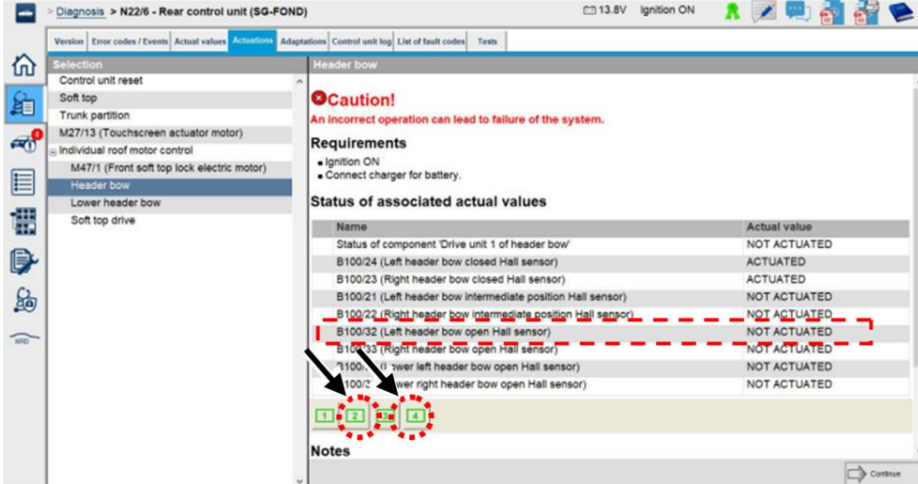
Figure 8

Note: Per actuation, the mechanical system is moved backwards by approx. 1-2 mm

6. Gradually move back convertible roof frame outlet flap (GAK) via XENTRY to a distance of **17 mm** (figure 8).

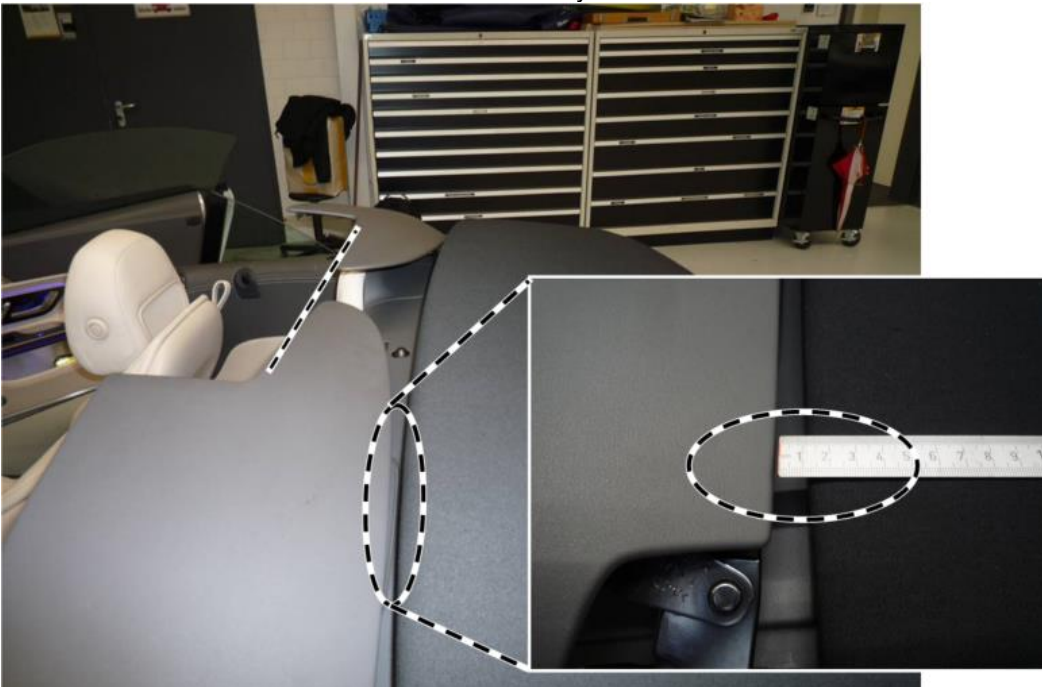
Figure 9

i Both convertible roof frame outlet flaps (GAK) must align (figure 9).

i A distance of **at least 15 mm must** always be ensured at both convertible roof frame outlet flaps to the soft top!

7. Carry out position adjustment of GAK via XENTRY (figure 9).
