**HYUNDAI**
Technical Service Bulletin

GROUP CAMPAIGN	NUMBER 23-01-042H
DATE APRIL 2023	MODEL(S) PALISADE (LX2) SANTA FE PLUG-IN HYBRID (TM PHEV)

SUBJECT: ENGINE MOUNTING SUPPORT BRACKET RETIGHTENING
(CAMPAIGN TAG)

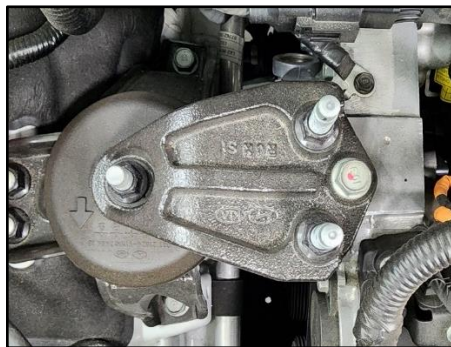
Description: Certain Palisade (LX2) and Santa Fe Plug-In Hybrid (TM PHEV) vehicles may have been produced with engine mounting support bracket fasteners that were not tightened to torque specification. Follow the procedure outlined in this bulletin to retighten the indicated fasteners to the correct specified torque values.
