TECHNICAL SERVICE BULLETIN

Classification: KS13-050F	Reference: NTB13-107F	Date: April 27, 2023
------------------------------	--------------------------	-------------------------

VEHICLE KEY NOT DETECTED / AUTHENTICATED, ENGINE WILL NOT START

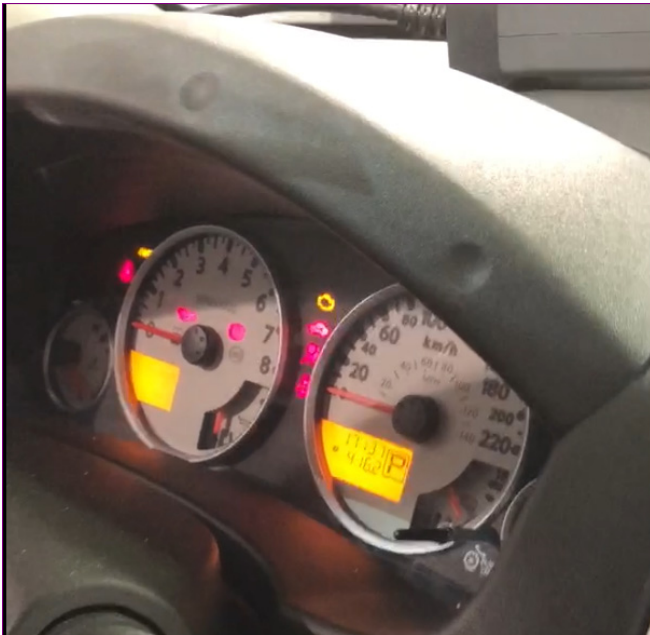
Figure 1

- The Intelligent Key is not detected, causing:
 - The engine to **not** start (no response when the Stop/Start button is pressed)
 - "Incorrect Key ID" displayed in the instrument cluster
 - "No I-Key Detected" displayed in the instrument cluster
- Intermittent operation of the buttons on the remote (key fob).
- Intermittent operation of the door request switches.

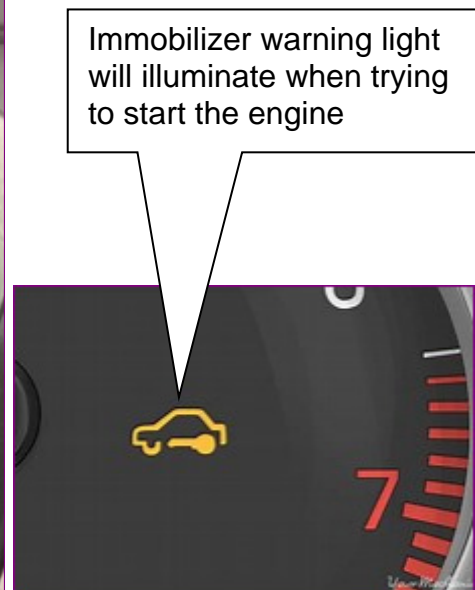
Figure 2

- The NATS key is not detected, causing:
 - The engine to **not** start (no response when the key is turned)
 - Illumination of the Immobilizer warning light (Figure 2 on page 2)
 - DTCs B2191 (Difference of key) to be stored in the BCM, and P1615 (Difference of key) to be stored in the ECM

- If the Immobilizer warning light (Figure 2) remains illuminated during attempts to start the engine, this could indicate that the key was not authenticated properly.
- The supplemental diagnostic items listed on the next page should be checked before replacing any parts or performing any repairs.
- Refer to the appropriate Electronic Service Manual (ESM) for complete key system diagnosis and repair information.

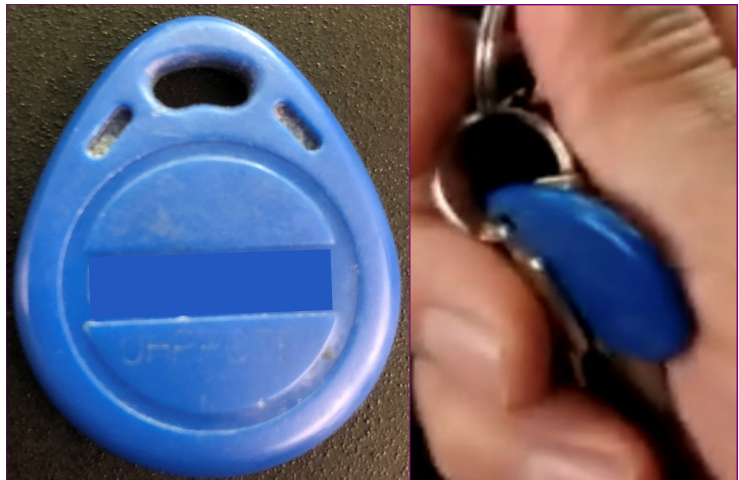
Figure 3

- If an RFID (Radio Frequency Identification) token (Figure 3) is placed within close proximity to the vehicle key, it can interfere with the RF signals, resulting in an inability to authenticate the key and cause a no start concern.
 - Other contributors are:
 - Keys with a similar transponder frequency
 - Multiple keys on one keyring
- Remove all aftermarket devices from the vehicle, including all other keys, while diagnosing a no start concern.

- NATS keys also contain a transponder that can be affected by interference.
- For interference to cause a no start condition, the source of the interference will typically be in close proximity to the key; for example, an RFID chip on a key chain with the key (Figure 3).

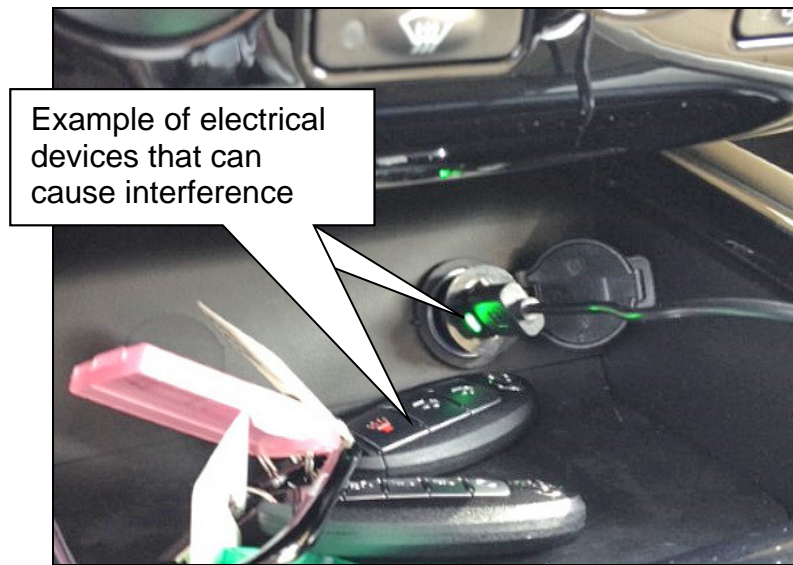
Figure 4

- If the conditions on the previous page are not the cause of the symptoms, check for the presence of an aftermarket alarm system, radar detector, or **ANY** electronic devices, including other keys.
- RF signals coming from the vehicle surroundings can interfere with the key signals, such as radar detectors or aftermarket alarm systems **in other vehicles or surrounding buildings**.
- If you are unable to duplicate the concern, it is important to determine WHERE the vehicle was located when the customer experienced the no start concern.
