Technical product information

Topic	Bentayga V8 Kovomo - DTC P310B00 with Symptom Code 2638 - Check Engine Lamp - Fuel Pressure Regulation
Market area	Bentley: worldwide (2WBE)
Brand	Bentley
Transaction No.	2058484/12
Level	EH
Status	Approval
Release date

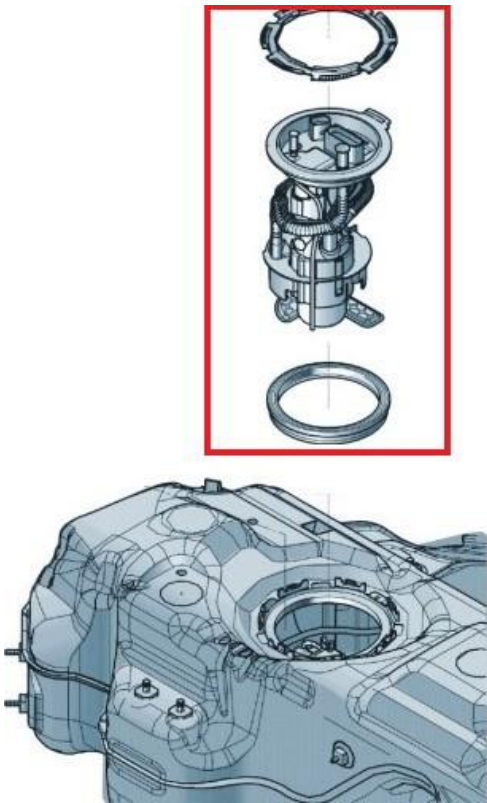
1) Referring to the example shown in Figure 1 - Check the actual pressure value

- In the event the fuel pressure actual value is above 450kPa the Fuel Delivery Module within the fuel tank (Figure 2) should be replaced

- In the event the fuel pressure actual value is above 475kPa (2023MY) the Fuel Delivery Module within the fuel tank (Figure 2) should be replaced

<input type="checkbox"/> Extended ambient conditions:		
Engine rpm	639.5	1/min
Normed load value	13.725490449999999	%
Vehicle speed	0	km/h
Coolant temperature	82	°C
Intake air temperature	42	°C
Ambient air pressure	1000	mbar
Voltage terminal 30	12.4	V
Dynamic environmental data	20 96 28 11 CE 11 94 11 C8 12 80 11 C9 F8 41 11 A4 26 66 12 8A AA 15 9F 66 60 15 A0 66 64	
Unlearning counter according OBD	40	
Low fuel pressure, specified value	450.0	kPa
Fuel low pressure, actual value	501.3	kPa
Fuel pump adaptation	-198.3	kPa
Fuel pump, specified value	14.99939	%
Fuel temperature	79.5	°C
Fuel high-pressure, actual value	13.104	MPa
Fuel pressure rail 2	13.106	MPa

The fuel tank flange seal and securing ring should also be replaced

- Refer to Repair Group 20 Fuel supply, gas operation / 4.0L V8 TSI / Fuel pump, fuel level sensors, and jet pump (RH) - To remove and fit

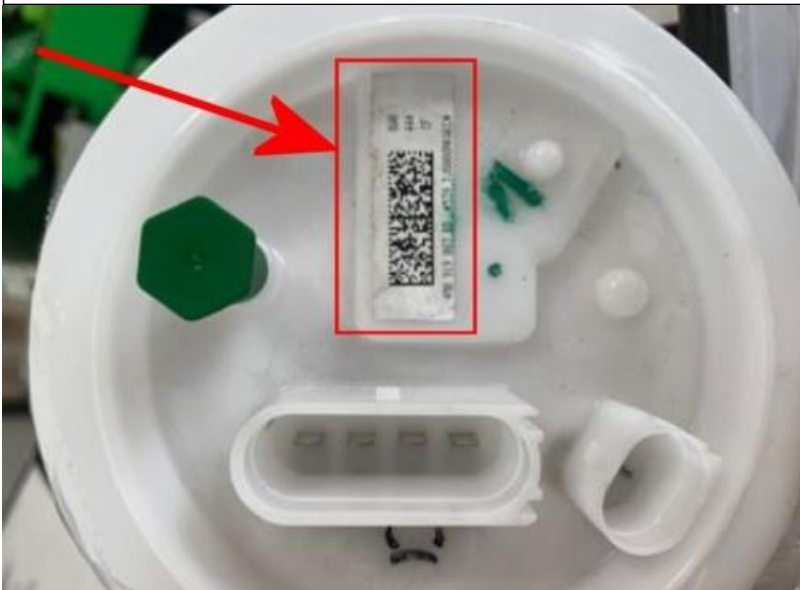
IMPORTANT: Once the fuel delivery module has been replaced, the operative should attach a clear photograph of the manufacture information label as shown in Figure 3
