Technical product information

| Topic | Rotating display/screen - Fault diagnosis - Mechanical malfunction DTC B140107 is evident within 005F |

New Continental GT

- Bentley Rotational Display (BRD) operational issues
- Mechanical malfunction DTC B140107 evident within 005F

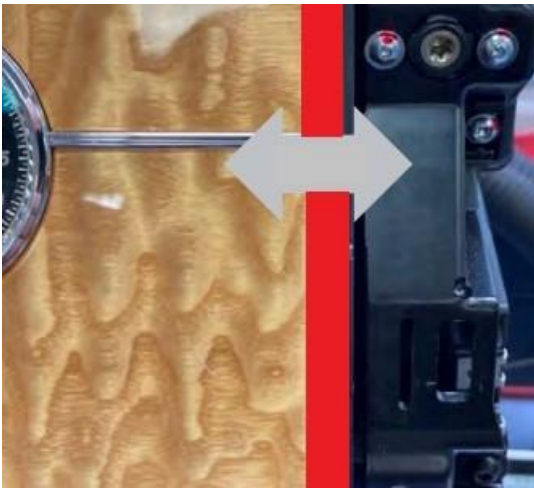
Figure 1

HINT: Referring to Figures 1 and 2, if there is a large gap on one side of the fascia panel and a small gap on the opposing side or a report of clashing with driver fascia or clunking the operative should check to confirm the bearings of the unit have not displaced as shown in Figure 3

In the event the symptoms are as detailed within Figures 1,2 and 3 please do not continue with any further diagnosis as the only possible method of repair is to replace the BRD unit, prior to replacing the BRD the operative must raise a Technical DISS query to request permission to replace the BRD unit ensure clear photographs or videos of the issue are attached

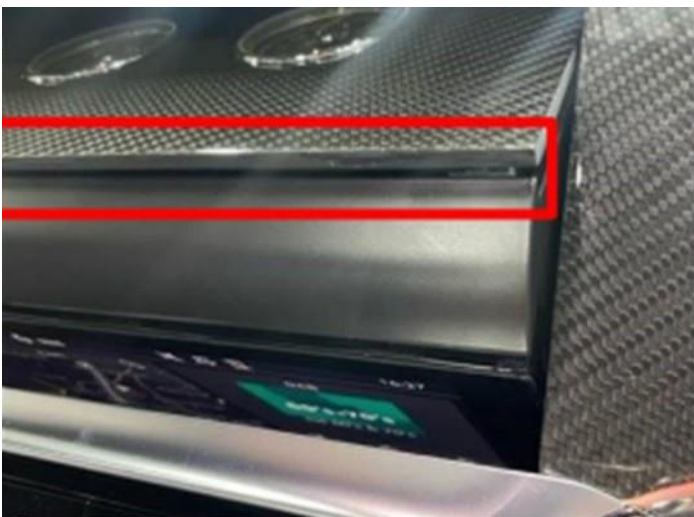
Figure 4

4) Conduct a visual check to ensure that the display clocks, dials fascia and veneer fascia are not unclipped from the rotating display assembly (Figures 4 and 5 show an example of the display clocks and/or dials fascia unclipped)

Please note: The BRD must be removed (Rep.Gr 91) to allow visual inspection of the panel at the back of the BRD for signs of unclipping (Figure 4)

5) Referring to Rep.Gr 91 - Remove the applicable fascia (Display clocks, dials fascia and/or Veneer fascia)

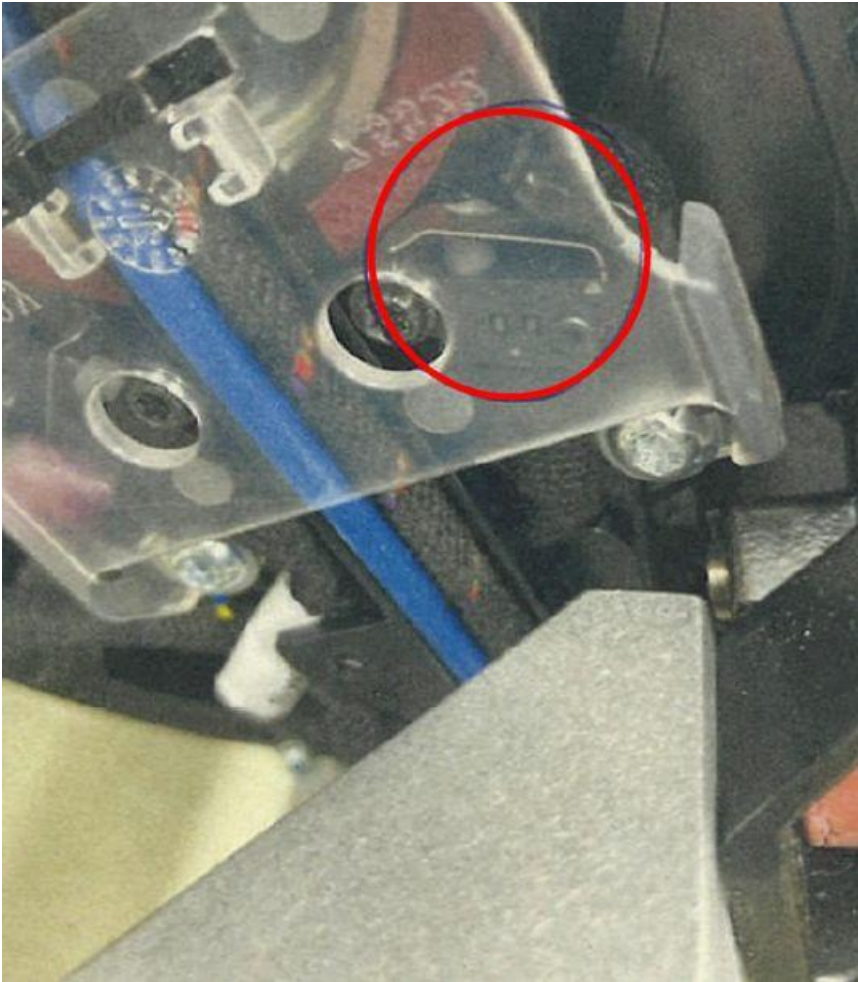
NOTE: Figure 10 shows an example of striker misalignment and switch damage

- Once the afore mentioned work has been conducted successfully - Referring to Rep.Gr 91 - Refit the BRD
