## Technical product information

<b>Topic</b>	Vehicle sitting low or high on one or more corners when static with no relevant DTCs stored
<b>Market area</b>	Russische Föderation (5RU),Australia E04 Bentley rest Asia and Australia (6E04),China 796 VW Import Comp. Ltd (Vico), Beijing (6796),Germany E02 Bentley rest Europe (6E02),Japan E03 Bentley Japan (6E03),Korea, (South) E08 Bentley South Korea (6E08),United Arab Emirates E06 Bentley Middle East and Africa (6E06),United Kingdom E01 Bentley UK (6E01),United States E05 Bentley USA and rest America (6E05)
<b>Brand</b>	Bentley
<b>Transaction No.</b>	2064582/5
<b>Level</b>	EH
<b>Status</b>	Approval
<b>Release date</b>

Vehicle sitting low or high on one or more corners when static with no relevant DTCs stored

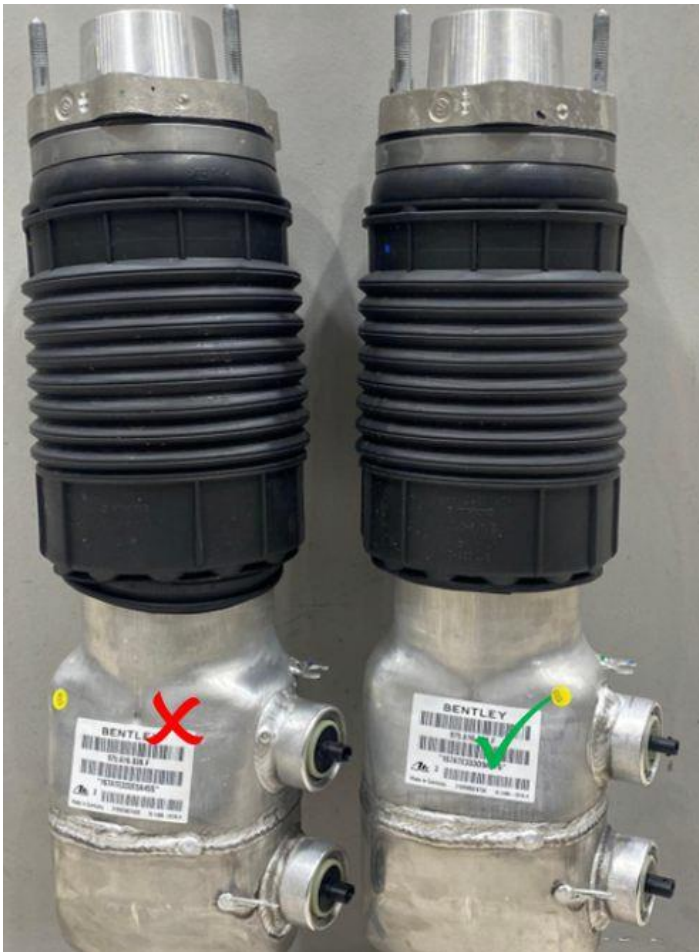
8) Referring to Figure 3 - Inspect the left and right hand front air springs checking for any signs of damage and/or distortion

NOTE: Figure 3 shows the left hand front air spring damper distorted

- In the event an issue is found with the left and/or right air spring damper - Refer to Rep.Gr 40 - Replace the left and right hand front air spring dampers

Within the front air spring damper procedure there are single use items which must be replaced and not reused. Ensure that new replacements are available prior to starting this procedure - Refer to the ETKA parts catalogue
