# TECHNICAL SERVICE BULLETIN

Classification: HA23-004	Reference: NTB23-032	Date: April 12, 2023
-----------------------------	-------------------------	-------------------------

## HVAC BLOWER DOES NOT OPERATE ON COLD STARTS

**APPLIED VEHICLES:** 2021-2023 Rogue (T33)

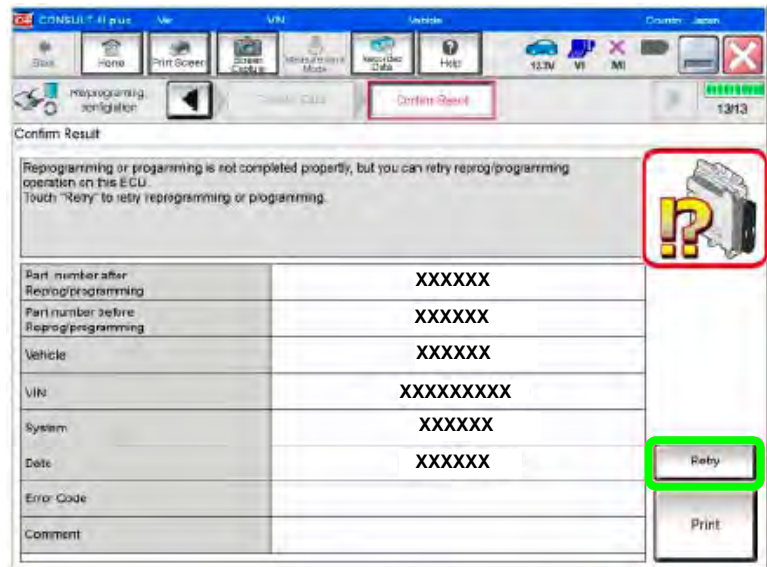
Figure 12

If reprogramming does not complete, and the “!?” icon displays as shown in Figure 12:

- Check battery voltage (12.0 V – 15.5 V).
- Ignition is ON, engine is OFF.
- External Bluetooth® devices are OFF.
- All electrical loads are OFF.
- Select retry and follow the on screen instructions.
- “Retry” may not go through on first attempt and can be selected more than once.

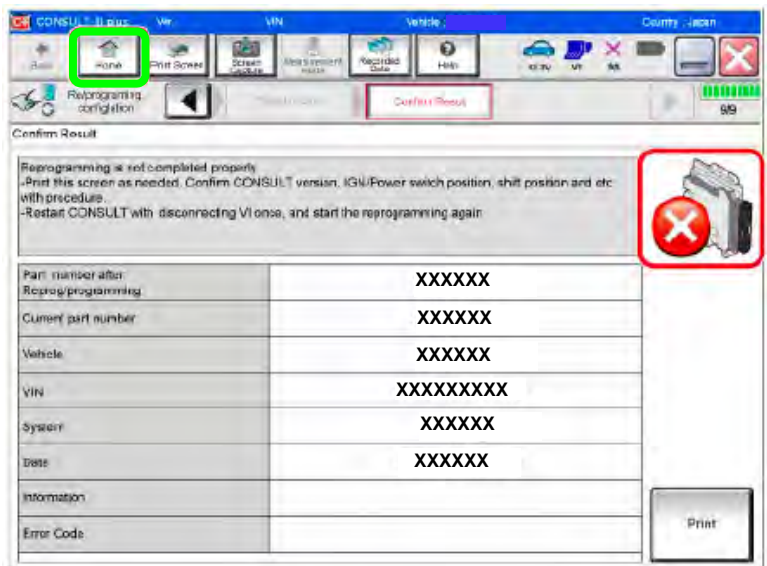
Figure 13

If reprogramming does not complete, and the “X” icon displays as shown in Figure 13:

- Check battery voltage (12.0 V – 15.5 V).
- CONSULT A/C adapter is plugged in.
- Ignition is ON, engine is OFF.
- Transmission is in Park.
- All C-III plus / VI cables are securely connected.
- All C-III plus updates are installed.
- Select Home, and restart the reprogram procedure from the beginning.
