Service Bulletin

Bulletin No.: 17-NA-216

Subject: Convertible Top Back Glass Separation from Top Cover Material

Brand:	Model:	Model Year:		Date Breakpoint:		Engine:	Transmission:
		from	to	from	to		
Buick	Cascada	2016	2019	—	—	All	All
Chevrolet	Camaro Convertible	2016	2022	SOP	December 1, 2021

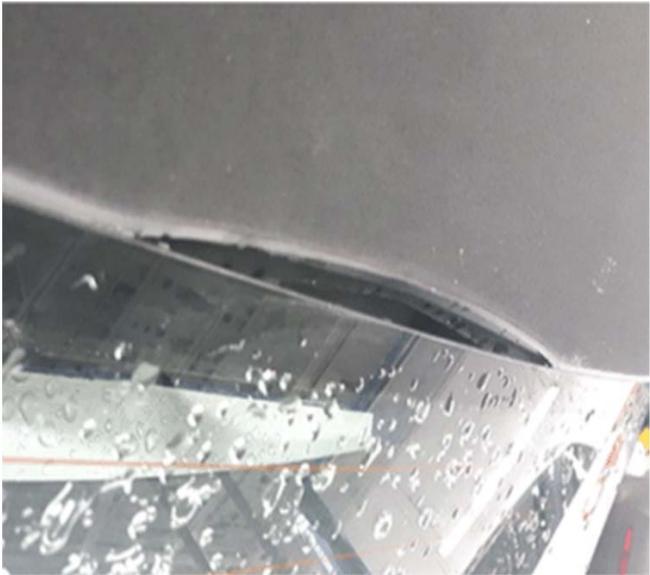
4794660

Involved Region or Country	North America, Argentina, Brazil, Bolivia, Chile, Colombia, Ecuador, Paraguay, Peru, Uruguay, Europe, Middle East, Israel, Japan
Condition 1	<p>Some customers may comment on seeing the back glass separating from the convertible top cover material.</p> <p>Several examples of the separation are shown in the graphic examples below:</p>

<p>4794670</p> <p>4794682</p>
<p>Cause 1</p>	<p>The cause of this condition may be an insufficient amount of primer used during the assembly process, which creates stress points allowing the material to separate from the glass.</p>

<p>4794112</p> <p>It will be necessary to replace the convertible top cover (1). Refer to <i>Folding Top Cover Replacement</i> in SI.</p>

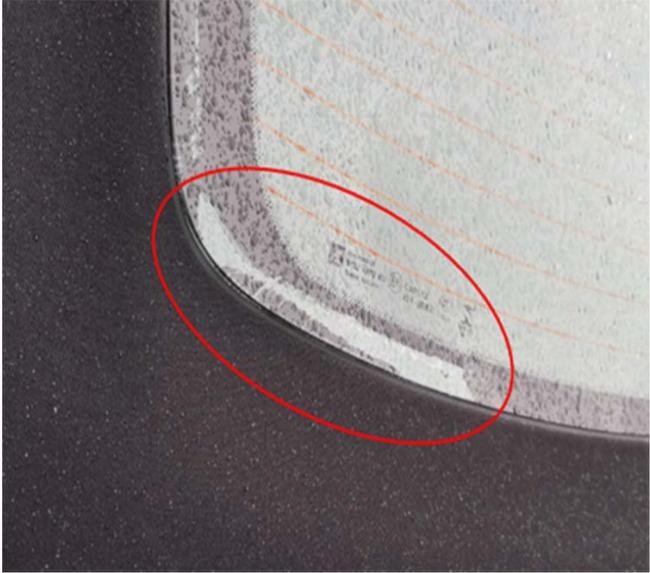
<p>5049793</p> <p>Some customers may comment that the vehicle may exhibit a condition where the back glass is separating from the top. This condition will typically start in the corner of the back glass.</p>
<p>Cause 2</p>	<p>The cause of this condition may be the back glass separating from the bond.</p>
<p>Correction</p>
