# Service Bulletin

Bulletin No.: 22-NA-007

**Subject: Poor Engine Performance in Extremely Cold Weather Conditions for LE2 Engines, Charge Air Cooler (CAC) Icing - Malfunction Indicator Lamp (MIL) Illuminated, DTC P0299, P0234, P0236, P2227, P00C7 Set**

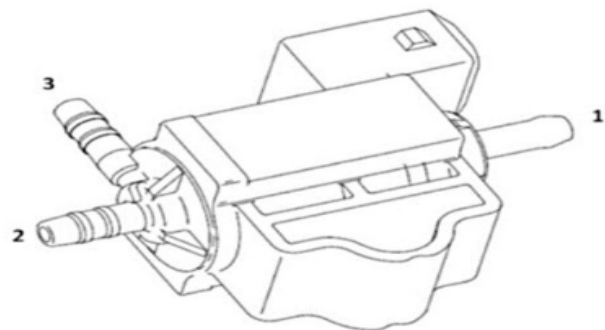
6055068

**Note:** Check port #2 to assure the spring gets lifted off the seat. This will be determined by the compressed air not dead heading when applied to port #2. When applying air to this port a small amount of air should be observed at port #3 and even less air will be noticed at port #1. If this does not happen, the TCV plunger may have hardened deposits from hot operating conditions which will impede TCV plunger movement, and the turbocharger wastegate regulator solenoid valve should be replaced.

3. Using clean shop air regulated to 80-100 PSI, blow through all three ports (1, 2 & 3) for 5 seconds each.

⇒ Repeat step 3 twice.
