Service Bulletin

Subject: Oil Leak from Front of Engine

Brand:	Model:	Model Year:		VIN:		Engine:	Transmission:
		from	to	from	to	Engine.	Transmission.
Chevrolet	Corvette	2023	2023	_	_	5.5L (RPO LT6)	—

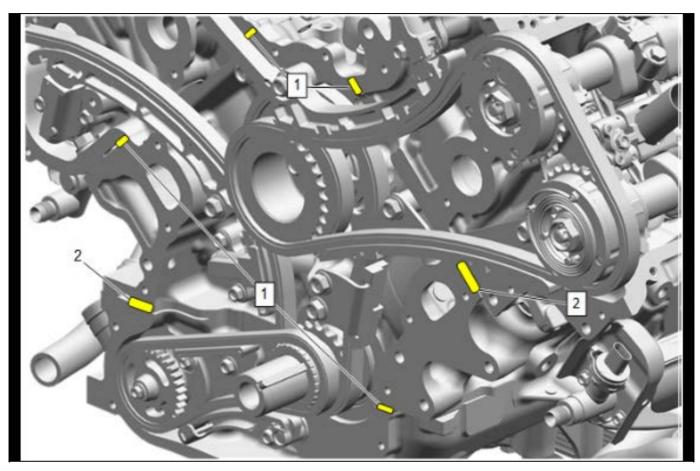
6002788

Important: Application of the RTV has changed. Please refer to the picture and steps below for proper RTV application.

Note: The sealing surface must be clean and free of contaminates prior to applying the RTV sealant. Do not touch the sealing surface once it has been cleaned.

1. Clean the sealing surface at the T-Joints (1 and 2) with low VOC brake cleaner, then wipe dry with a clean lint-free cloth.

Note: Do not allow RTV to skin over. The engine front cover gaskets and engine front cover must be installed within 8 minutes of RTV application.

- 2. Apply a 5 mm wide x 15 mm bead of sealant to the 4 T-Joints (1) between the cylinder head-to-engine block and the engine block-to-lower crankcase.
- 3. Apply a 5 mm wide x 25 mm bead of sealant to the 2 T-Joints (2) between the cylinder head-to-engine block and the engine block-to-lower crankcase.
