# Service Bulletin

Bulletin No.: 23-NA-078

**Subject:** Changing Front Pedestrian Braking Alert Options Error

Brand:	Model:	Model Year:		VIN:		Engine:	Transmission:
		from	to	from	to		
Chevrolet	Traverse	2021	2023

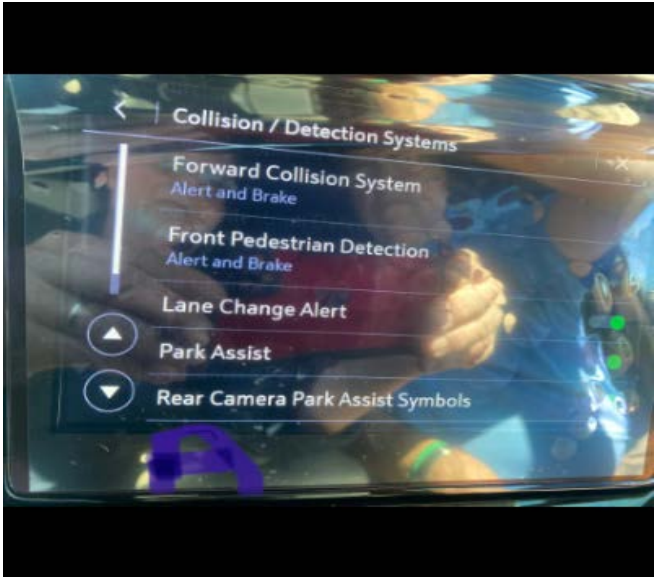
6182077

<b>Involved Region or Country</b>	United States, Canada
<b>Additional Options (RPOs)</b>	Equipped with RPO UGN Radar Based Sensing
<b>Condition</b>	Some customers may comment on not allowing the driver to change the option from Alert/Braking to only alert or off. Pedestrian Braking feature is not affected, only the option for changing the alerts.
<b>Cause</b>	The cause of the condition may be software anomalies.
<b>Correction</b>	<p>Verify the option is not available then reprogram the Active Safety Control Module.</p> <div style="text-align: center;">

1. Reprogram the Active Safety Control Module.  
Refer to *K124 Active Safety Control Module: Programming and Setup* in the Service Manual.
