SERVICE BULLETIN

APPLICABILITY: 2010-2013 Legacy and Outback Models
SUBJECT: Sunroof Does Not Open or Close Properly
 Popping or Slamming Sound When Glass Lowers
 Prior To Opening

NUMBER: 07-72-13
DATE: 01-29-13

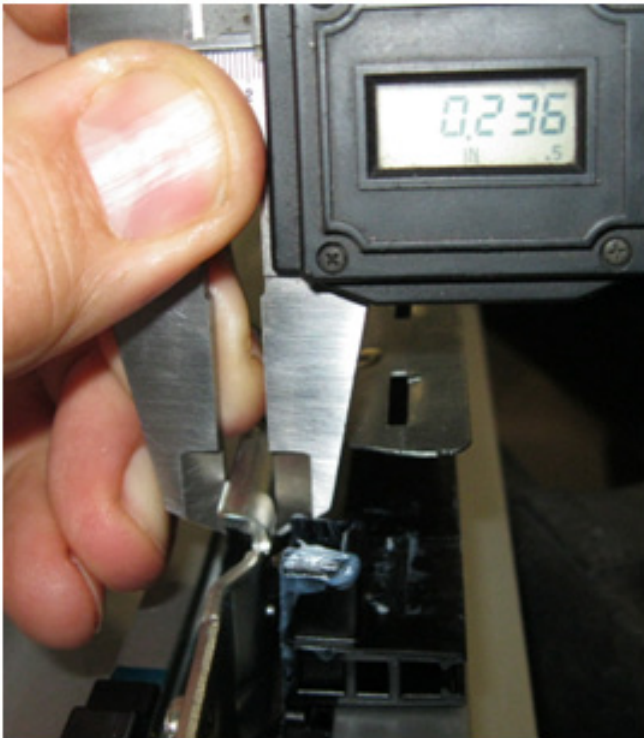
Original Cable Bracket

While the rail (sunroof frame) assembly remains virtually unchanged, significant revisions have been made to the cable assemblies (lid brackets) to increase their durability, rigidity and ease of operation as shown in the photos below.

The “Cable Repair Kit” consists of a revised lid bracket and sunroof operating cable assembly.

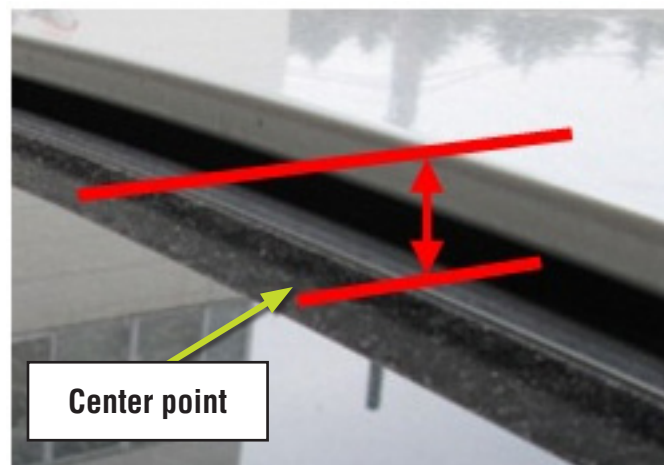
- Open the sunroof to the point where the rear edge of the glass is fully dropped down, just before it retracts under the roof panel.
 - o Determine the center point of the back edge of the glass panel by measuring from the outside edges in toward the middle from each side.
 - o Measure the distance between the top outside edge of the roof opening flange and the glass panel as shown in the photo below.

The standard values are 21.7 mm for Legacy, and 21.9 mm for Outback.

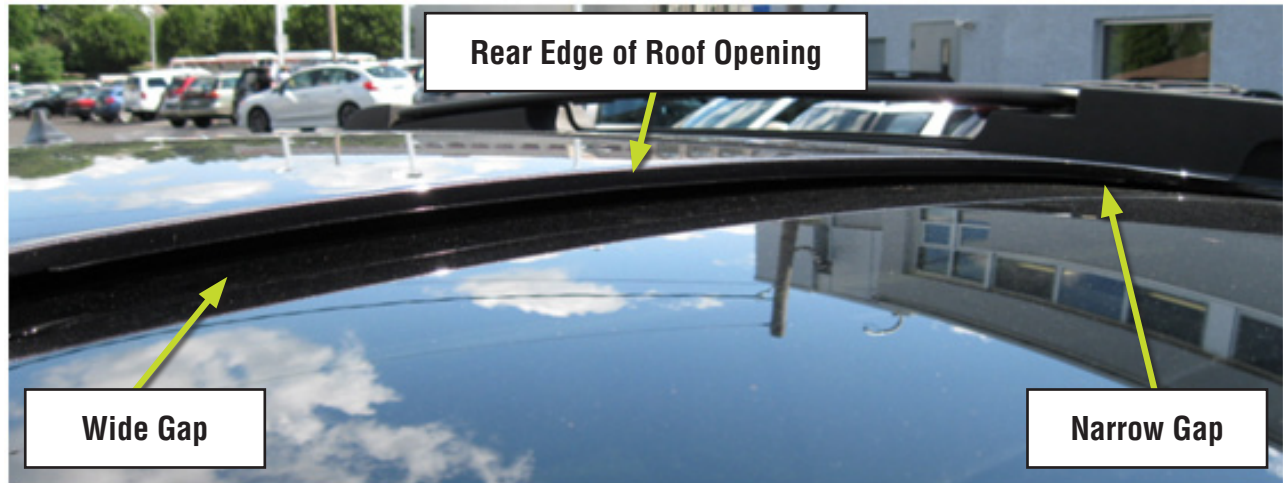
If the measurement is correct, inspect the gap from side to side and make sure it is even (one side is not higher or lower than the other). The photo below shows an Outback sunroof with the left (driver's) side of the glass panel much higher (narrow gap) than the right.

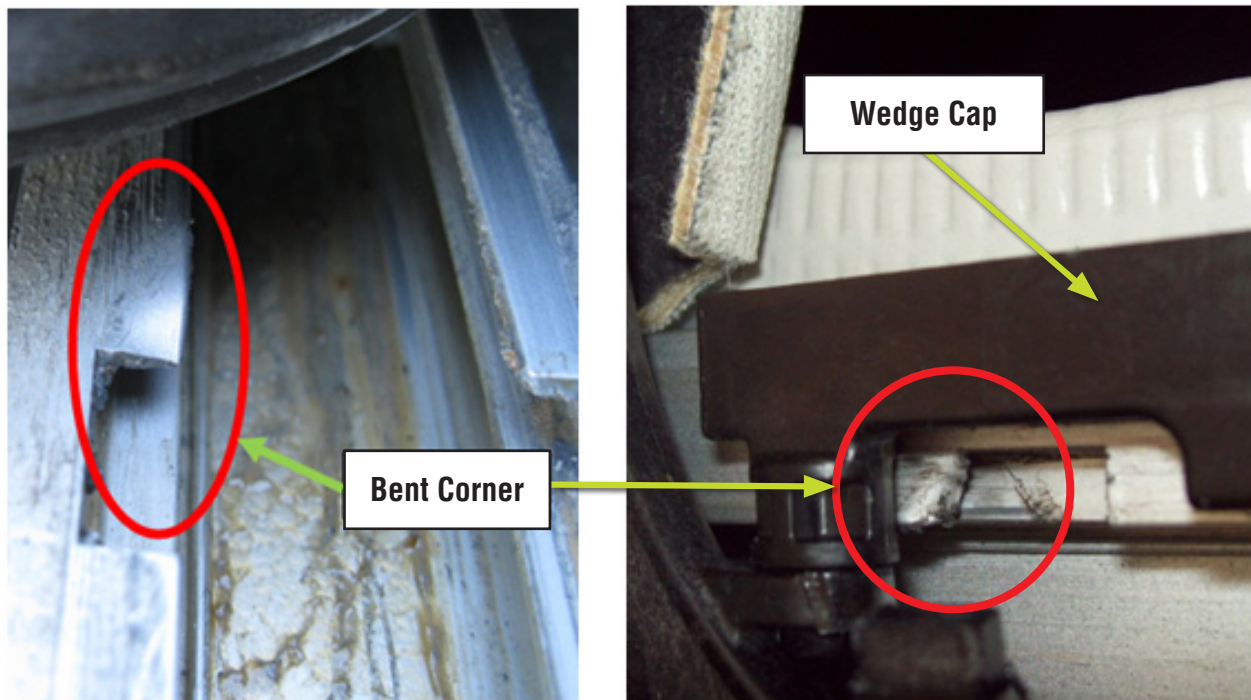
In this case, although the sunroof on this vehicle is operational, the corners of the rectangular openings in the side rails have become deformed (bent) as shown in the photos below. This keeps the lid bracket shoe from dropping into the rectangular opening in the side rail as it should. Instead, when the glass panel retracts, the lid bracket shoe rides on top of the side rail instead of inside the channel causing the condition shown in the photo above. Again, if any deformation of the rail or the wedge cap is confirmed, replacement of the rail assembly along with both cable assemblies is required.

- Transfer the sunshade to the new frame assembly.
- Fit the new cable assemblies to the frame then re-install the sunroof assembly.
- Reconnect the battery.
- Perform the sunroof motor initialization procedure outlined in the applicable Service Manual.
- Confirm proper operation of the sunroof’s tilt, open, and close functions along with the auto-reverse safety feature.
- Take time to make sure **all** trim panels are reinstalled properly.
- Wipe off any dirt, grease or smudges with a clean cloth.
- Reset the radio station presets (and navigation system favorites if applicable).
