## SERVICE BULLETIN

**APPLICABILITY:** 2013MY Legacy and Outback 2.5L Models  
 2012-13MY Impreza 2.0L Models  
 2013MY XV Crosstrek  
 2011-2014MY Forester  
 2013MY BRZ

**NUMBER:** 11-130-13R

**SUBJECT:** Difficulty Starting, Rough Idle, Cam Position or Misfire DTCs  
 P0340, P0341, P0345, P0346, P0365, P0366, P0390, P0391,  
 P0301, P0302, P0303 or P0304

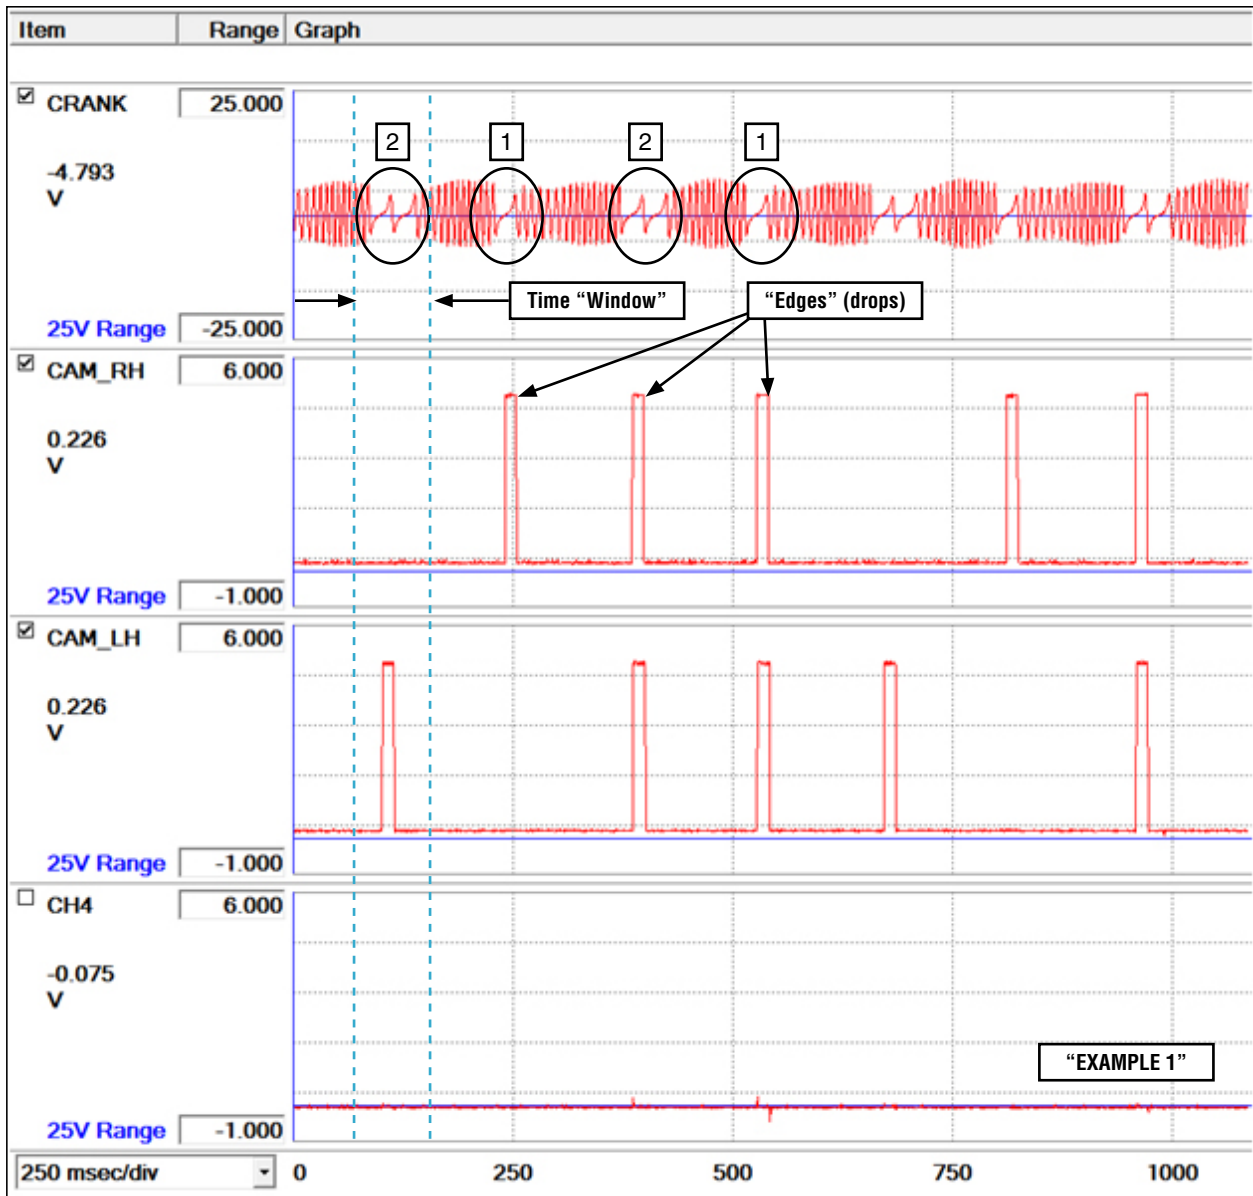
Engine Firing Order	#1	#3	#2	#4
Crank Signal ("1" or "2"?)	"1"	"2"	"1"	"2"
Is Cam Signal Edge Within Window RH?	Yes	No	Yes	Yes
Is Cam Signal Edge Within Window LH?	Yes	Yes	No	Yes

Using the chart above and comparing it to **Example 1**, it can be determined the first cylinder shown in the screen shot is #3 because the crank signal is a "2" and there is an edge signal within the window on the LH but not the RH cam sensor. Next cylinder in the firing order would be #2 as the crank position signal is a "1" and there is an edge signal in the window for the RH but not for the LH, and so on...

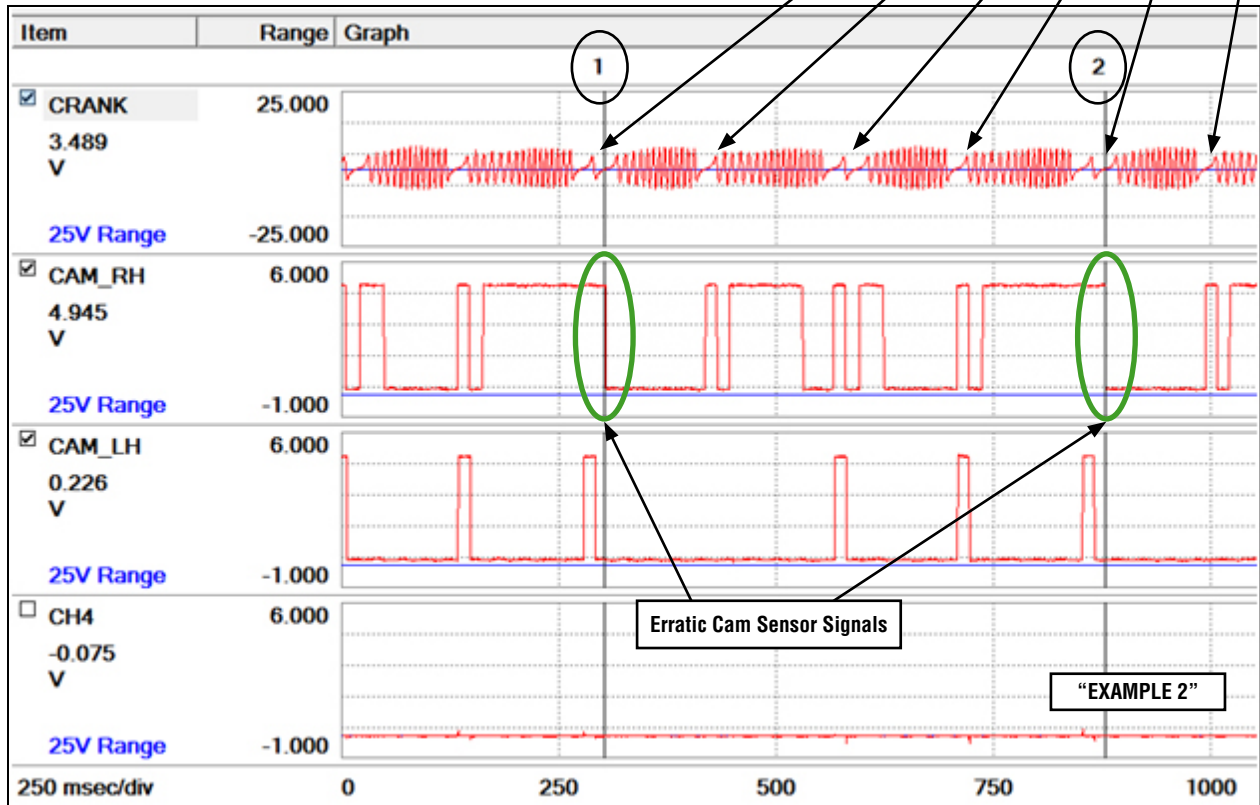
**Example 2** below shows a “Bad” pattern for the RH cam sensor. Marks #1 and #2 show what appears to be #4 cylinder firing but, the next cylinder to fire according to the screen shot is #2 followed by #4 then #1. The pattern for the RH sensor never shows the proper sequence to fire #3 cylinder. In this case, recheck the data again after installing a .2mm shim under the RH cam sensor.

**Proper Firing Order is:** #3 #2 #4 #1 #3 #2

**Firing Order shown in screen shot:** #4 #2 #4 #1 #4 #2

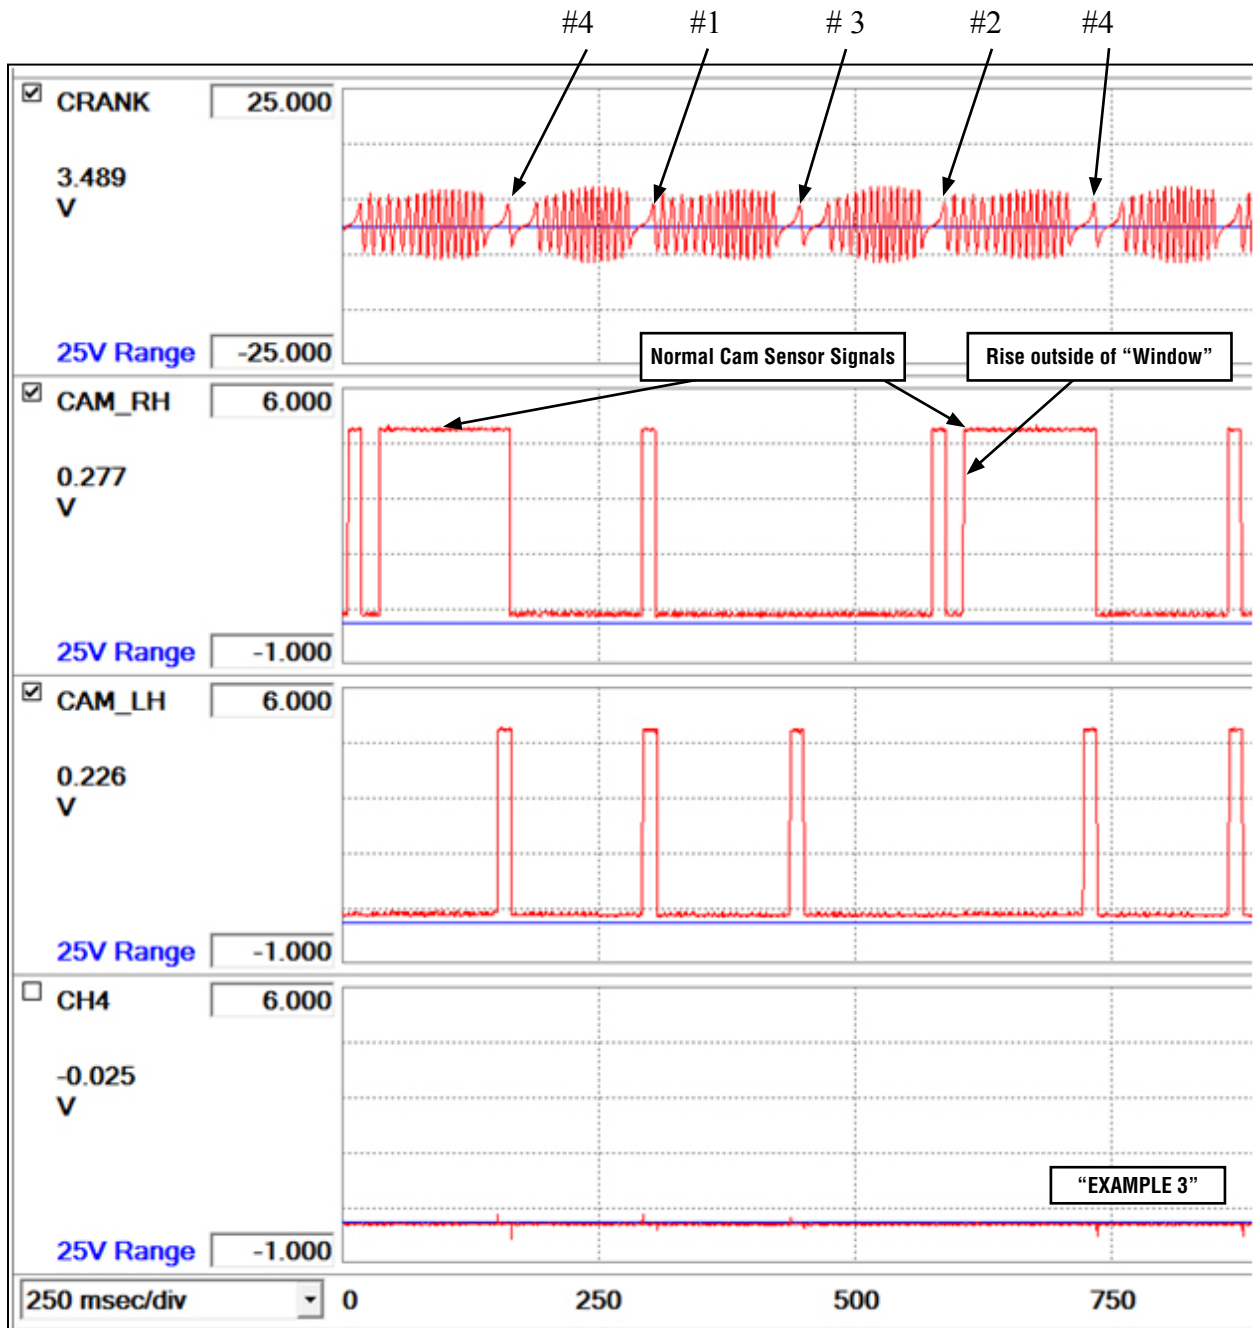
**Example 3** shows what *appears* to be an erratic signal from the RH cam sensor but, you can see all the cam sensor data signal edges (drops) follow the chart and firing order as they are supposed to. Other signal edges (rises or drops) outside the “window” or a longer time line as shown here prior to the #4 signal edges seen on the RH cam sensor pattern are examples of signals which will be “ignored” by the ECM and are not a cause for concern.

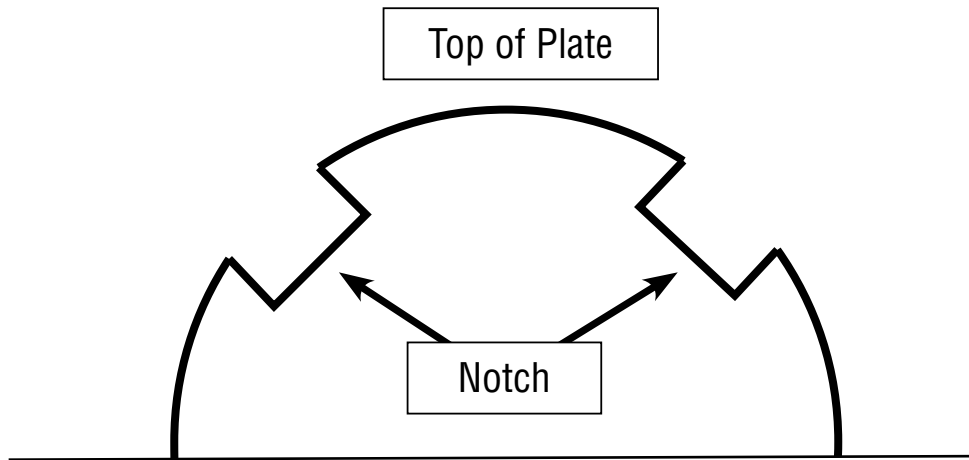
**NOTE:** When measuring “A”, make sure you are measuring to the outside diameter or “top” of the sensor plate and not to the bottom of a notch as shown below. Be sure to record all measurements.

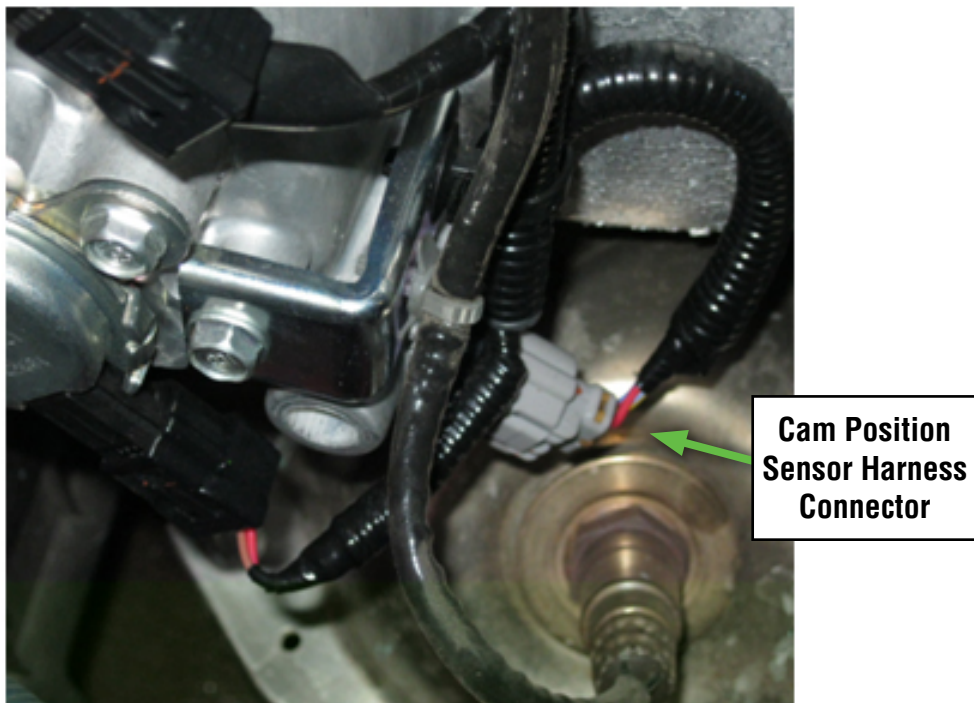
In the event you have a DTC stored for an exhaust camshaft position sensor, the repair procedure has been revised. Due to the position of the right-hand (Bank 1) sensor, measurement of the gap without removing the front catalyst is extremely difficult as shown in the photo below.

1. Confirm the irregular oscilloscope pattern for the corresponding DTC stored.
2. Remove the sensor from the timing cover and install a .2mm thick shim from the applicable kit.
3. Reinstall the sensor, torque the sensor retaining bolt to 6.4 Nm (4.7 ft. lbs. or 56.4 inch-pounds) then recheck the oscilloscope pattern.

If the pattern is normal, the repair is complete. If the irregular pattern persists, repeat Steps 2 and 3 after removing the .2mm shim and installing a .3 mm thick shim. **ONE SHIM ONLY, NO STACKING.** Repeat as necessary increasing the shim thickness .1 mm at a time until a normal scope pattern can be verified.
