SERVICE BULLETIN

APPLICABILITY: 2013 Legacy & Outback Models with 2.5L FB Engines

NUMBER: 02-143-13R

SUBJECT: Surface Treatment Change To Oil Control Piston Rings

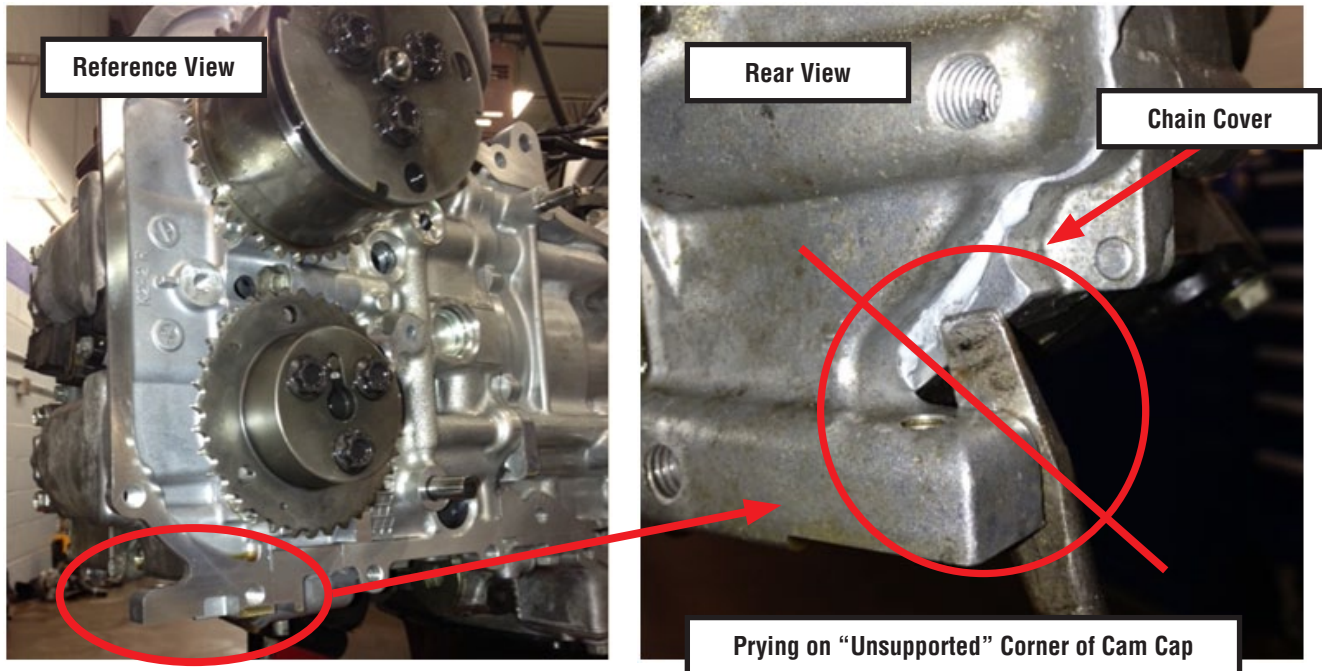
- **IMPORTANT:** After all 32 bolts securing the chain cover are removed, be **VERY** careful where you pry and what you pry on to break the silicone sealant bond. The photos below show an example of where NOT to pry. In this case, the cam cap became cracked requiring a complete cam carrier replacement. Patience is the key!
