Tesla, Inc. Service Bulletin		<h2>Retrofit A/C Compressor Pipes With Support Bracket, North America</h2>	
SB-23-18-004 April 6, 2023			
Classification		Section/Group	Mobile Service
Repair Bulletin		18 - Thermal Management	Can Perform (where permitted)
Model Year	Model	Country/Region	Build Location
2021 - 2023	Model S, Model X	North America	Fremont
<small>The model(s) and model year(s) listed are a general approximation of the affected VIN list. Refer to the VIN/Bulletin Tracker or Customer/Vehicle profile to determine applicability of this bulletin for a particular vehicle.</small>

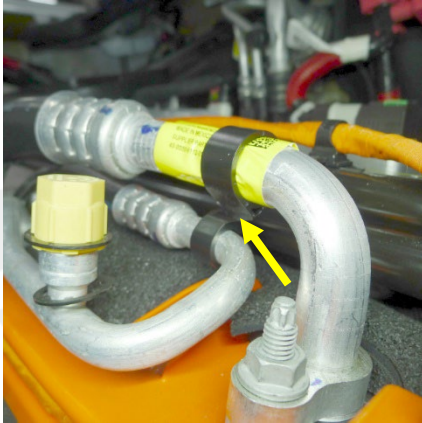
Figure 1 – Support bracket on pipes without foam sleeve

1. Inspect the A/C compressor pipes for a support bracket (Figure 1 and 2):
 - If a support bracket is installed, go to step 5 to complete this procedure. Use correction code S022318004.
 - If a support bracket is not installed, continue to the next step.

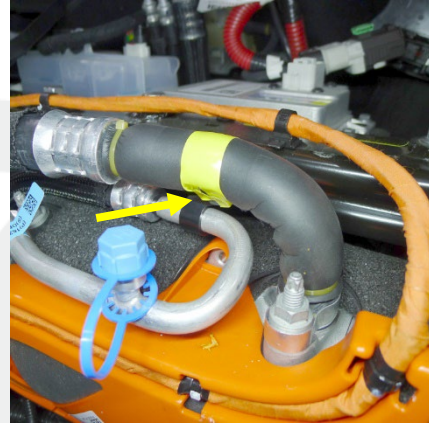
Figure 2 – Support bracket (under tape) on pipes with foam sleeve

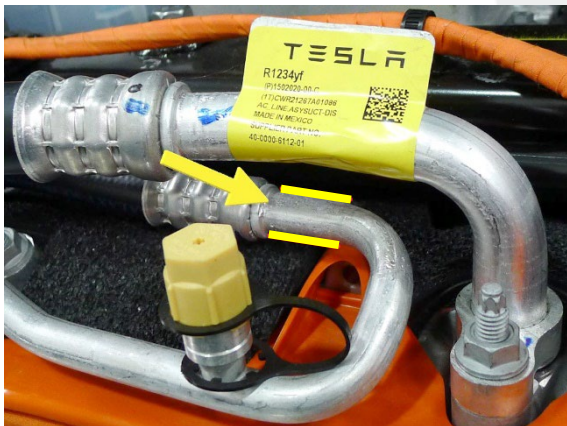
Figure 3 – Suction pipe without foam sleeve

2. Press the smaller clip of the support bracket onto the A/C compressor discharge pipe (Figures 3 and 4).

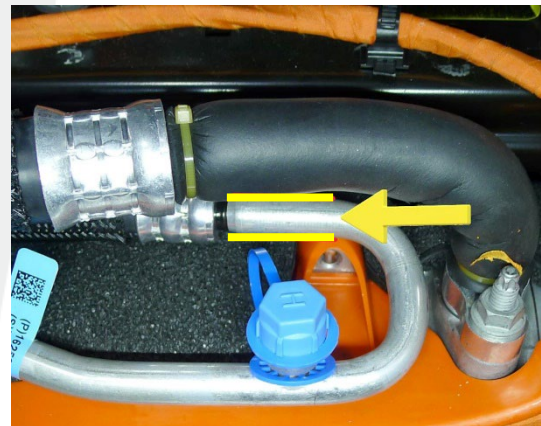
Figure 4 – Suction pipe with foam sleeve
