Campaign No. 2017030016, April 2017

SUBJECT: **Model 906, Model Year 2017
Retrofit SRS Control Module Reinforcement Plate/Protective Bracket**

Campaign No. 2017040008, May 2017

SUBJECT: **Model 447, Model Year 2017**
Retrofit Blind Spot Monitor System

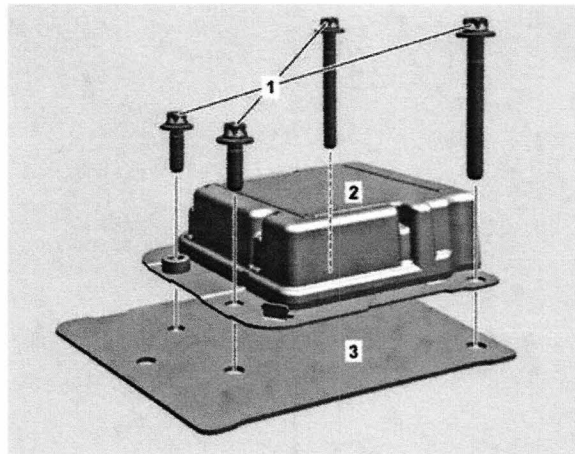
Figure 1

Daimler AG ("DAG"), the manufacturer of Mercedes-Benz and Freightliner Sprinter Vans, has determined that in certain Sprinter vehicles, the reinforcement plate/protective bracket was not installed to the airbag control module. This component is designed to protect the airbag control module in the event of a frontal crash and to ensure it remains operative after that crash. Without the reinforcement plate/protective bracket the airbag control module could be damaged and may not remain functional after a crash. An authorized Mercedes-Benz or Freightliner Sprinter dealer will install the reinforcement plate/protective bracket on affected vehicles.

Retrofit SRS control module reinforcement plate/protective bracket (3, Figure 1): Align reinforcement plate/protective bracket (3) with threaded mounting bores of SRS control module (2) at control module's installed position.

Reinstall SRS control module (2, Figure 1) on top of reinforcement plate/protective bracket (3):

Torque mounting bolts (1) to: 10 Nm.

**Note:**
 Check for correct seating of reinforcement plate/protective bracket (3) when installing SRS control module (2).
4.

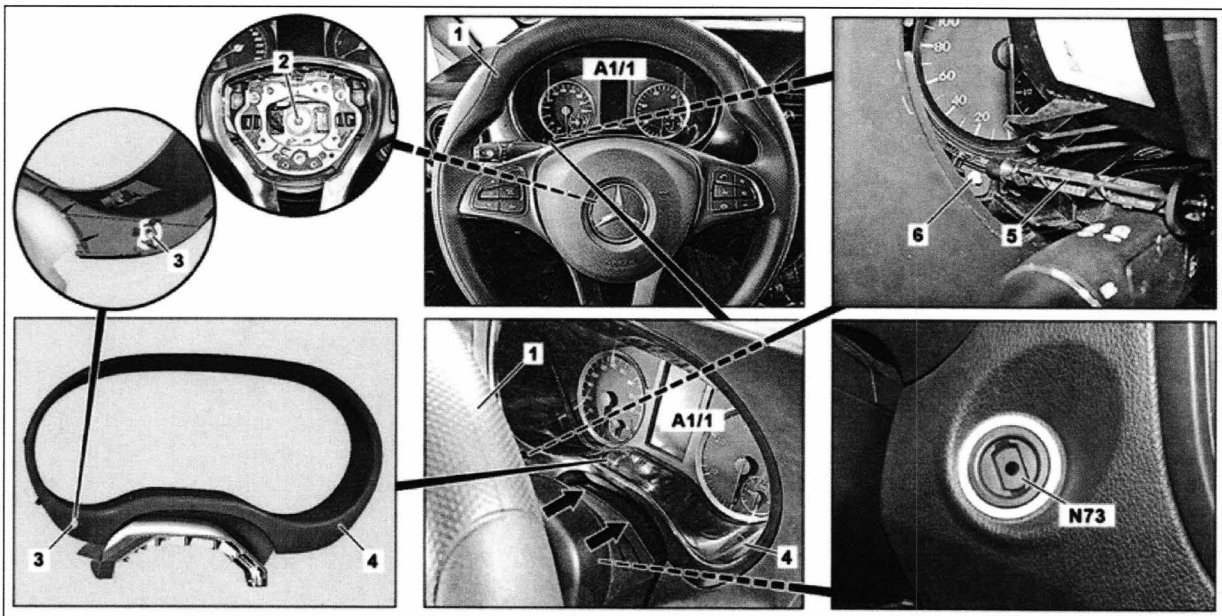
Figure 1

Daimler AG ("DAG"), the manufacturer of Mercedes-Benz Metris vehicles, has determined that certain Mercedes-Benz Metris vans were delivered without an operational passive Blind Spot Monitoring (BSM) function, despite being ordered by the customer. Due to a documentation error, the affected vehicles were fitted with an instrument cluster and steering wheel which do not support the BSM function. The absence of the BSM function could increase the risk of a crash should the customer attempt to operate the vehicle with the expectation that the BSM function is operational.

Replace steering wheel (1, Figure 1), refer to WIS: AR46.10-S-0100E.

Install new steering wheel mounting bolt (2) and torque to proper specification.

**Note:**
 The adjustment shaft extension (5, Figure 1) is retrofitted. To attach the adjustment shaft extension (5) to the instrument lighting adjustment shaft (6), the cover (3) on the trim (4) must be removed.

Perform function test of instrument cluster (IC) control unit (A1/1, Figure 1) and steering wheel (1).

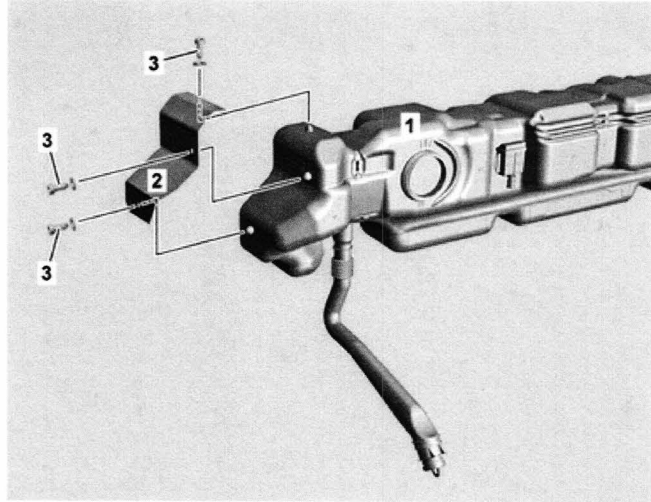
Figure 1

Daimler AG ("DAG"), the manufacturer of Mercedes-Benz Sprinter Vans, has determined that certain Sprinter 4x4 vehicles may not have been equipped with the correct fuel tank. The installed fuel tank is not equipped with a front protective plate or a fire resistant foam ring at the filler neck to prevent leakage after a rear-end crash. In the event of a rear-end crash, the drive shaft may cause damage to the fuel tank, which may result in loss of fuel and an increased risk of fire. This could lead to an increased risk of injury to occupants. An authorized Mercedes-Benz Sprinter dealer will replace the fuel tank on affected vehicles.

Remove fuel tank (1, Figure 1) refer to WIS: AR47.10-D-4100SD.

Mount heat shield (2, Figure 1) to new fuel tank (1) using screws (3) with washers.
3.

Install new fuel tank (1).

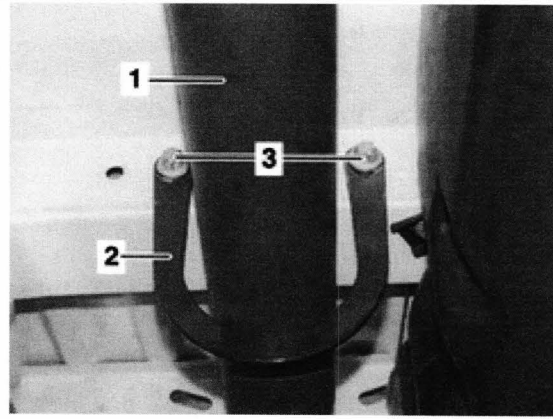
Figure 1 (1 Drive shaft, 2 Drive shaft strap/loop, 3 Bolts)

Daimler AG (DAG), the manufacturer of Mercedes-Benz Sprinter Vans, has determined that certain Sprinter 4x4 vehicles were not equipped with a drive shaft loss protection catch strap. As a result, in the event of a crash, the missing catch strap may lead to the drive shaft damaging the fuel tank, increasing the risk of fuel loss and a fire. In addition, the vehicle will not fulfill the requirements of Federal Motor Vehicle Safety Standard FMVSS 301 (Fuel System Integrity). An authorized Mercedes-Benz Sprinter dealer will retrofit the additional drive shaft catch strap to the affected vehicles.

Retrofit drive shaft strap/loop (2, Figure 1) to cross member with mounting bolts (3).

Torque mounting bolts (3) to: 70 Nm.
