May 3, 2023

Version 5

Warranty Extension: 2016-20 HR-V CVT Premature Belt Deterioration

Supersedes 21-047, Dated December 16, 2021, to revise the information highlighted in **yellow**.

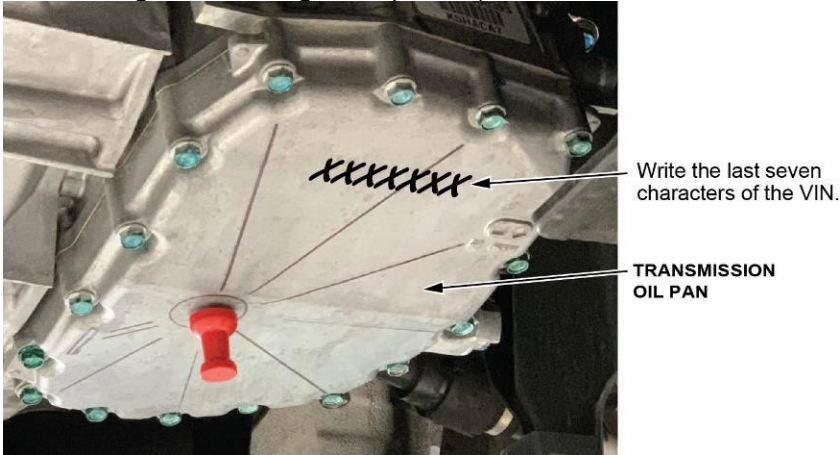
- Provide a clear picture of the magnet sticking on the CVT oil pan at the inspection area (this picture should have been taken during the CVT magnet inspection). Also, write the last seven characters of the VIN on the transmission oil pan.

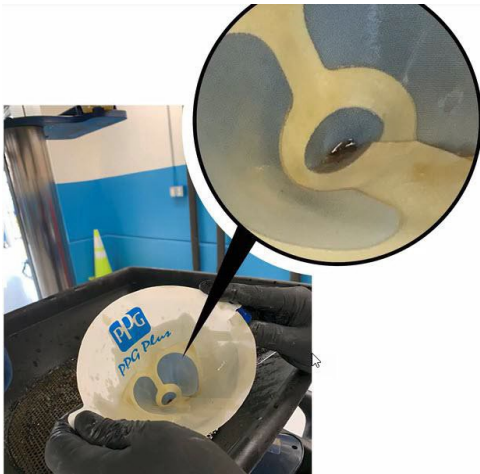
- Drain the CVT fluid through a paint strainer as shown below. Provide a clear picture of the inside of the strainer showing any contamination.

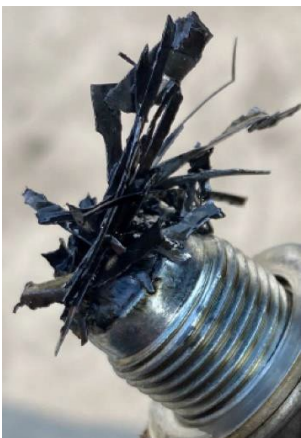
- Provide a clear picture of any contaminants on the end of the oil pan drain plug.
